DESCRIPTIVE REPORT (HYDROGRAPHIC)

Type of Survey ... Field Examination

Locality San Marcos Wreck

F.E. 3 (1950)
SAN MARCOS WRECK
CHESAPEAKE BAY, VA.

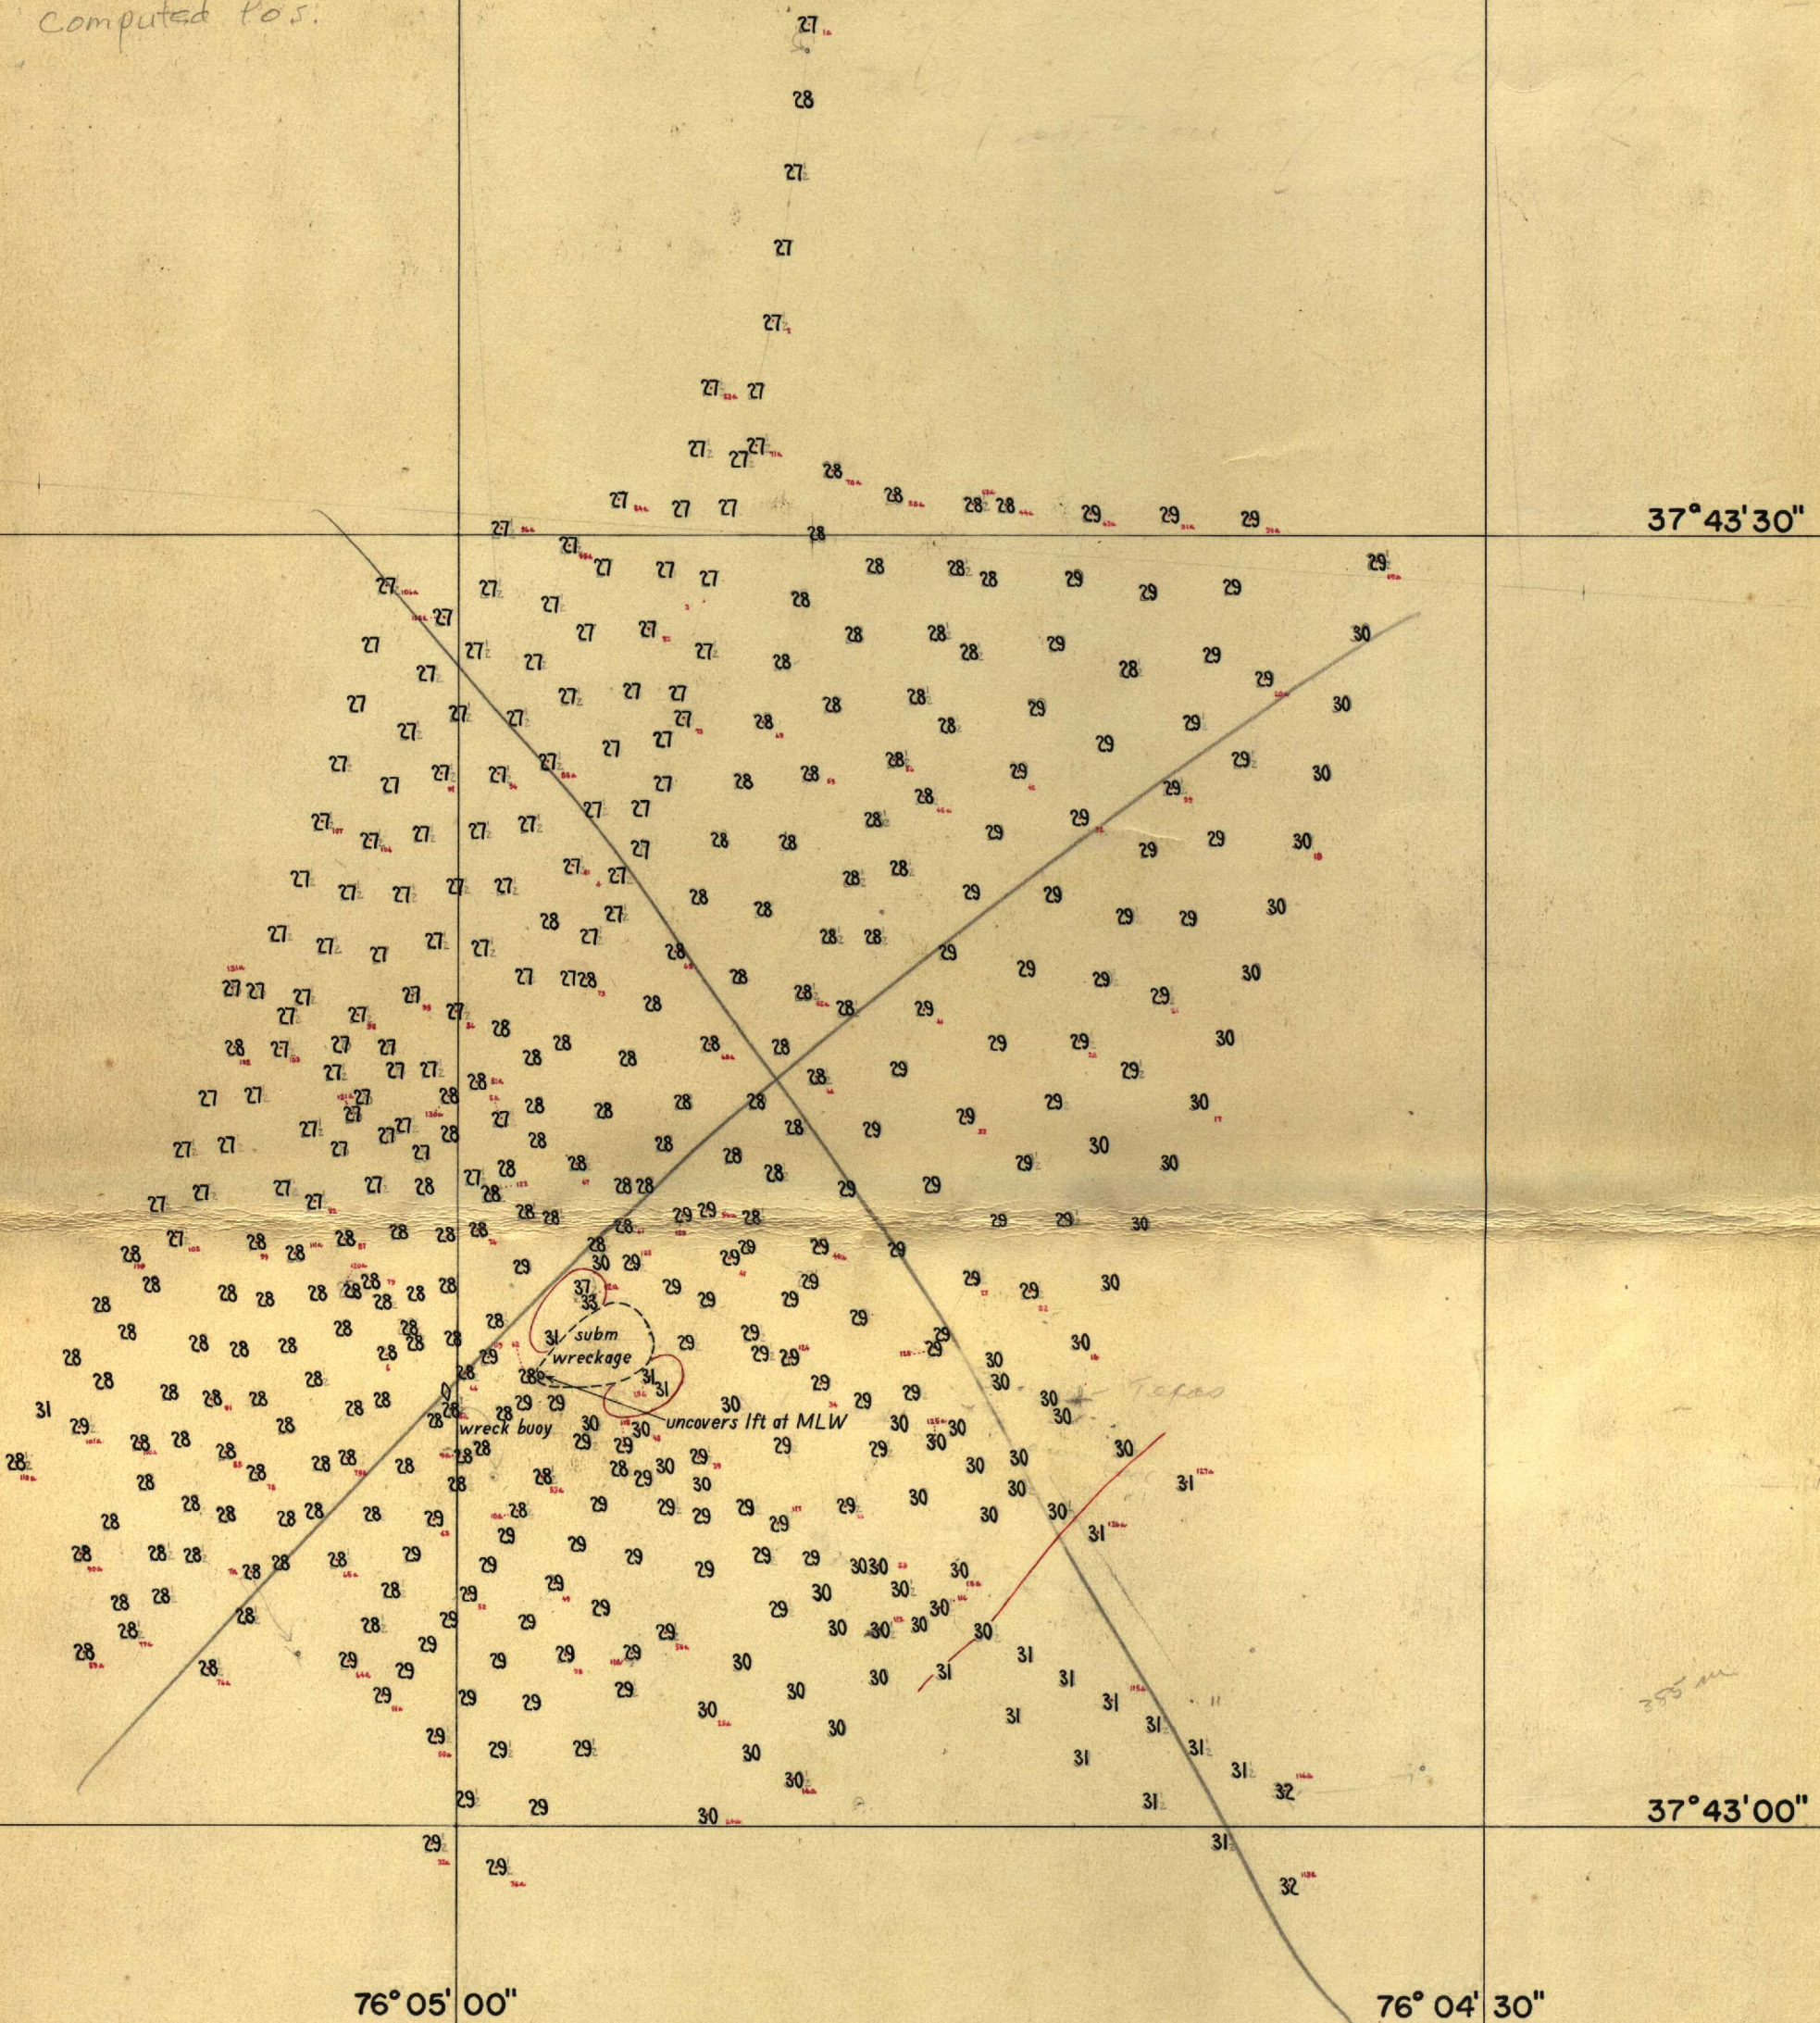
The extent of the wreckage is delineated by a dashed curve covering an area approximately 50 meters wide by 90 meters long. A part of the wreckage uncovering 1 ft. at M.L.W. lies 70 meters east-northeastward of the bell buoy. The outlined area is defined by three detached positions. The area was circled at distances of 50 feet and 100 feet without finding any further trace of wreckage on the fathogram. Furthermore, no traces of wreckage are shown on the fathograms in the area covered beyond the limits of the indicated wreckage.

A comparison with Chart 1223 (2/6/50 print) reveals that the present positions of the wreck and the bell buoy are 330 to 360 meters west of their charted positions. The position of the charted SAN MARCOS wreck symbol was computed from intersection angles taken in 1911 and checked at that time by a sextant angle at the wreck. The computations and plotting of both the present survey position and the 1911 position have been checked but no cause for the discrepancy in the two positions could be ascertained. The 1911 position, listed in the Descriptive Report for H-3313, is superseded by the position on the present survey for charting. The wreck of the motor vessel LEXINGTON charted southeast of the SAN MARCOS from Chart Letter No. 355 (1940) was not found to be separated from the outlined wreckage area. The position of the charted bell buoy corresponds to the position given in the Light List for 1949.

NOTE: POSITION OF WRECK, BUOY AND SOUNDINGS ARE IN ERROR -
 DISREGARD FOR CHARTING.
 SEE ~~CH. L. 724 (1956)~~ FOR CORRECT POSITION OF WRECK AND BUOY
 F.E. 7 (1956)

The redetermination of the position of the San Marcos wreck buoy and the wreck reported in Chart Letter 724 (1956) and F. E. 7 (1956) reveals an error in the positions determined on F. E. 3 (1950). The positions of the survey buoys on F. E. 3 were replotted from the original records and are correct with respect to the recorded angles. However, it is considered probable that the recorded observations for buoy BAR are faulty and the buoy should plot about 60 meters easterly of its plotted position. In this position the sounding lines would plot north - south and east - west, and the position of the wreck would plot in agreement with the 1911 triangulation determination. Because of the probable error in the position of the survey buoy, F. E. 3, 1950 is considered to be erroneous in position and information from this field examination should be disregarded for charting. The position of San Marcos Wreck and the wreck buoy should be charted from F. E. 7, (1956).
