**DESCRIPTIVE REPORT**

Type of Survey Wire Drag  
Field No. R/H-20-1-78  
Registry No. F00222

State Virginia-Maryland  
General Locality Chesapeake Bay  
Sublocality Chesapeake Channel to  
Cove Point  
1978  
CHIEF OF PARTY  
R.V. Smart

Project No. OPR-E609-RU/HE-78

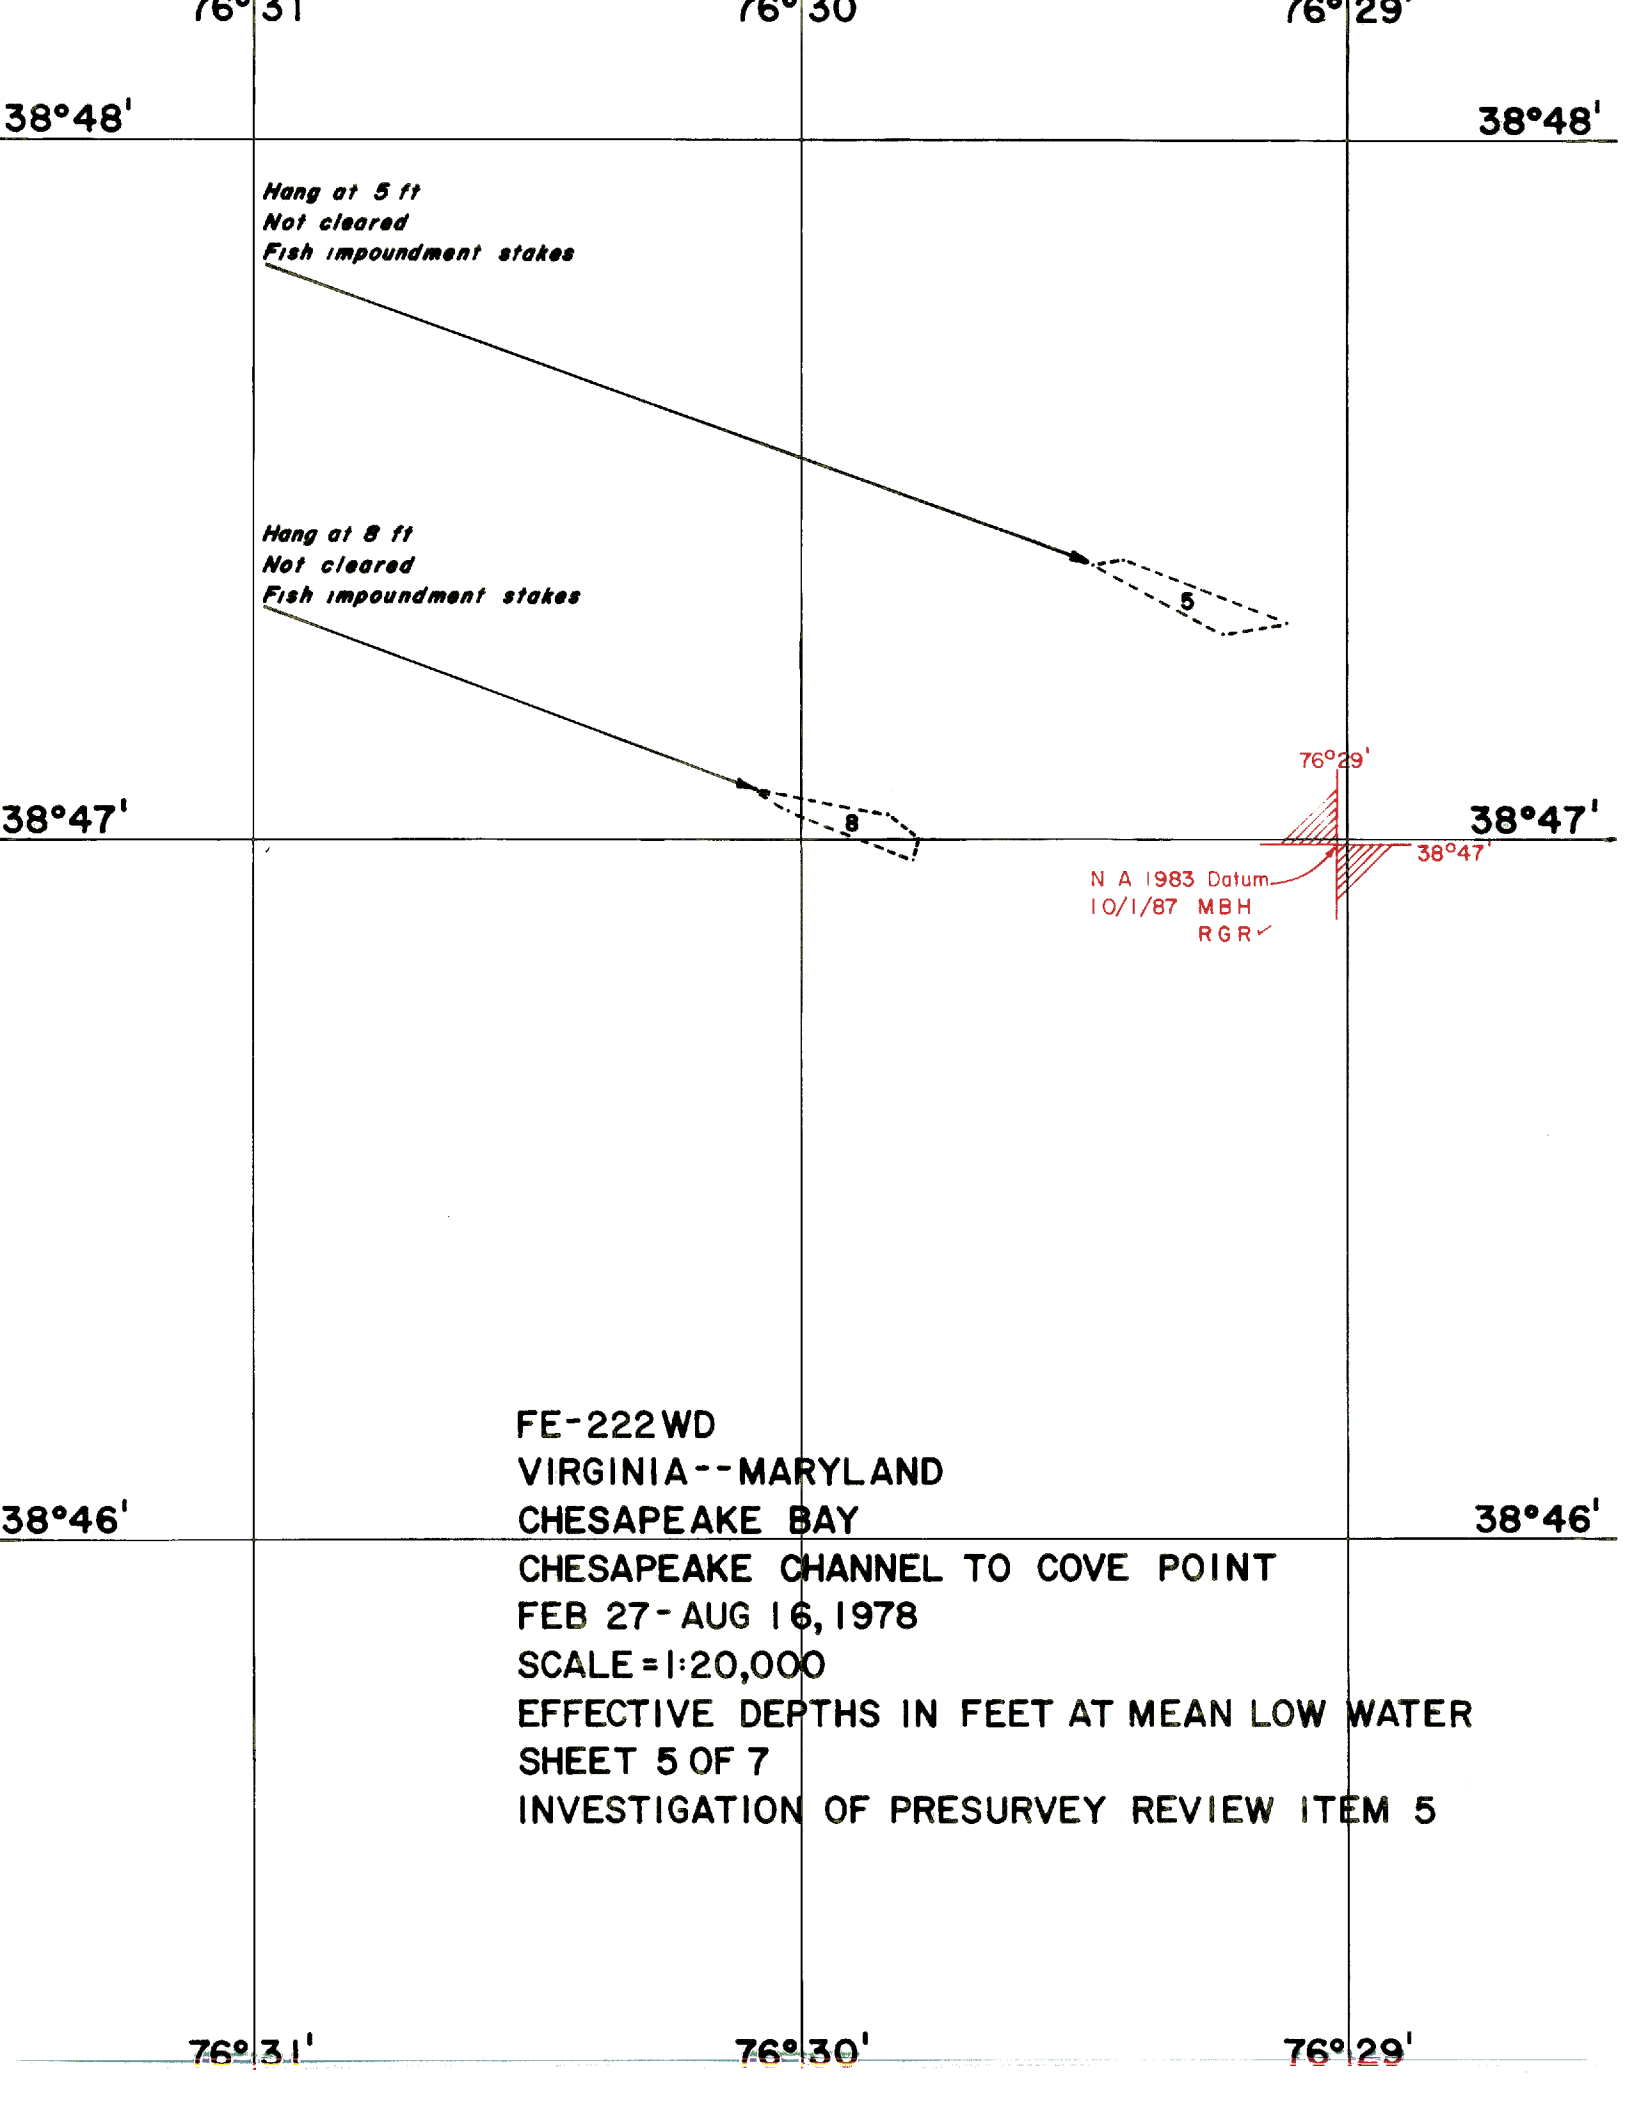
Hang at 5 ft  
Not cleared  
Fish impoundment stakes

Hang at 8 ft  
Not cleared  
Fish impoundment stakes
