DESCRIPTIVE REPORT

Registry No. **F00505**

General Locality Baltimore Harbor

Sub-locality Sparrows Point to Locust Point

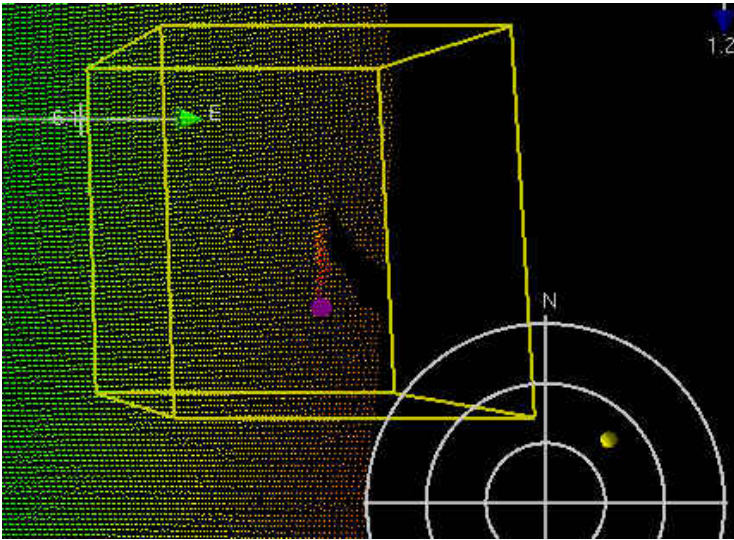
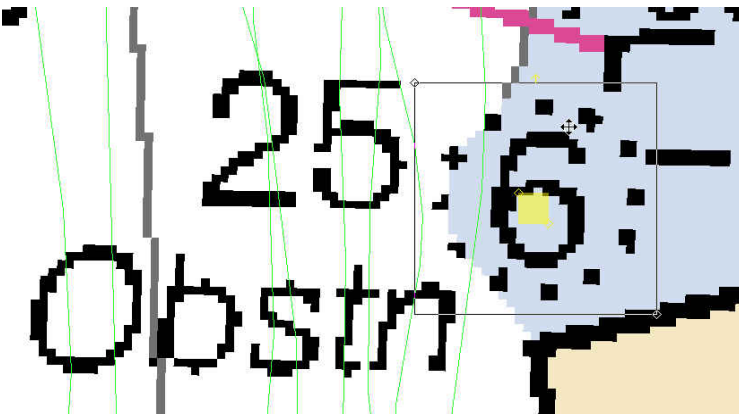
AWOIS 13,243

The least depth obtained from the SWMB system is deeper than the charted least depth, however, the sounding was observed with the outermost beam and it is possible that the object is shoaler than the surveyed depth of 4.027m. Due to the location of the obstruction, a closer survey line was deemed unsafe by the Officer in Charge.

Due to the limited search radius of the item, the Hydrographer recommends retaining the current charted feature and least depth of 6 ft. **Concur. Retain the dangerous 6 ft Obstn.**

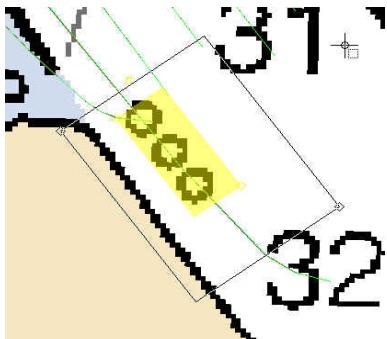
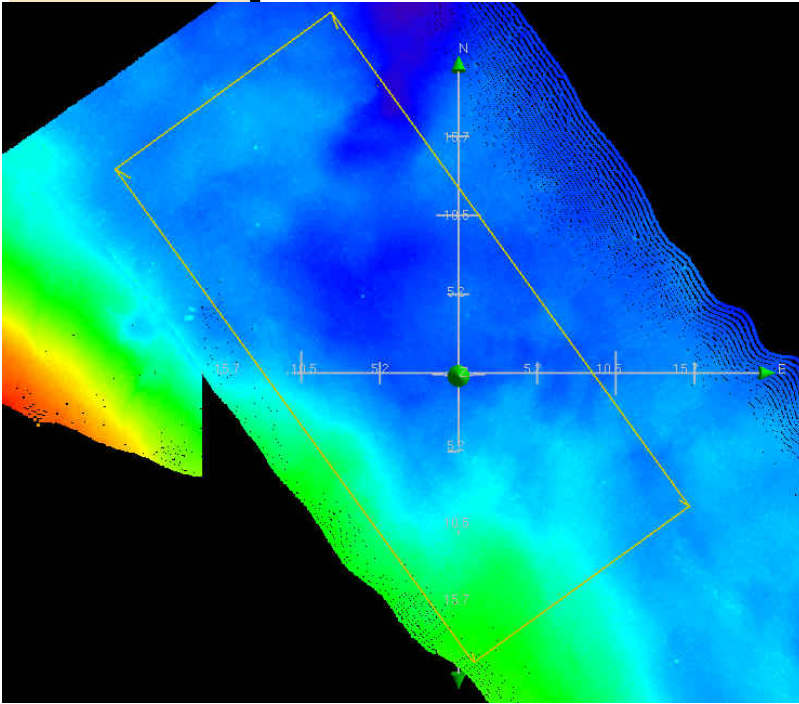
The Hydrographer recommends the removal of three charted obstructions centered at $39^{\circ} 14' 27.61''$ N / $076^{\circ} 33' 54.67''$ W. (Screen grabs have been provided below)

Concur. Delete 3 pile symbols centered at the above position.

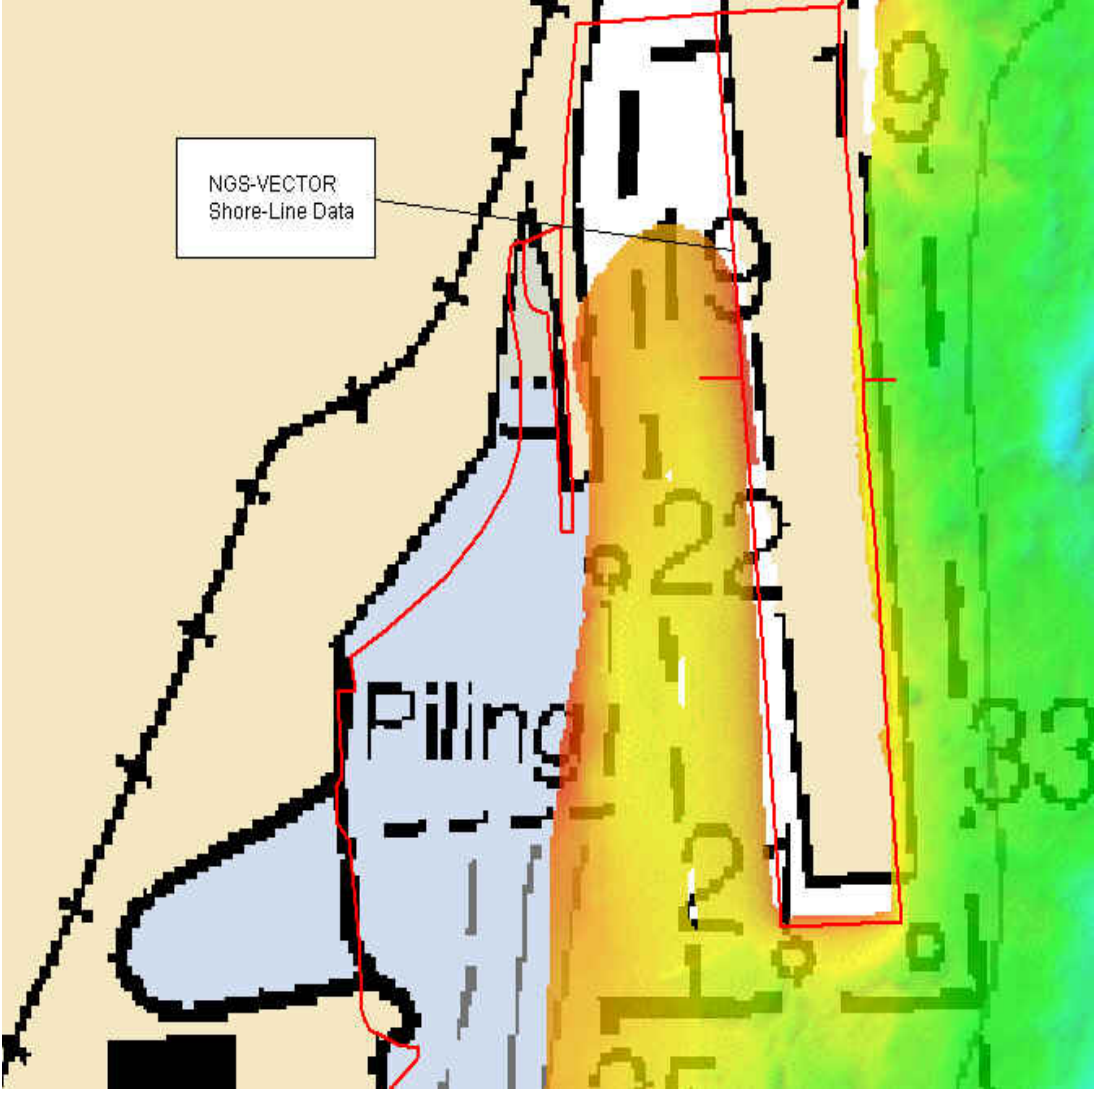
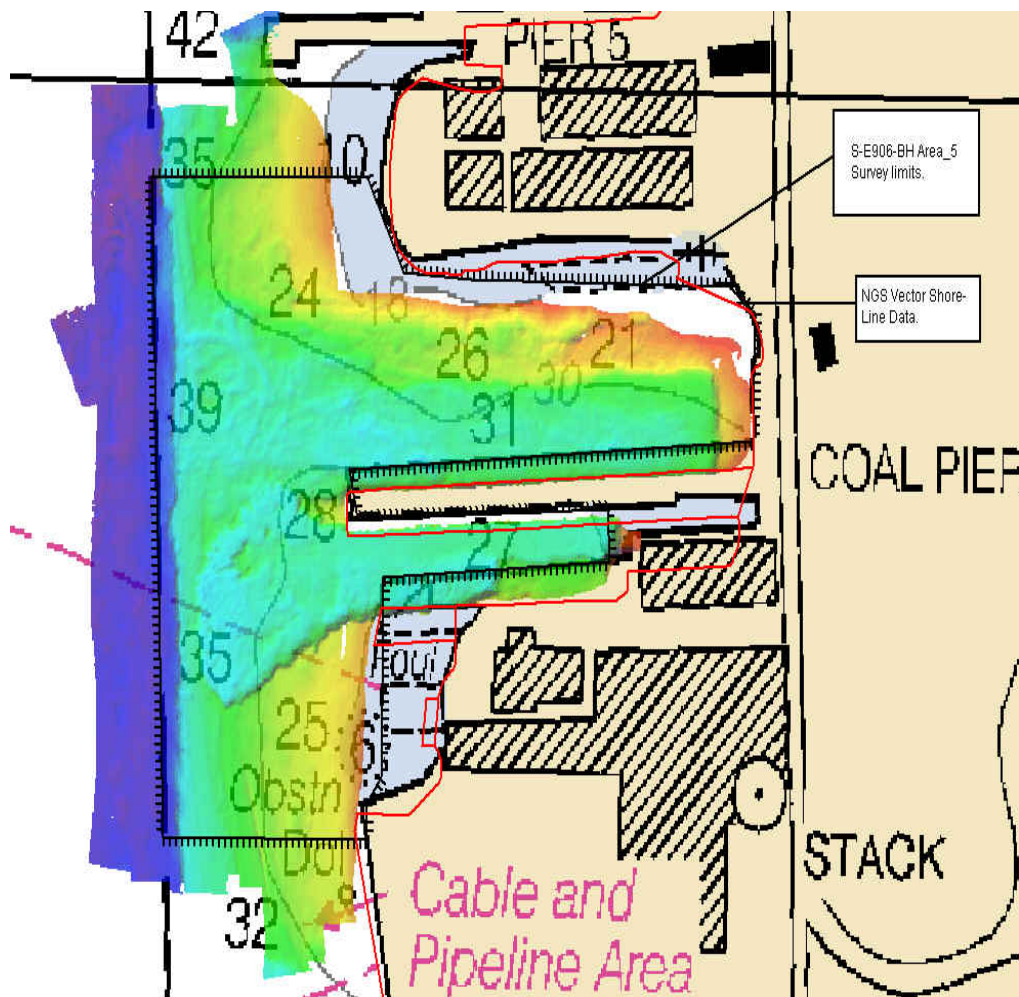
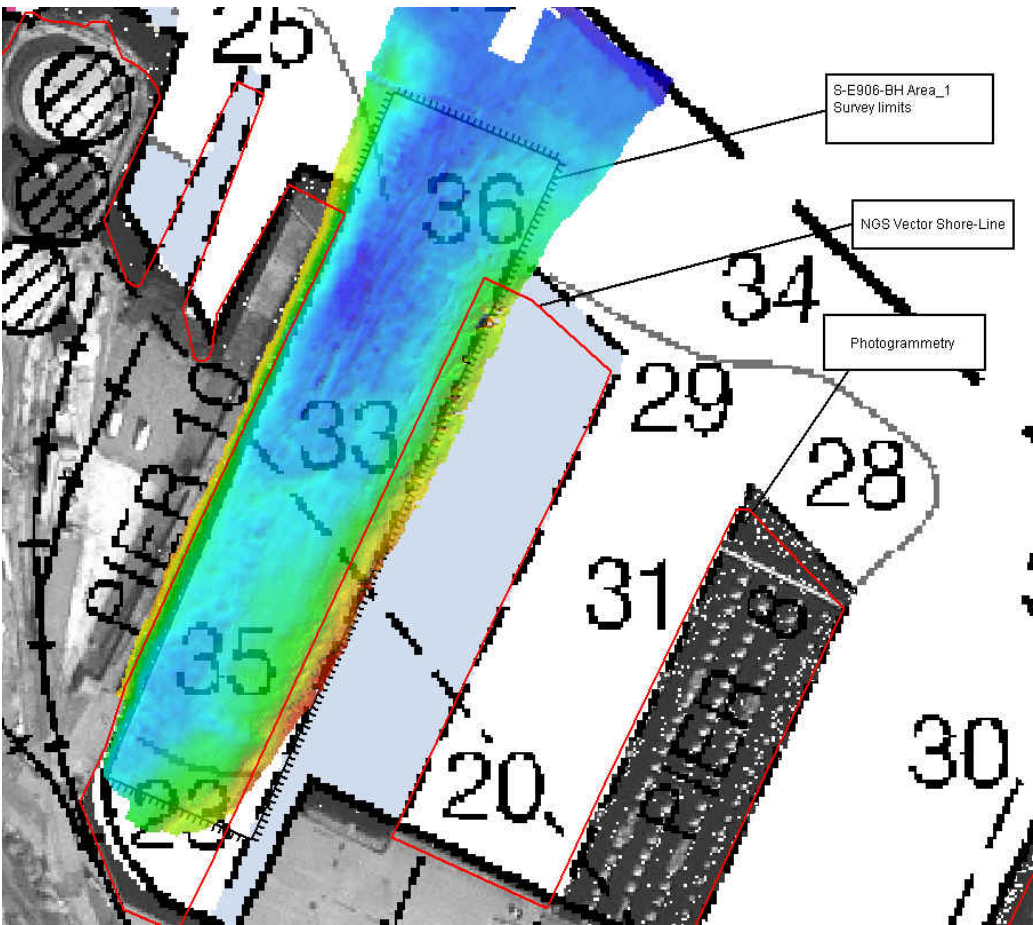
A discrepancy in the charted shoreline of chart 12281 was noted throughout survey S-E906-BH, Baltimore Harbor. The error was originally noticed while gathering SWMB data and further investigated using a portable Trimble TSC1 Asset Surveyor GPS system. Four piers were walked while continually recording data on the Trimble GPS unit. The SWMB and GPS unit data were in agreement with the correlating Photogrammetry and NGS Vector shoreline files.

The Hydrographer recommends revising the charted shoreline of Charts 12281 and 12278 with the most current data. *Concur.*

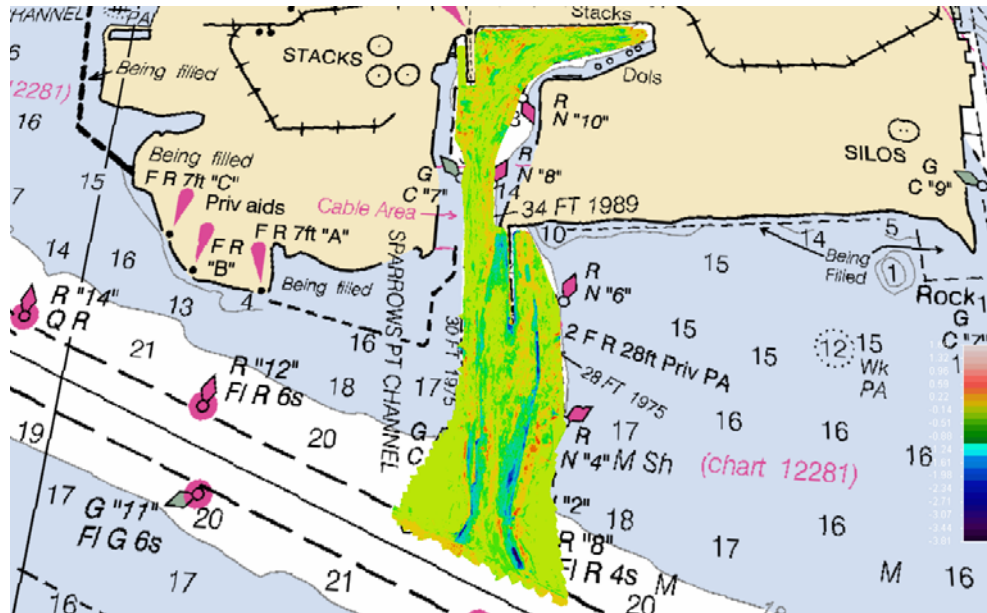
A SWMB comparison of Sparrows Point (Area_4) was made with Survey F00495, Project S-E913-BH dated 03/01/2004 – 03/25/2004 to determine if any significant changes have occurred since the timing of the previous survey. Analysis of the fully processed SWMB data from the current survey (S-E906-BH) resulted in significant changes due to dredge work in the region.

A difference surface for the Sparrows Point area was created by subtracting data collected in 2003 from data collected for E906 in 2005. The surface was created using IVS Fledermaus software. It should be noted that since both surfaces are measured in meters below MLLW, and that soundings are therefore negative values, a negative value in the difference surface represents an area that is deeper in 2005 than it was when surveyed in 2003. Areas with positive values on the difference surface are shallower in 2005 than they were when surveyed in 2003.

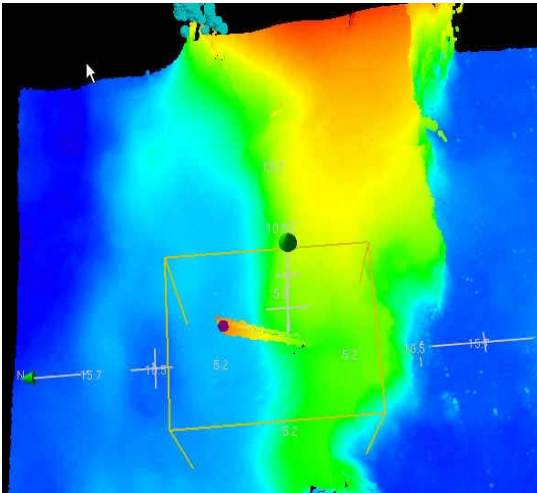
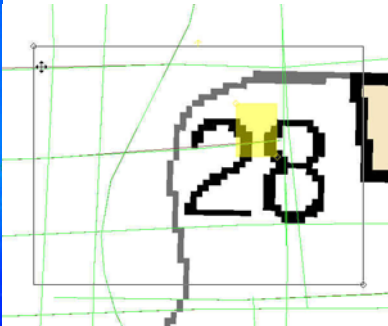
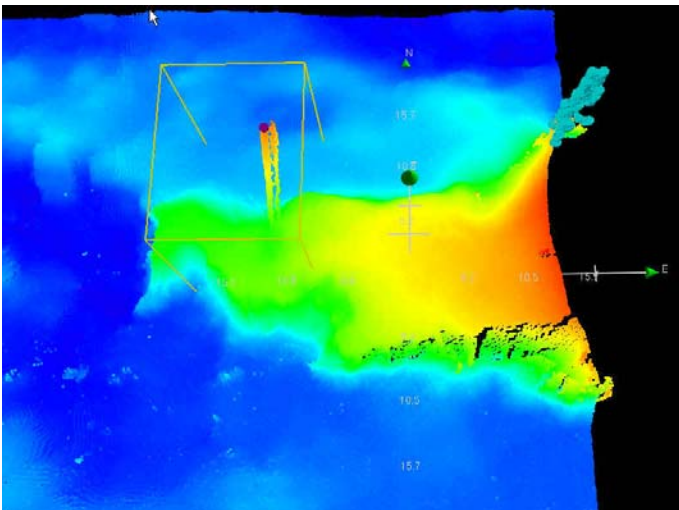
On July 26, 2005, the BAY HYDROGRAPHER located a long, narrow contact off the Baltimore Harbor coal pier. At least 20 ft. in length, the object appears to be a pipe or piling that protrudes away from the pier face toward the dredged area north of the pier. A least depth of 23 ft was observed on the object, and it is recommended that this object be removed or charted as an obstruction. Please see the accompanying graphics for further details.

Chart as a 23 ft obstruction with danger circle. Pass information along to USACE for possible removal.

The Obstruction has been removed. See the correspondence appended to this Danger to Navigation.

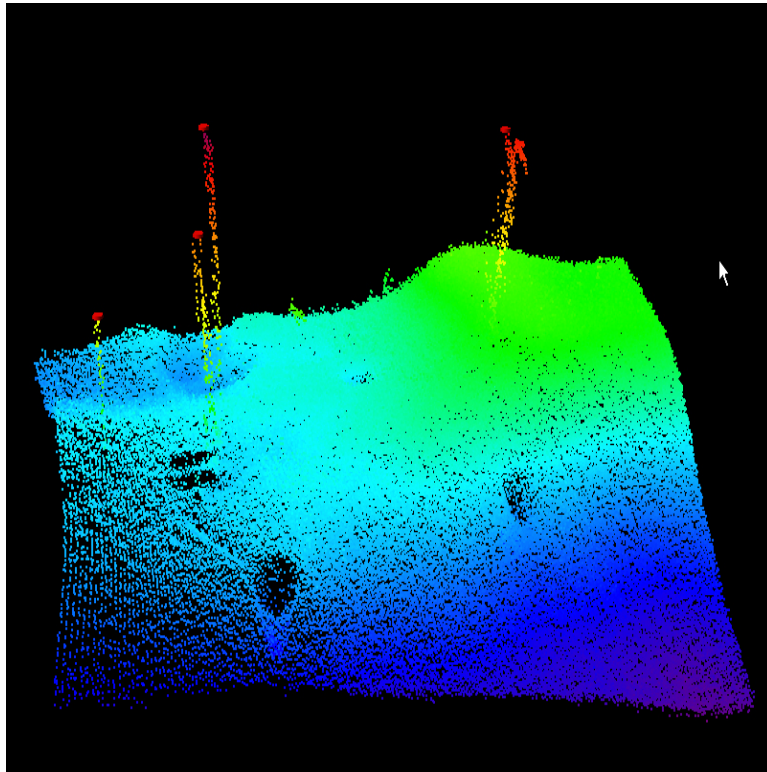
Figure 1.F.1

Recommend charting a Subm Piles with least depth of 4.479m (14-ft).

Do not concur. Do not chart due to chart scale. See DtoN 1.2 for charting recommendation.

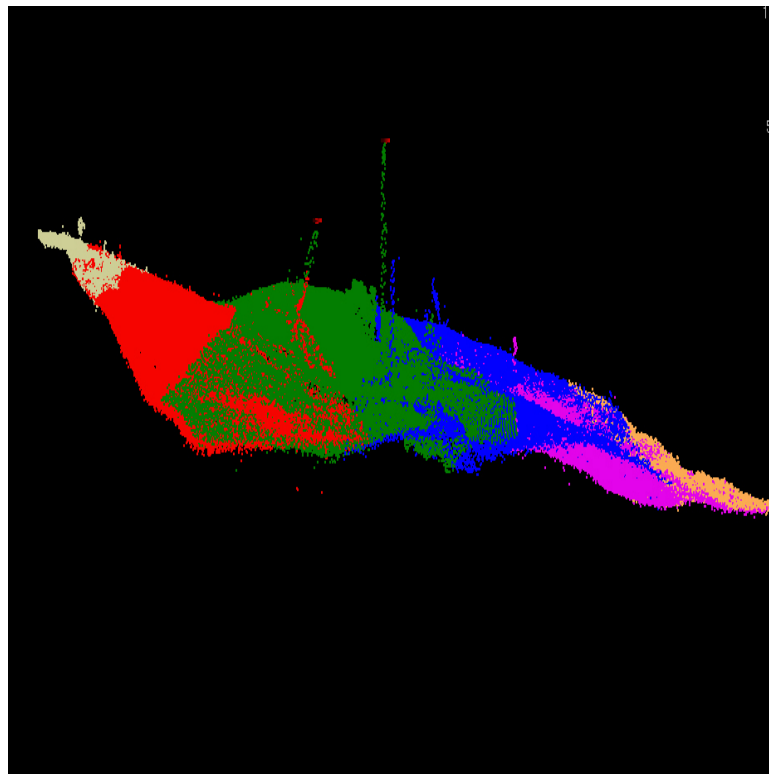
Figure 1.3.1

1.3) Area7 subm Obstns 14-ft 4774/89

Geo object 1: Obstruction (OBSTRN)
Attributes: HORACC - 5.0 m
 INFORM - Two Submerged Obstructions
 OBJNAM - 14-ft Subm Obstns
 QUASOU - 1:depth known
 TECSOU - 2:found by side scan sonar; 3:found by multi-beam
 VALSOU - 4.374 m

Concur. Chart dangerous 14-ft Obstns.

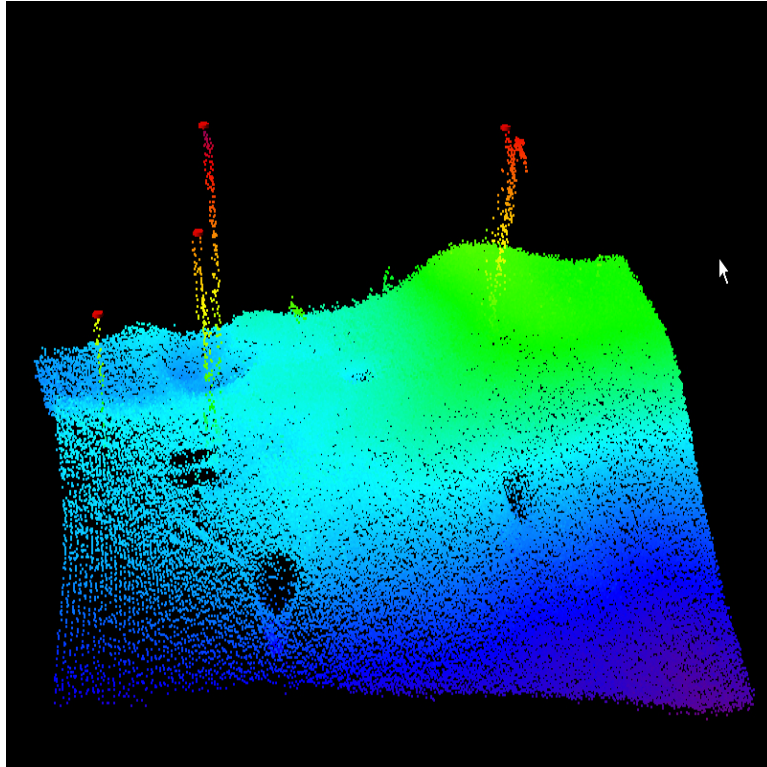
Figure 1.4.1

1.4) area7 subm piles 14ft 5018/213**DANGER TO NAVIGATION****Survey Summary**

Do not concur. Do not chart due to chart scale. See DtoN 1.2 for charting recommendations.

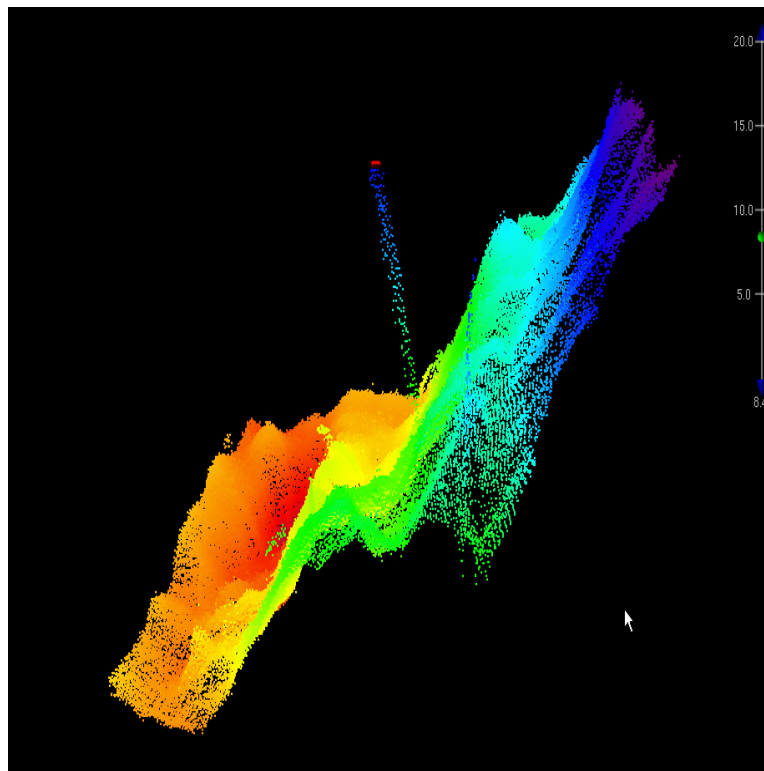
Figure 1.5.1

1.5) Area5 26ft Subm Pile 106/228**DANGER TO NAVIGATION****Survey Summary**

Concur in part. Chart a dangerous 26-ft Obstn.

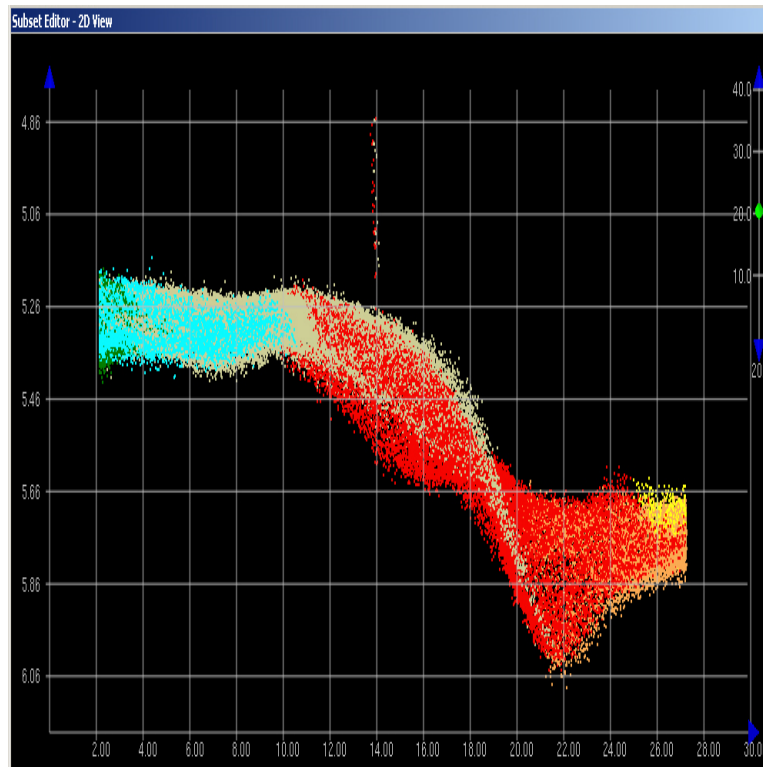
Figure 1.0.1

1.6) Area7 16-ft Subm Pile 525/199

Do not concur. Do not chart due to chart scale. See DtoN 1.2 for charting recommendation.

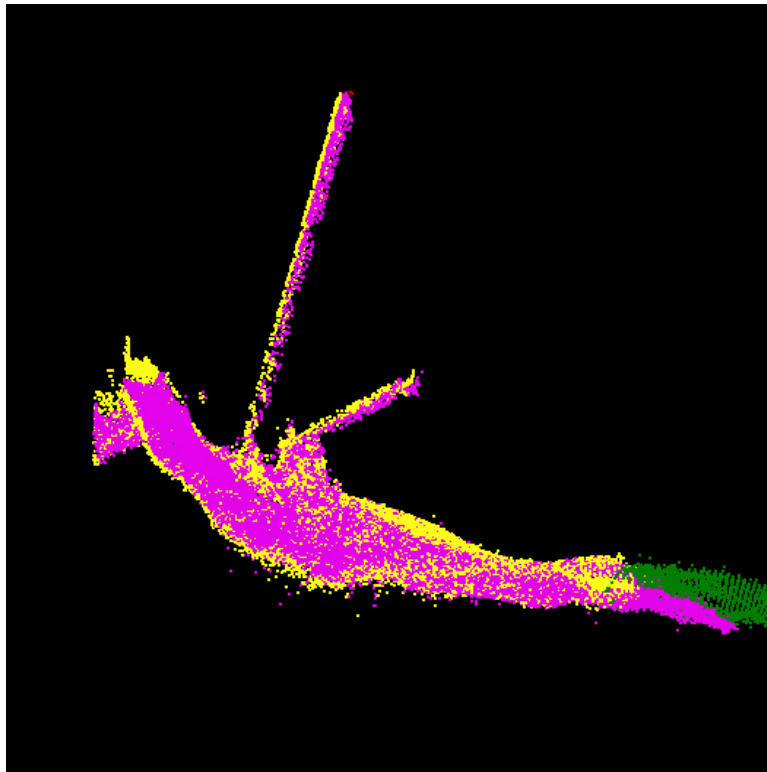
Figure 1.7.1

1.7) Area7 Obstr-2subm piles 11-ft 6180/73

Concur in part. Chart as a dangerous 11-ft Obstns.

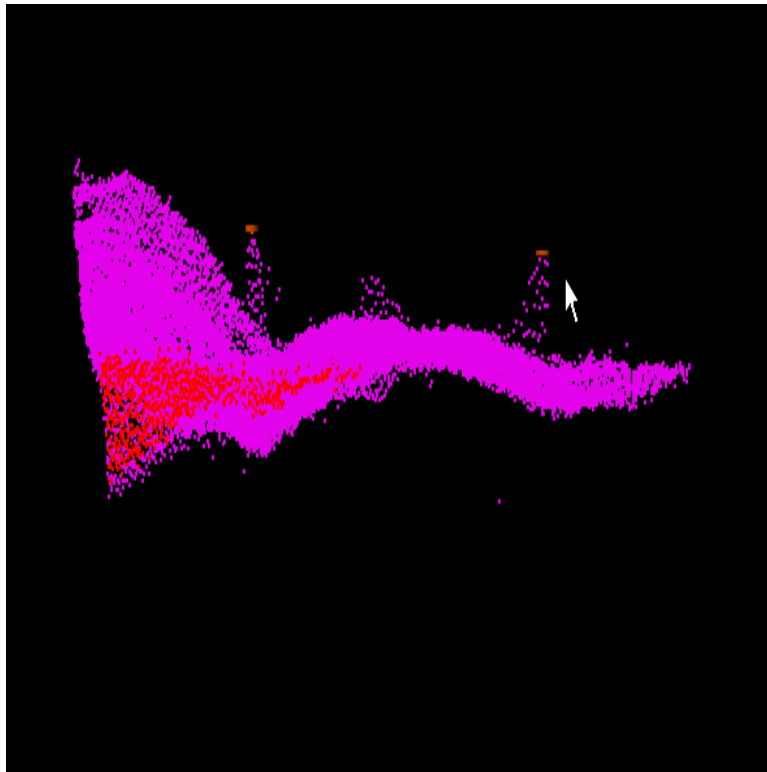
Figure 1.8.1

1.8) Area 7 20-ft Obstn 212/208**DANGER TO NAVIGATION****Survey Summary**

Geo object 1: Obstruction (OBSTRN)
Attributes: HORACC - 5.0 m
 OBJNAM - 20ft Subm Obstn
 QUASOU - 1:depth known
 TECSOU - 2:found by side scan sonar; 3:found by multi-beam
 VALSOU - 6.295 m

Recommend additional field work. Chart 20-ft Obstn.

Concur. Chart a dangerous 20-ft Obstn.

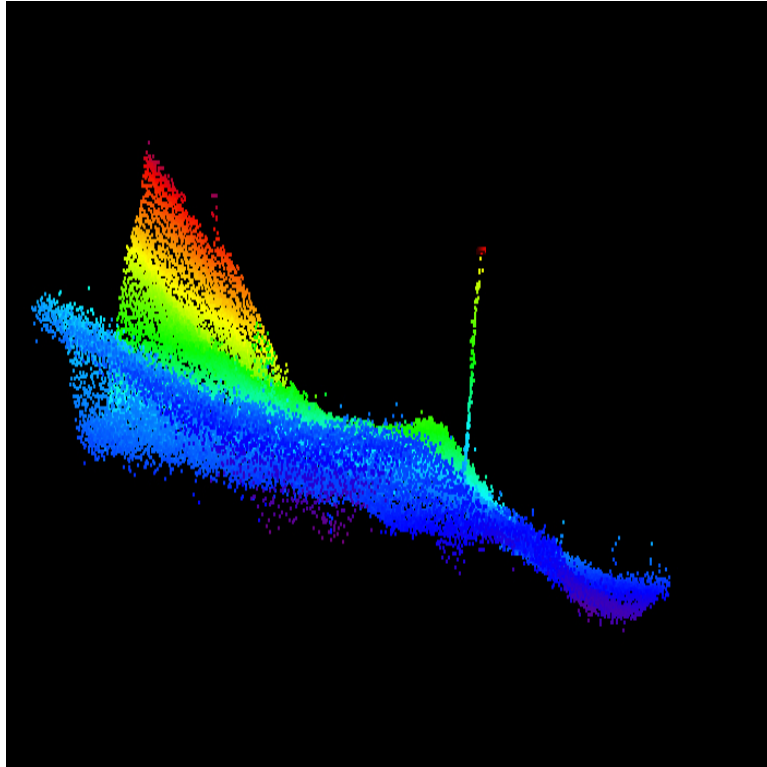
Figure 1.9.1

1.9) Area7 19-ft Subm Pile 824/10

Do not concur. Do not chart a 19-ft obstruction due to a shoaler 17-ft obstruction in the immediate area. See DtoN 1.10 for charting recommendations.

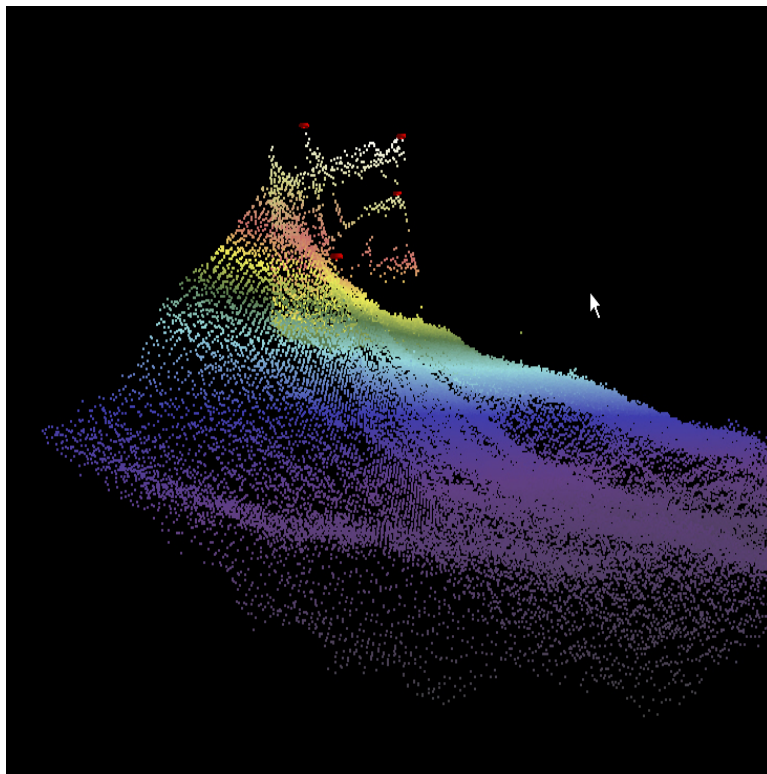
Figure 1.10.1

1.10) Area7 17-ft Obstns 1102/190**DANGER TO NAVIGATION****Survey Summary**

Geo object 1: Obstruction (OBSTRN)
Attributes: HORACC - 5.0 m
 INFORM - Submerged Obstruction
 OBJNAM - 17ft Subm Obstn
 QUASOU - 1:depth known
 TECSOU - 2:found by side scan sonar; 3:found by multi-beam
 VALSOU - 5.124 m

Concur. Chart a dangerous 17 Obstns. Extend the danger curve to include item discussed in DtoN 1.9.

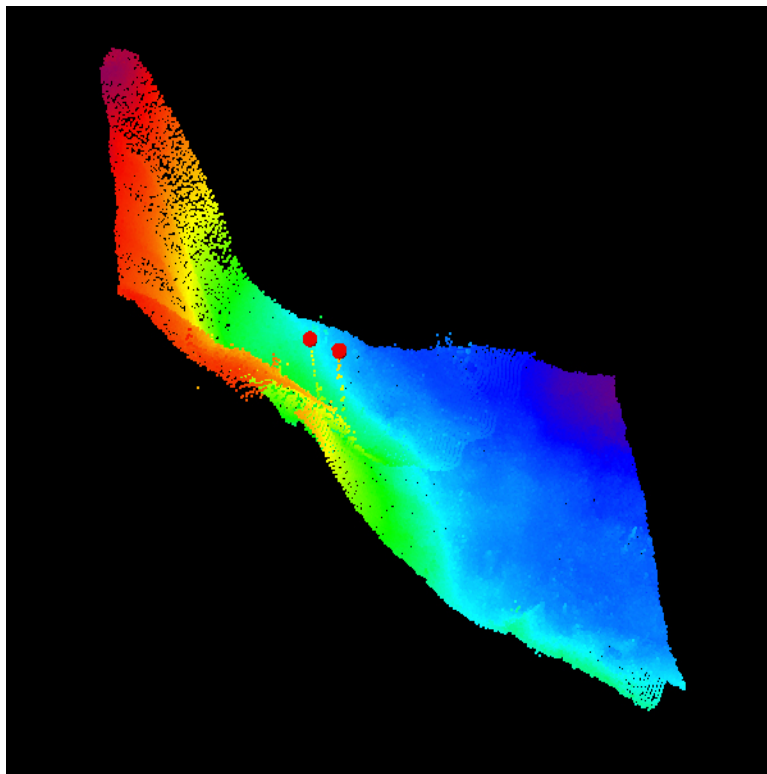
Figure 1.11.1

1.11) Area2 subm pile #1 23-ft 80/238**DANGER TO NAVIGATION****Survey Summary**

Concur in part. Due to the scale of the chart, to eliminate congestion, chart a pile symbol and the notation Subm piles. Defer to MCD for charting disposition of the pier.

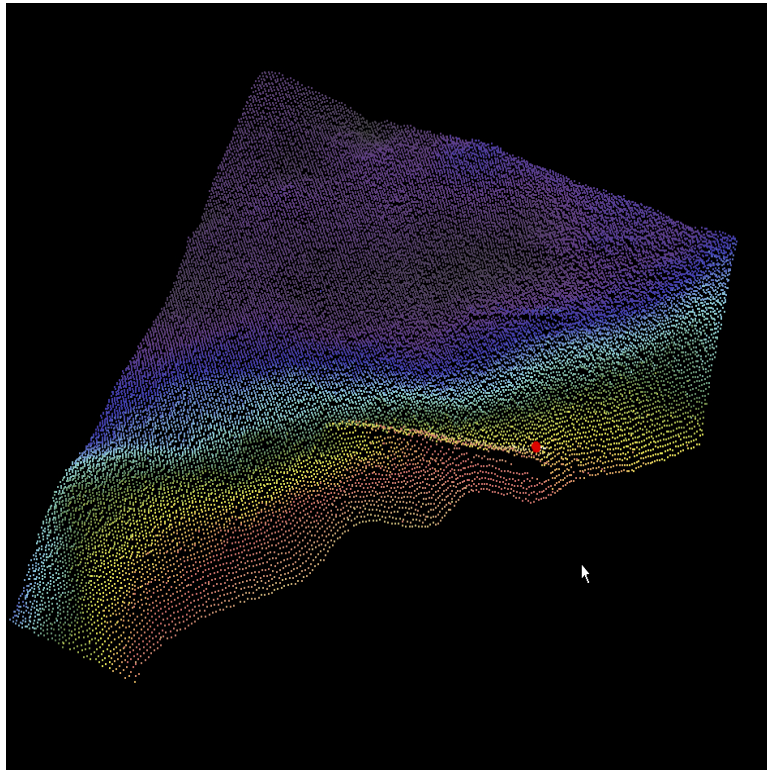
Figure 1.12.1

1.12) Area3 29-ft Obstn 291/4**DANGER TO NAVIGATION****Survey Summary**

Geo object 1: Obstruction (OBSTRN)
Attributes: HORACC - 5.0 m
 INFORM - Submerged Obstruction
 OBJNAM - 29ft Subm Obstn
 QUASOU - 1:depth known
 TECSOU - 2:found by side scan sonar; 3:found by multi-beam
 VALSOU - 9.029 m
 VERACC - 0.25 m

Chart 29-ft Obstn. Recommend additional field work for confirmation.

Concur. Chart a dangerous 29-ft Obstn. Defer to MCD for charting disposition of the shoreline in the area.

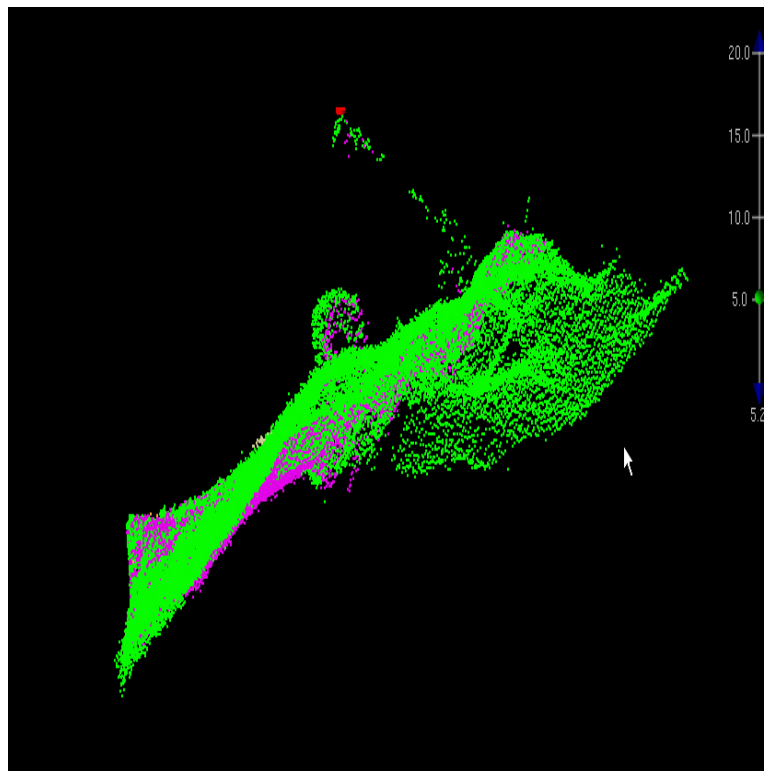
Figure 1.13.1

1.13) Area1 25-ft Obstn 372/143**DANGER TO NAVIGATION****Survey Summary**

Concur. Chart a dangerous 25-ft Obstn.

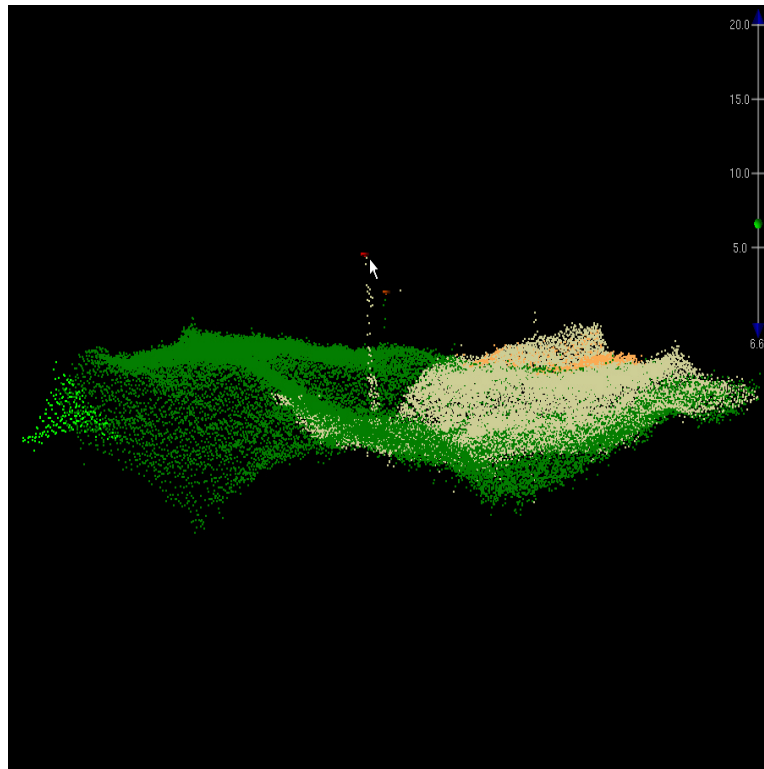
Figure 1.14.1

1.14) Area7 21-ft Subm Pile 4/195**DANGER TO NAVIGATION****Survey Summary**

Do not concur. Do not chart due to chart scale. Another obstruction is in the immediate are. See DtoN 1.8.

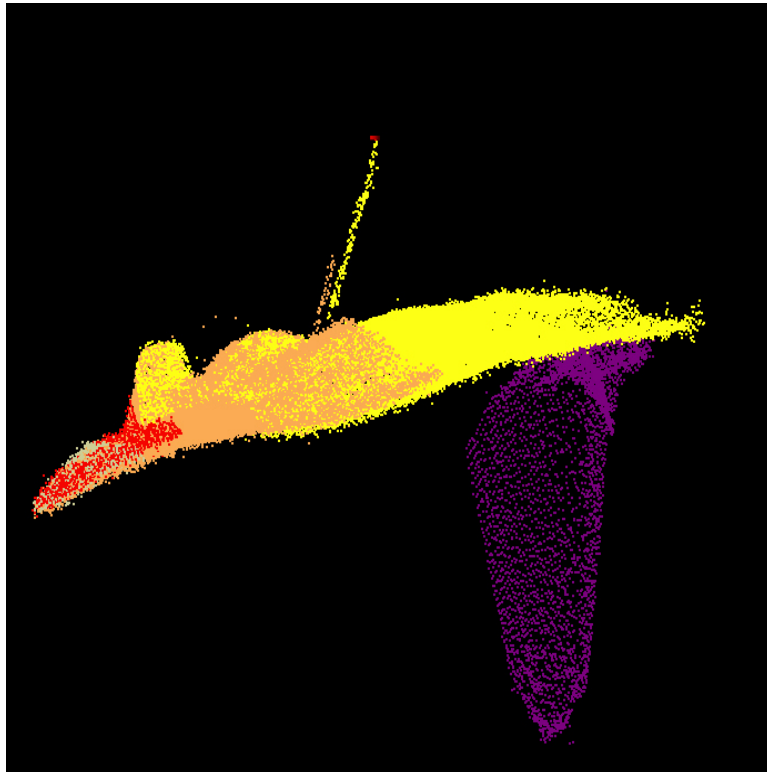
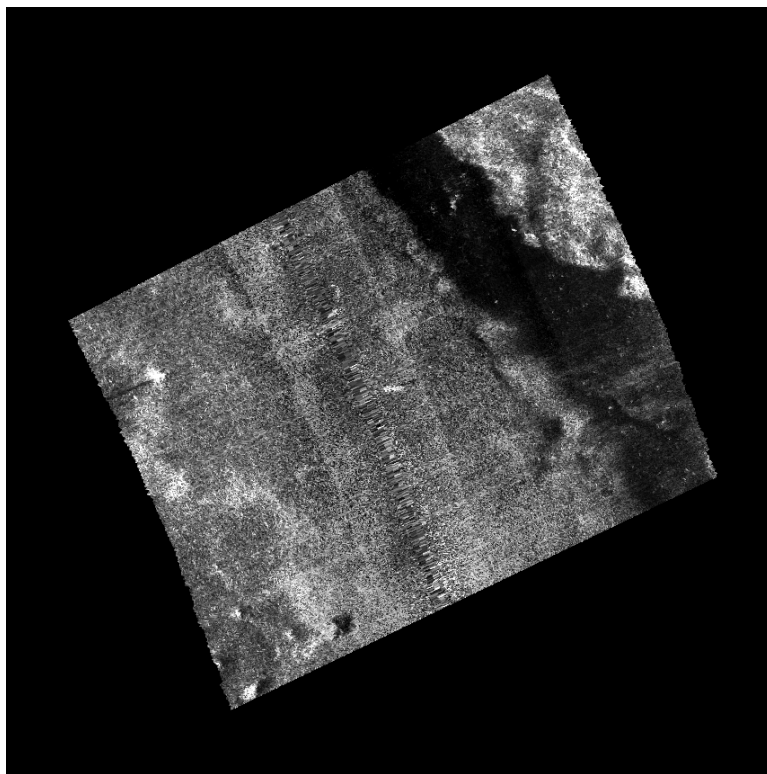
Figure 1.15.1

1.15) Area7 Subm Pile 15-ft 1467/122**DANGER TO NAVIGATION****Survey Summary**

Do not concur. Do not chart due to chart scale. See DtoN 1.2 for charting recommendation.
