U.S. Department of Commerce National Oceanic and Atmospheric Administration National Ocean Service		
1	DESCRIPTIVE REPORT	
Type of Survey:	Navigable Area	
Registry Number:	F00734	
	LOCALITY	
State(s):	Texas	
General Locality:	Port Lavaca, TX	
Sub-locality:	Matagorda Bay	
	2019	
	CHIEF OF PARTY Andrew Orthmann	
	LIBRARY & ARCHIVES	
Date:

Descriptive Report to Accompany Survey F00734

Project: OPR-K376-KR-18 Locality: Port Lavaca, TX Sublocality: Matagorda Bay Scale: 1:20000 August 2018 - February 2019 **Terrasond, Ltd.**

Chief of Party: Andrew Orthmann

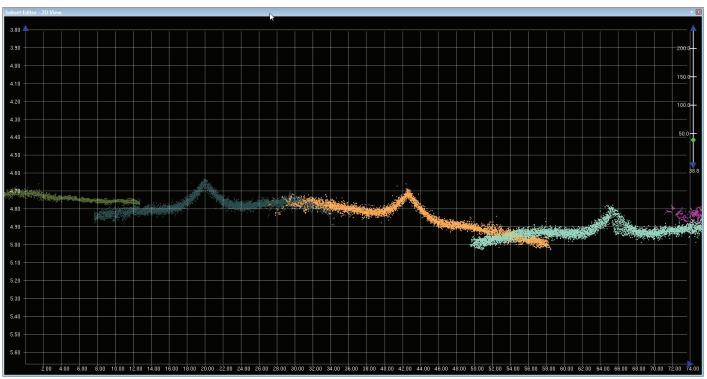
A Reson Seabat T50-IDH (integrated dual-head) MBES system was initially installed and operated on the Bella Marie. A near-nadir artifact and excessive noise was experienced with this installation that could not be tuned out. After consultation with the sonar manufacturer it was decided that the likely cause was insufficient sonar deployment depth between the catamaran-style hulls on this vessel causing acoustic reverberation off the twin hulls. Instead of modifying the mount to deploy the MBES deeper and run additional risk of damaging the system on the seafloor, the system was reconfigured to operate as a standard single-head system, which eliminated the issue.

The system was configured as a dual-head from JD2018-247 to JD2018-256 and all data collected during this period exhibits the issue. Noisy data as well as the nadir artifact was manually rejected in either CARIS Swath Editor or Subset mode. Due to the upward curvature at nadir, a nadir artifact of about 5-10 cm adversely affects the data. However, this is within specifications and final surfaces meet TVU requirements.

Figure 8: Bella Marie T50-IDH artifact after manual editing of soundings. Near-nadir soundings are adversely impacted by 5-10 cm.

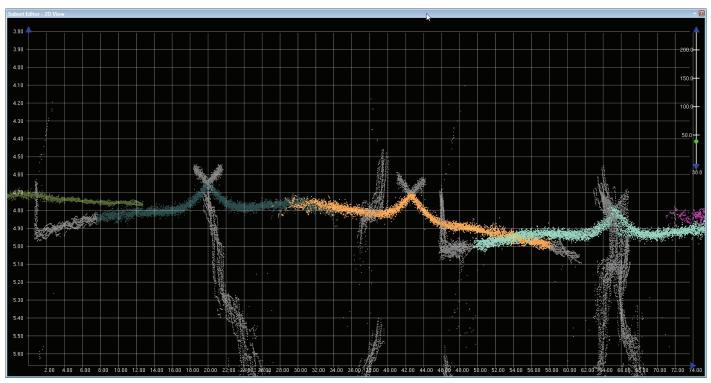
Figure 9: Bella Marie T50-IDH artifact showing rejected soundings (gray).

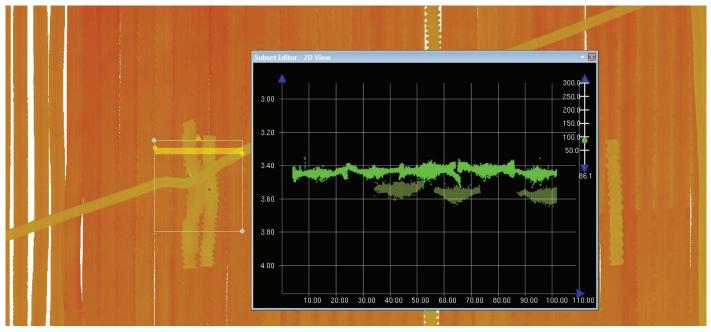
During the 2019 deployment of the Bella Marie to the survey site, the vessel utilized an alternate MBES and POSMV system compared to what was used in 2018. This included a POSMV IMU mounted well forward of the vessel CoG (and MBES). This resulted in remote heave, where vessel pitch was unintentionally measured by the system as additional heave. The majority of the effect was removed through a remote heave computation in the CARIS HVF as well as the POSMV system. However, some unresolved remote heave effects remains in the data, which appears as vertical busts both above and below previously run T50 data. The effect is usually less than 0.10 m but can approach 0.15m in places. Despite the residual remote heave artifact, final surfaces are within allowable TVU. This affects only data collected on with the Bella Marie in 2019, JD2019-015 to JD2019-038. Refer to the DAPR for more information and offsets. An example is shown below.

Figure 10: Example remote heave busts in CARIS Subset and its effect on final surfaces: Dark green data is from 2019 and exhibits the issue. The vertical offset is about 0.12 m in this example. The relatively small bust is readily visible in the final surfaces since the seafloor of the area is generally flat and uniform.

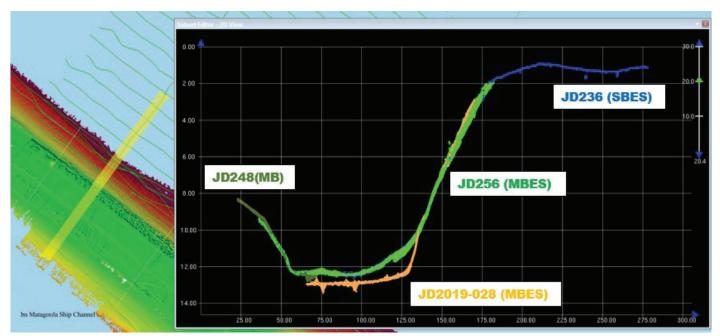
Bottom change is caused by sediment transport from high currents funneling through the channel as evidenced by sand waves but also from active dredging operations that were observed in the channel at various times during the survey.

Change is most significant at the southern approach to the survey area where the bay funnels into the channel and dredging was also occurring. Note that areas outside the channel were not noticeably affected.

Figure 11: Example of bottom change in channel: SBES and MBES lines run early in the project from JD236 through JD256 are in good agreement. However, new lines run in 2019 on JD28 agree with older data on the channel wall but not on the channel floor, where there is up to 1.4 m of difference from dredging.

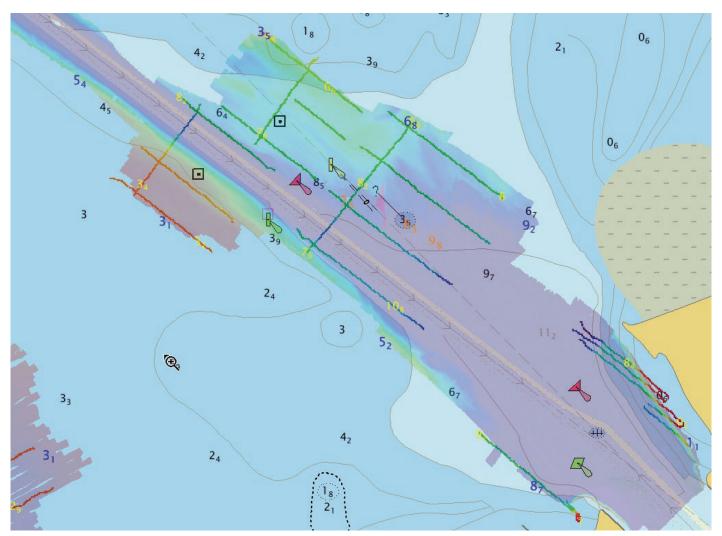
The southern part of this survey intersects chart US5TX33M. General sounding agreement is excellent, with most soundings comparing to 0.5 m or better, and many agreeing to 0.2 m or better. An exception is the area immediately inside the bay after approaching through the pass, which appears to have deepened by up to 2 meters outside of the channel.

Figure 16: Soundings from this survey (blue from MBES as well as orange critical soundings, yellow from SBES) overlaid on US5TX33M (black). Soundings in meters. Area immediately inside the bay from the pass, showing deepening by up to 2 m in places.

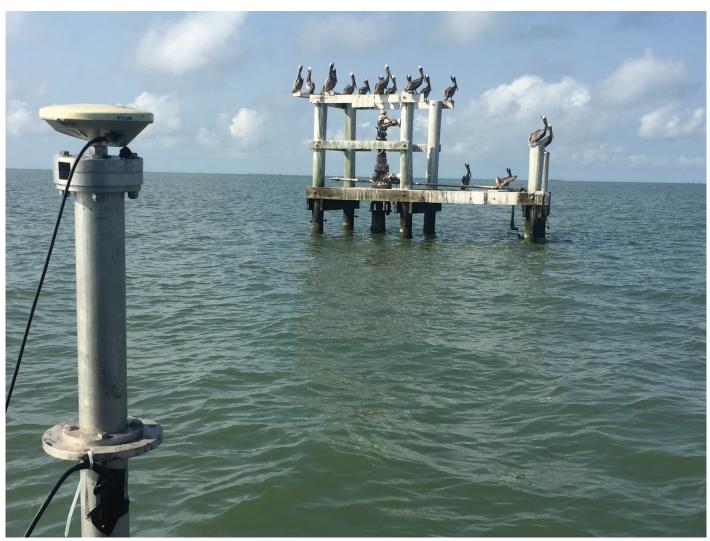
Figure 18: Uncharted obstruction (wellhead) submitted as a DTON

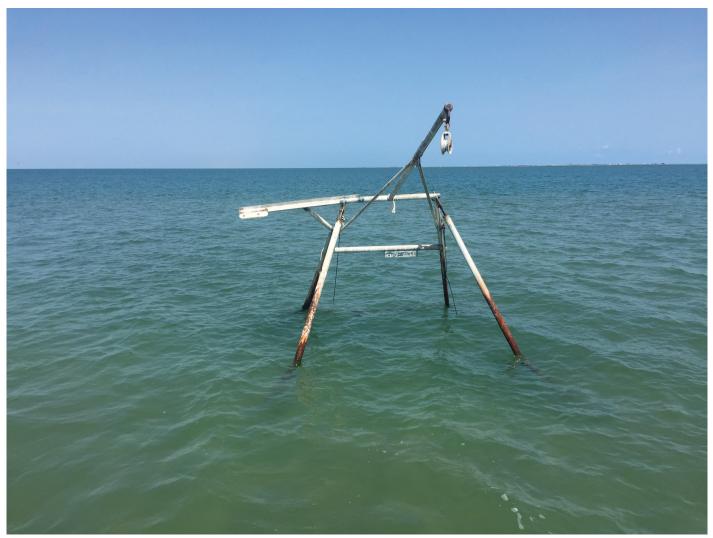
Figure 19: Uncharted obstruction (debris) submitted as a DTON
