DESCRIPTIVE REPORT

Type of Survey:	Support USCG			
Registry Number:	F00796			
	LOCALITY			
State(s):	Texas			
General Locality:	Galveston Bay, TX			
Sub-locality:	San Jacinto River at the I-10 bridge			
2019				
CHIEF OF PARTY				
	Dan Jacobs			
LIBRARY & ARCHIVES				
Date:

Sub-Locality: San Jacinto River at the I-10 bridge

Project Number: S-K924-NRT4-19

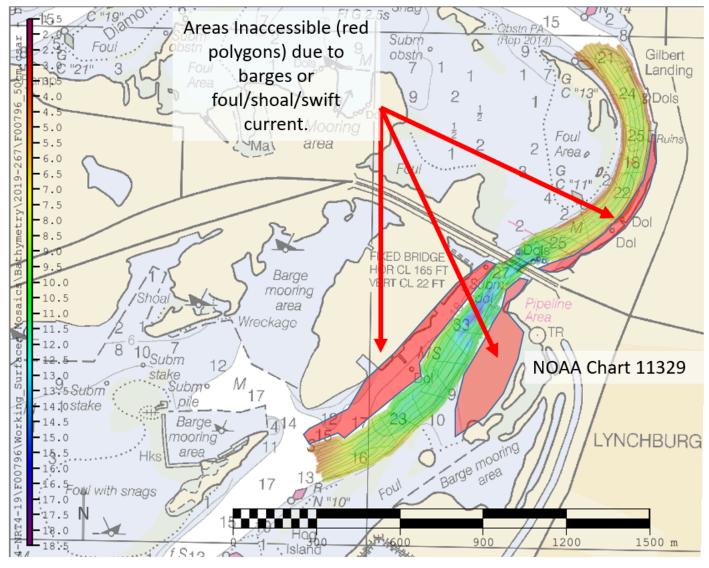
Figure 2: Main Areas of Incomplete Multibeam Coverage to NALL.

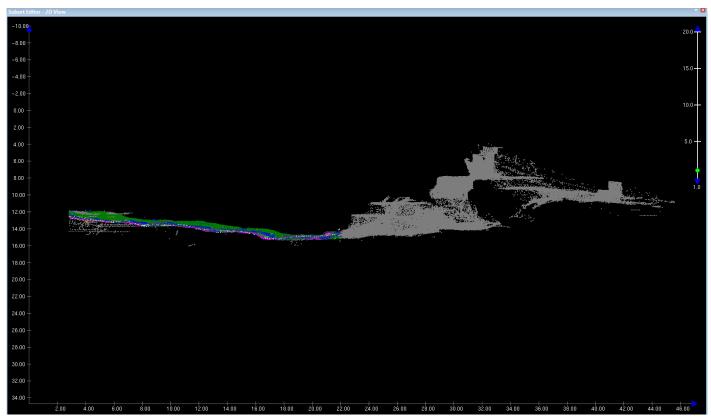
The navigable waterway underneath the interstate will require new bathymetry at the conclusion of salvage and construction activities presently occurring to the bridge. Most survey soundings over the sunken fendering at this location have been rejected in subset editor since the hazard is known and being remedied. A 1.78 meter sounding was designated on the shoalest point of this fending to preserve the least depth in the finalized grid. Bridge abutments in the waterway were also rejected. Additional information on this matter can be found in the Results and Recommendations section of this report.

Figure 4: Rejected soundings (grey), over sunken fendering and bridge abutments underneath Interstate 10 bridge.

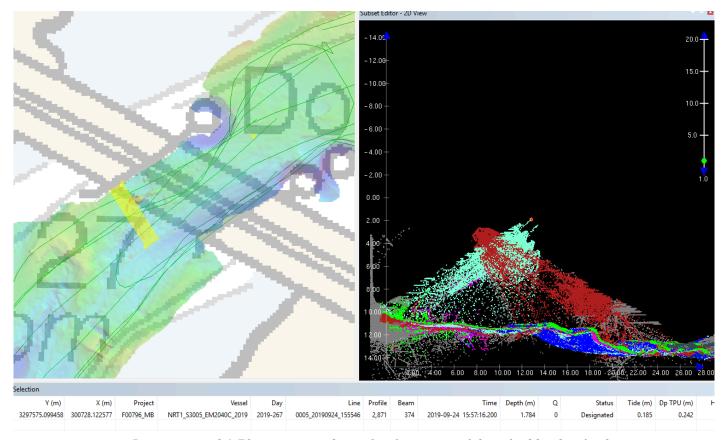
Figure 5: Designated 1.78 meter sounding, shoalest point of detached bridge fendering.

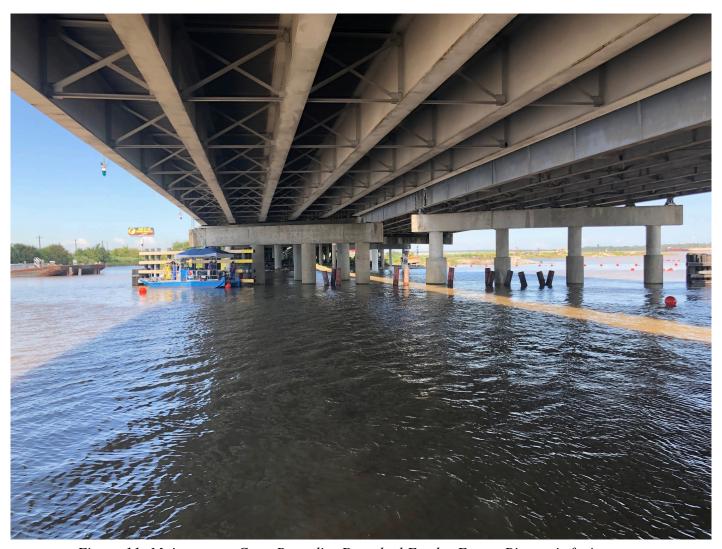
There are no feature investigation requirements for this project per F00796 Project Instructions. At the time of survey, a known 150 foot section of fender wales (fendering) had detached from the Interstate 10 Bridges pillars, southwestern side. It extended 55 feet into the western side of the navigable waterway underneath the bridge and showed a preliminary least depth of approximately 28 feet where surrounding depths measured 40 feet. No DtoN for this feature was submitted because 1.) USGC was aware of this hazard and had initiated a "broadcast to mariners" action the previous day; 2.) a maintenance crew was already on-scene, working from a utility boat alongside the hazard; 3.) and safety buoys had been sunk in the affected area to cordon off vessel traffic. The dolphins on the north side of the bridge suffered substantial damage yet were shown to be correctly positioned. See images, below. All vessel movements through this area required mandatory coordination with the USCG Vessel Traffic Service (VTS) Houston/Galveston on the day of survey. Findings for this day's survey were reported out to all interested parties including NRB Branch Chief and USCG Waterways Coordinator LCDR Timothy Tilghman. Please reference the Supplemental Survey Records Correspondence folder. Fender wales aside, no other significant concrete debris or other obstructions were evident along the bottom of the navigable channel in the area surveyed.

Figure 11: Maintenance Crew Remedies Detached Fender Fence. Picture is facing west.

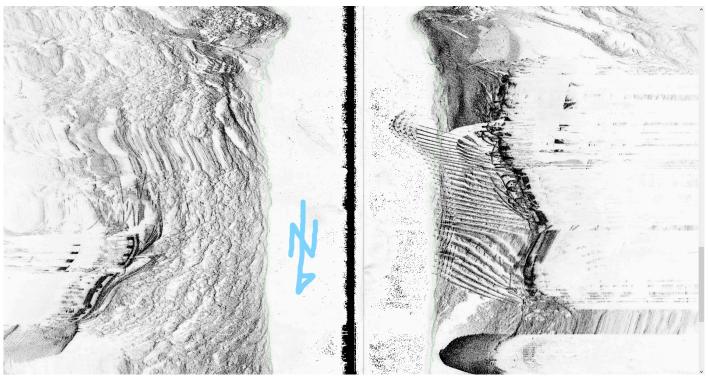
Figure 12: SSS Imagery, Detached Fendering, 50m Range Scale.

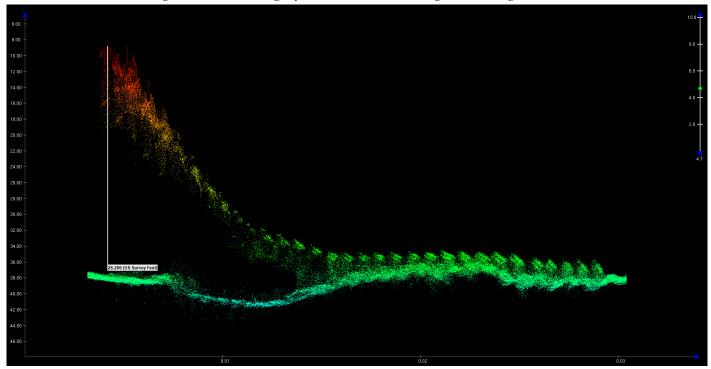
Figure 13: 2D Multibeam Imagery, Detached Fendering.

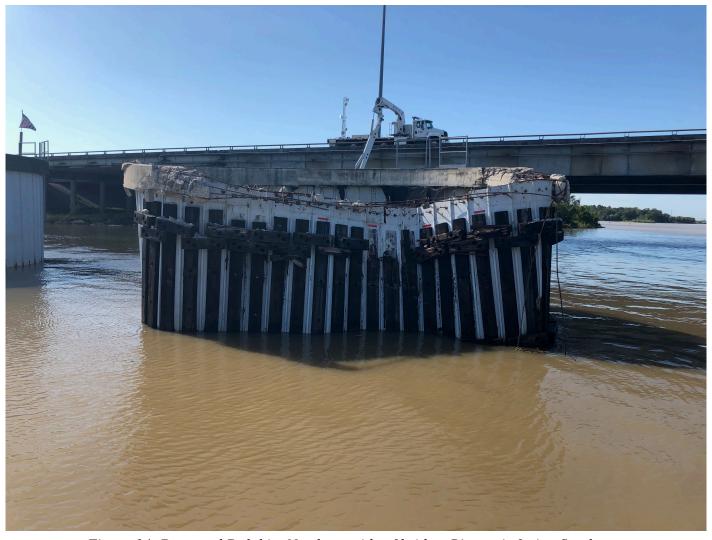
Figure 14: Damaged Dolphin, Northeast side of bridge. Picture is facing Southeast.

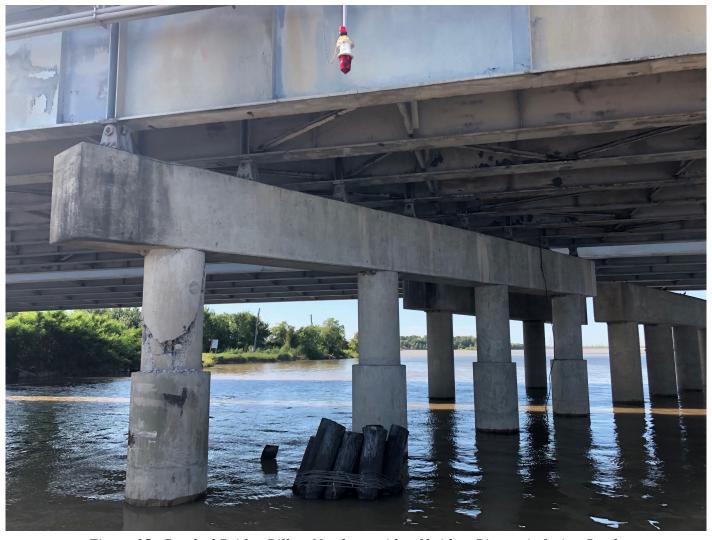
Figure 15: Cracked Bridge Pillar, Northeast side of bridge. Picture is facing South.

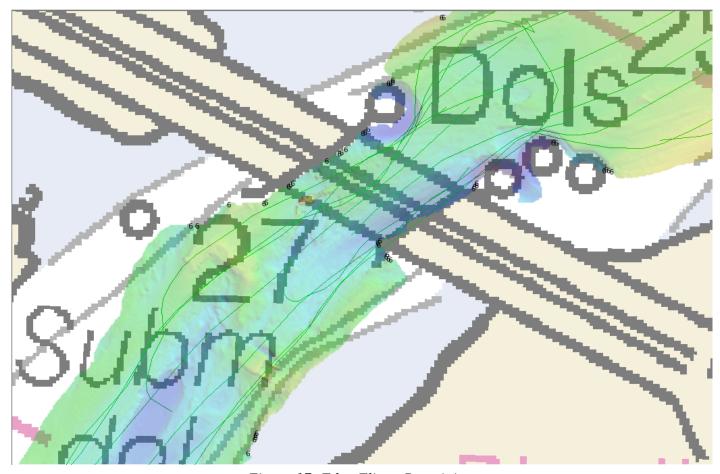
Edge Fliers exist in vicinity of the bridge despite ten separate iterations of manually rejecting noise and deeper soundings on a 50cm grid. Several hundred edge fliers existed at the start but by the fourth round of cleaning it became evident that 60 or so remaining would not delete but shift position by several meters. In total, 10 hours were spent addressing these fliers implementing a half meter "slice" in CARIS 11.1s Subset Editor concurrently with Pydros Flier Finder v8 tool. The default filter settings for this tool were not changed (Distance 1.0 node and Delta Z 0.01 meters). Despite NRT4's best effort to clean and smooth these edges in a shoal-biasing fashion, 52 edge fliers still remain. Additionally, one Gaussian Curvature flier (#2 category) remains as a result of designating a sounding over the least depth of the sunken fendering. Fliers of #3,#4,#5 categories were successfully corrected to zero instances or did not exist.

Figure 17: Edge Fliers, Remaining.

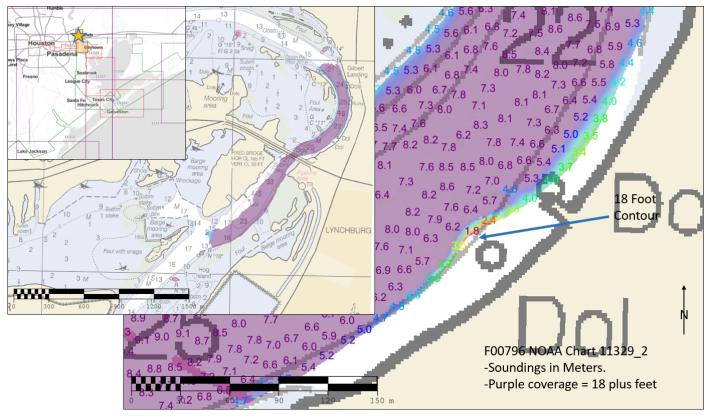
The 18 foot contour will require adjustment approximately 375 meters north of the bridge and on the eastern bank of the river. Minor shoaling at that location encroaches into the 18 foot contour, approximately 1 mm at survey scale. Correspondence with PHB regarding this shoal can be found in the correspondence folder. Additionally, a survey sounding was designated to preserve a least depth of 4.8 meters (15.7 feet) atop an 18

Figure 18: 18 foot contour adjustment, Chart 11329_2.

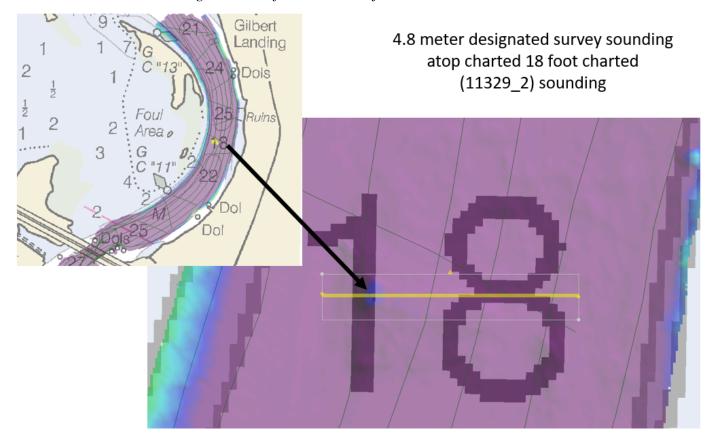
foot charted sounding located 525 meters north of the bridge and in the middle of the channel. See graphics, below.

Figure 19: 15.7 foot survey sounding found atop charted (11329_2) 18 foot sounding. Survey coverage (purple) indicates 18 feet and deeper.

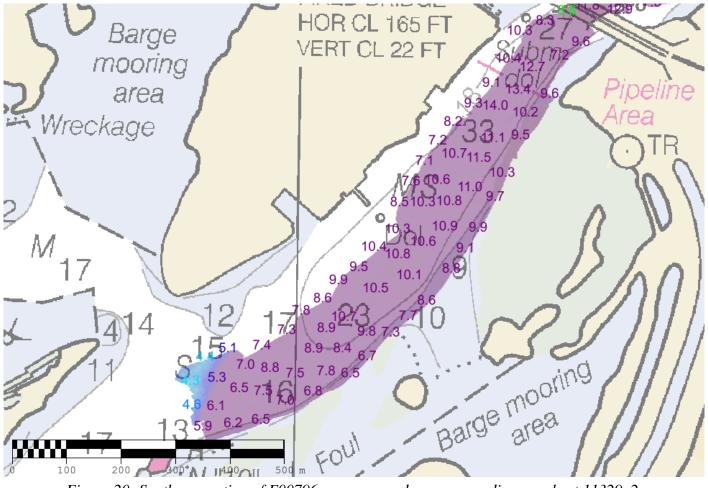
Survey soundings are significantly deeper than charted soundings and contours for the reach south of the interstate bridge. Survey depths of 22 feet and deeper exist in nearly all of the 50cm coverage. Tug and barge operations, barges at anchor and barges rafted to one another, alongside precluded coverage to the NALL in this heavily industrialized waterway. Graphic of the survey soundings vs charted soundings and contours shown below.

Figure 20: Southern portion of F00796 coverage and survey soundings vs chart 11329_2. Survey soundings in dark purple. Survey coverage (purple) indicates 18 feet and deeper.
