H10505

DESCRIPTIVE REPORT

StateVirgin Islands.....
General Locality St. Thomas Harbor.....
Sublocality East Gregerie Channel.....

DPR-1173-MI-93

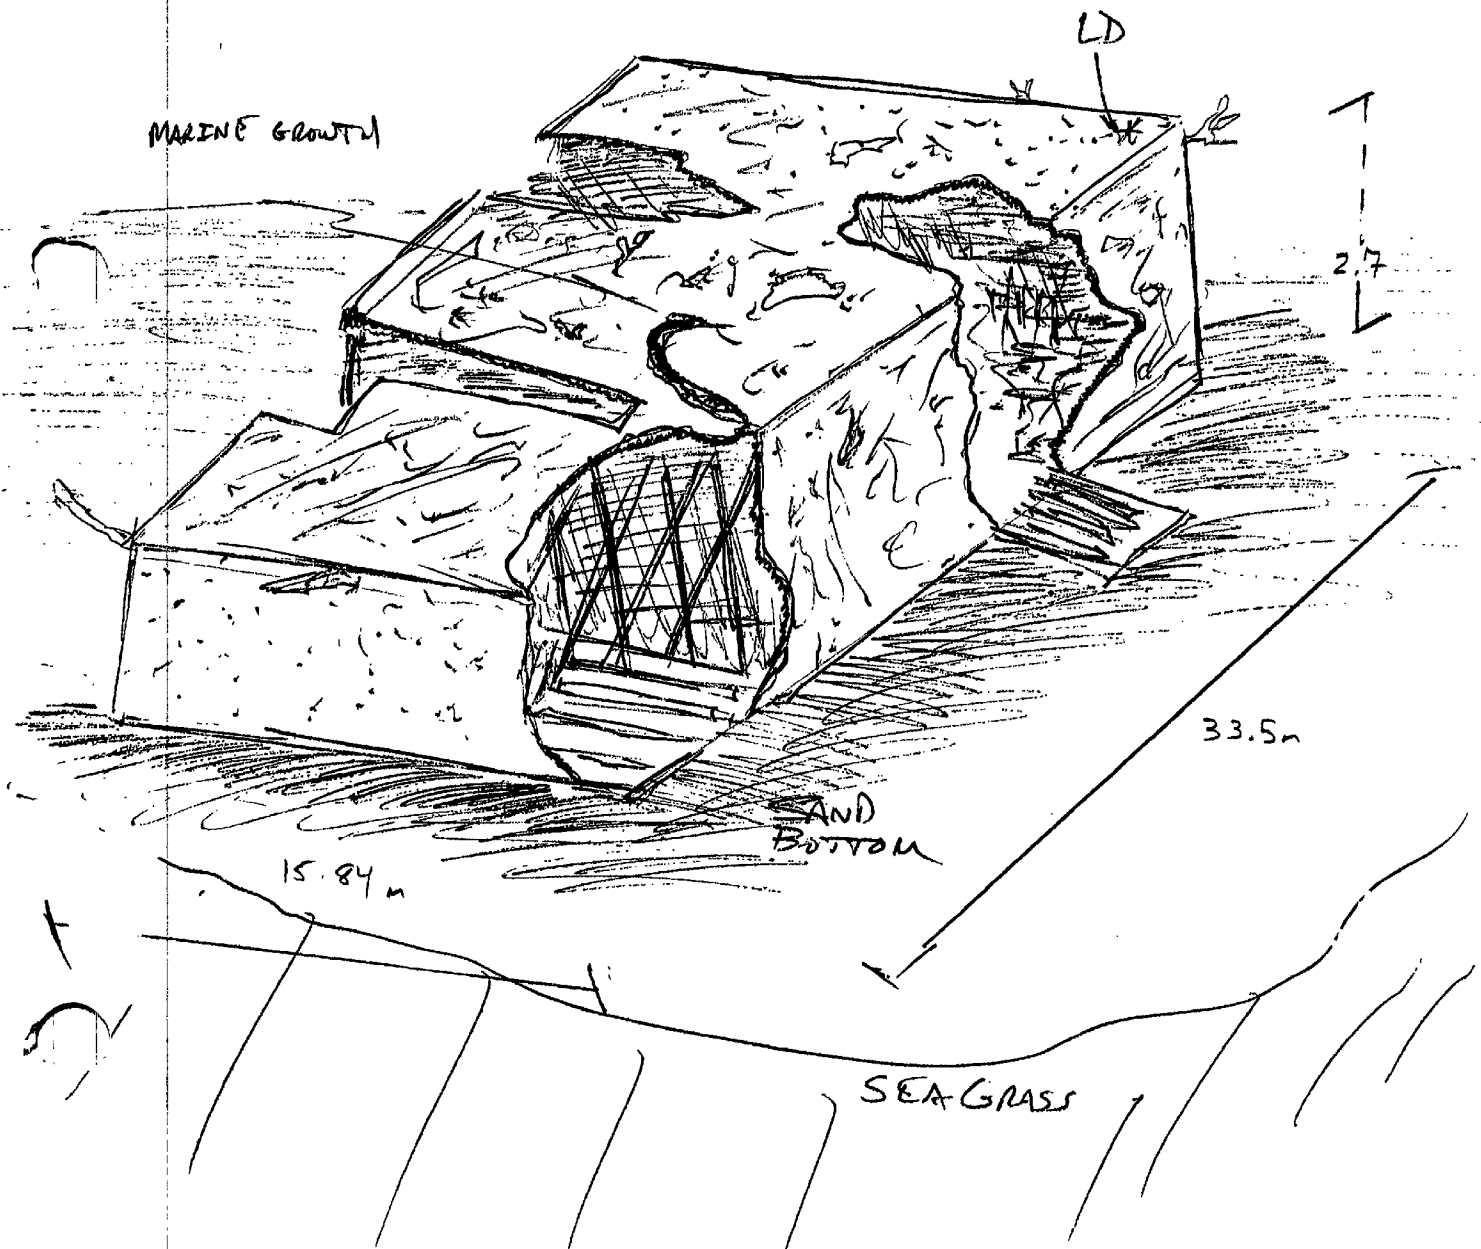
8537

Comparison with Prior Surveys: Prior survey H-8877 and H-9271 depict a submerged wreck near it's charted position. Further investigation was recommended.

LD = 8.35 @ 1143 HRS
SURROUNDING DEPTH by DEPTH GAUGE
= 36'
= 10.97m

Recommendation: Recommend repositioning the "dangerous submerged wreck" symbol on chart #25649 to new position: 18/18/40.660 N, 064/54/56.361 W. Add the annotation "8.1m." 7.6m (25FT) CONCUR CHART AS 25 WK

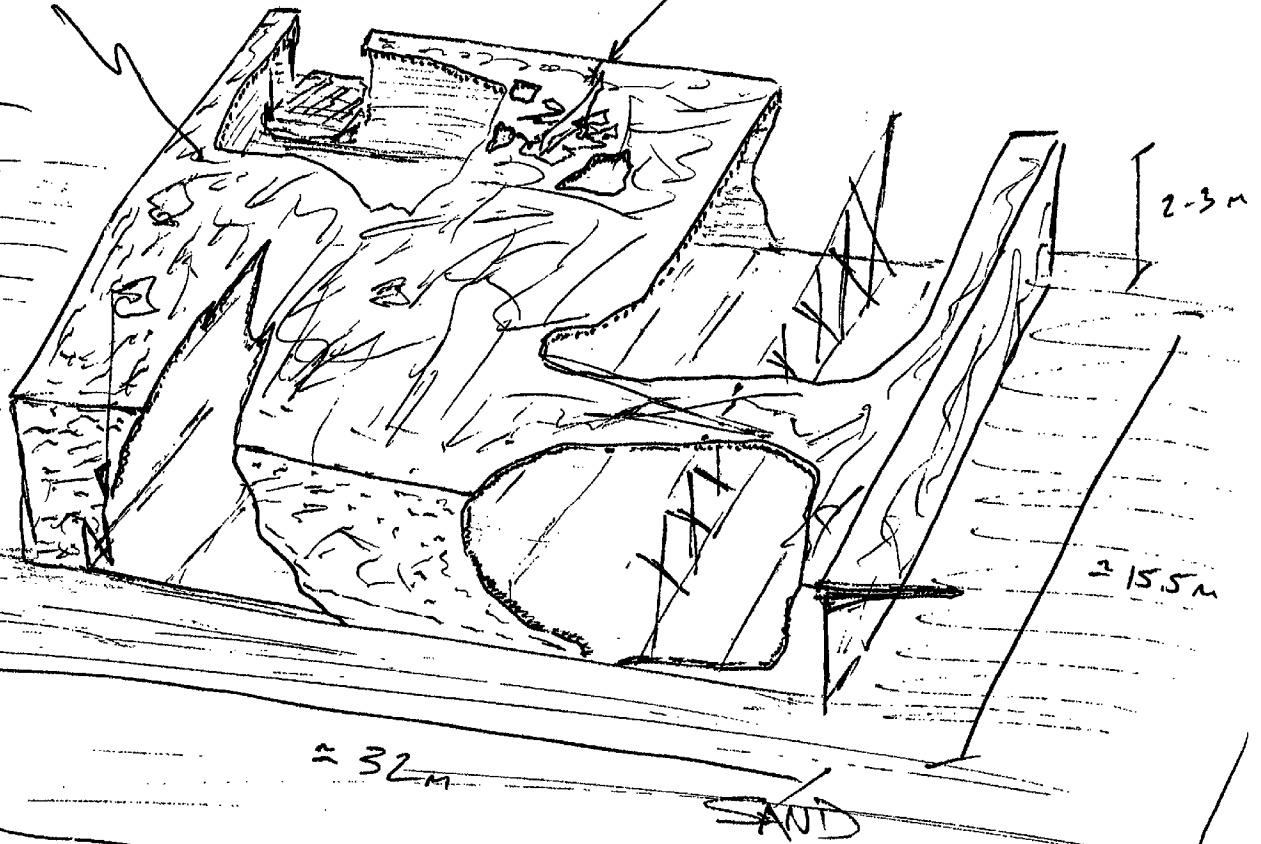
MARINE GROWTH VI

LEAST DEPTH
ON DEBRIS

Recommendation: Recommend repositioning the "dangerous submerged wreck" symbol on chart #25649 to new position: 18/18/44.776 N, 064/55/01.005 W; Annotate "~~7.9~~^{8.0}m." (26 FT) CONW

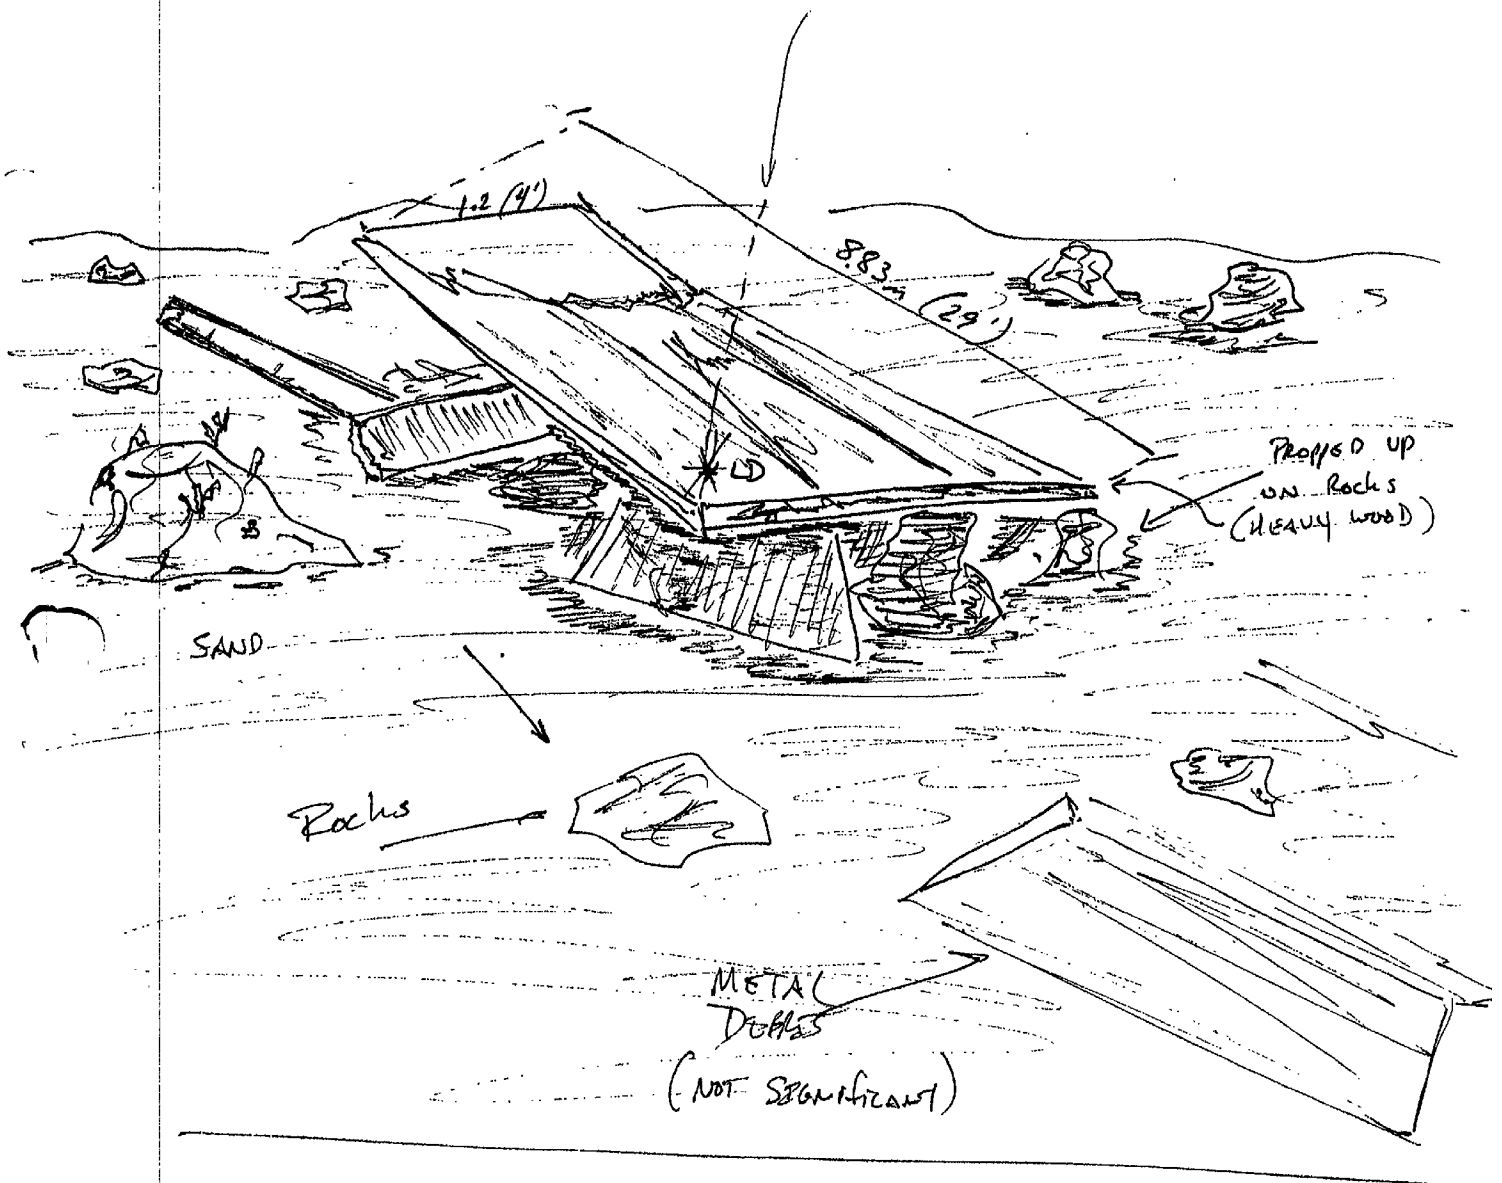
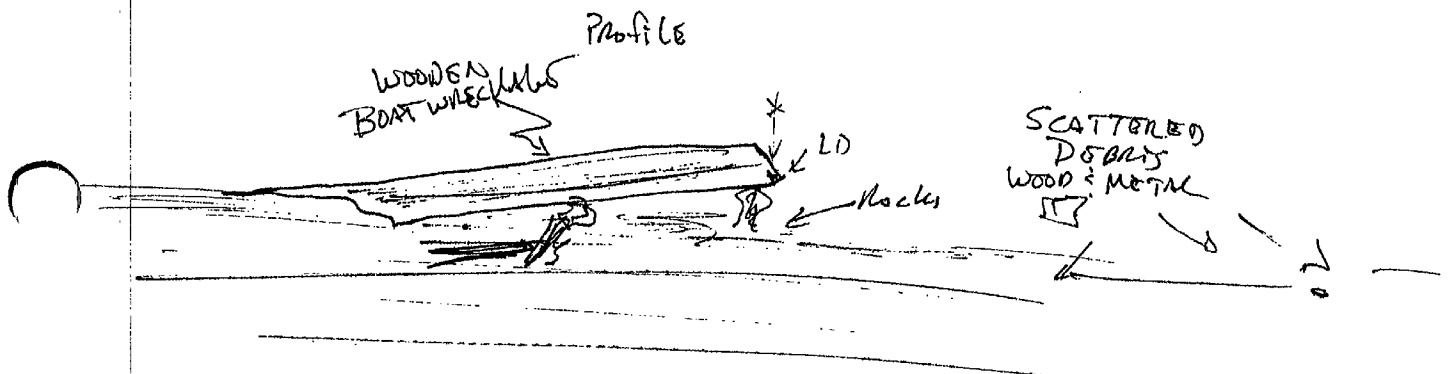
AWOES
8543

2 LD 6.6m @ 1538 GAT UNC

Recommendation: Recommend retain the submerged wreck symbol as charted. Delete the annotation "ED (13ft rep 1977)." Add the annotation "least depth 6.3m (20.7ft)." *DO NOT CONCUR CHART A WRECK WITH A LEAST DEPTH OF 20 FT, (20WK), IN LATITUDE 18°19'24.109"N, LONGITUDE 64°55'24.228"W. ALSO RECOMMEND DELETE CHARTED DANGEROUS SUNKEN WRECK, WITH NOTATION (13FT REP, 1977) ED.*

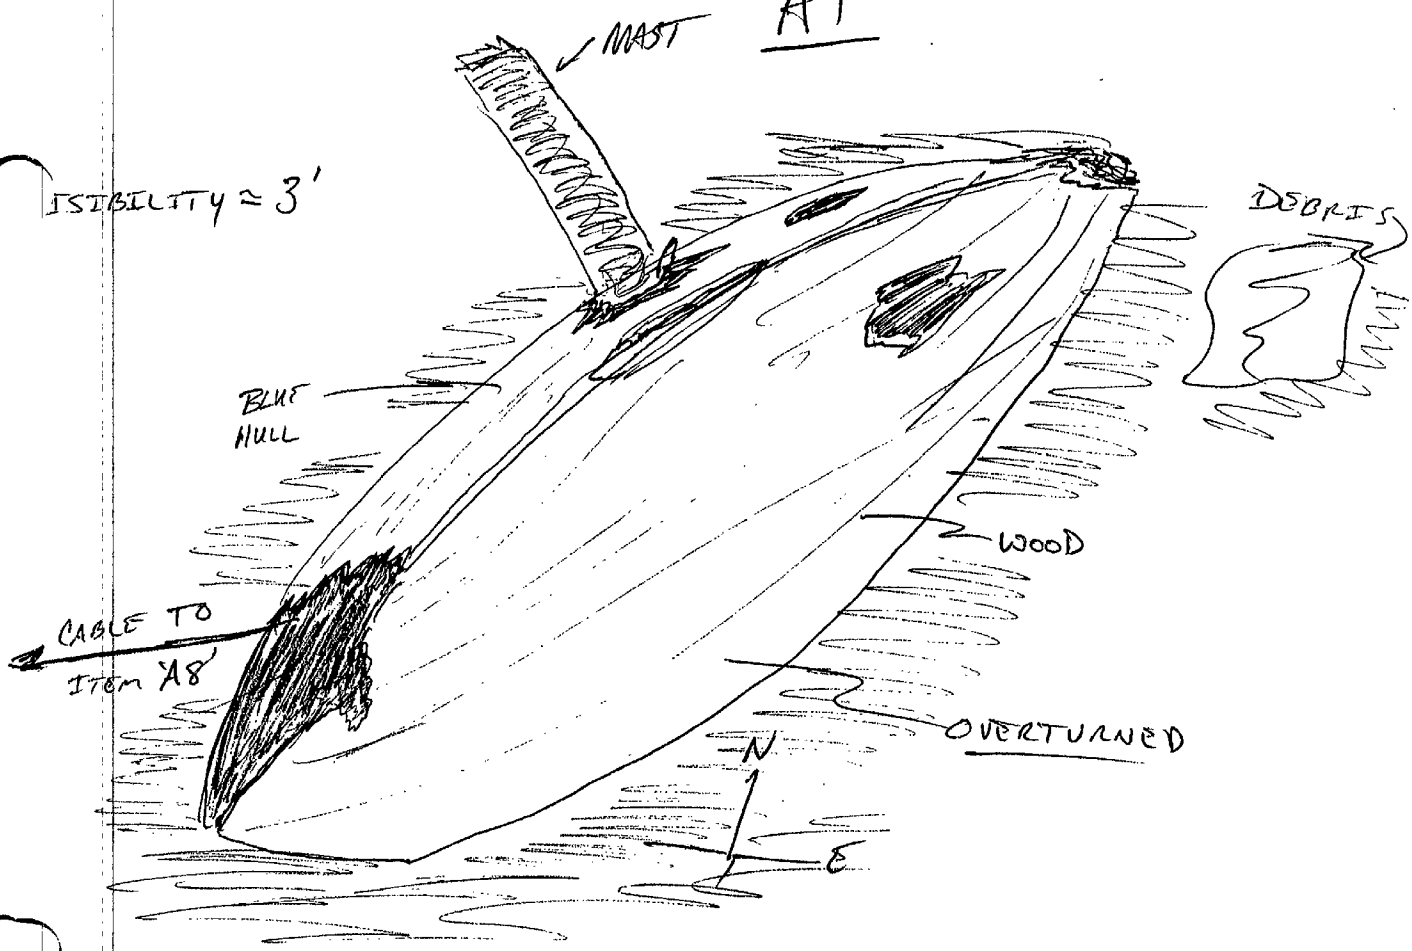
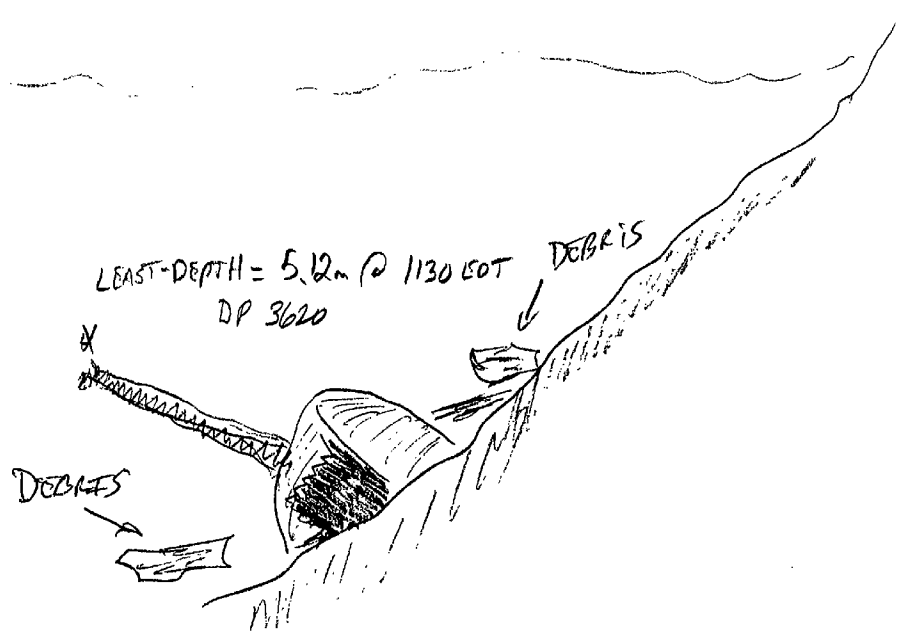
A9

STABILITY $\approx 3'$

LEAST-DEPTH = 5.12m @ 1130 EOT
DP 3620

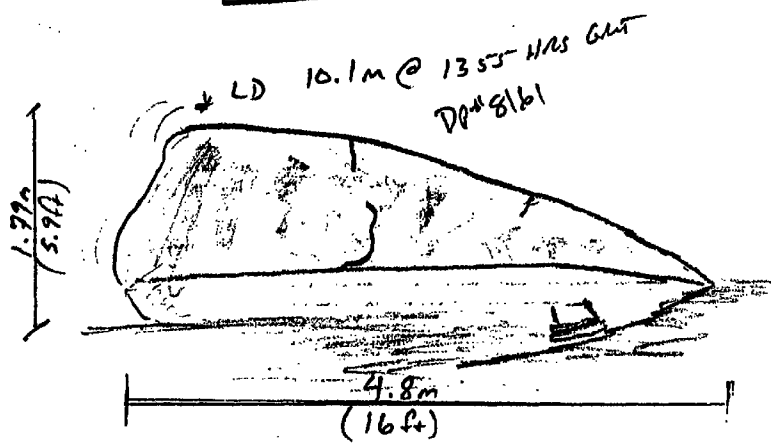
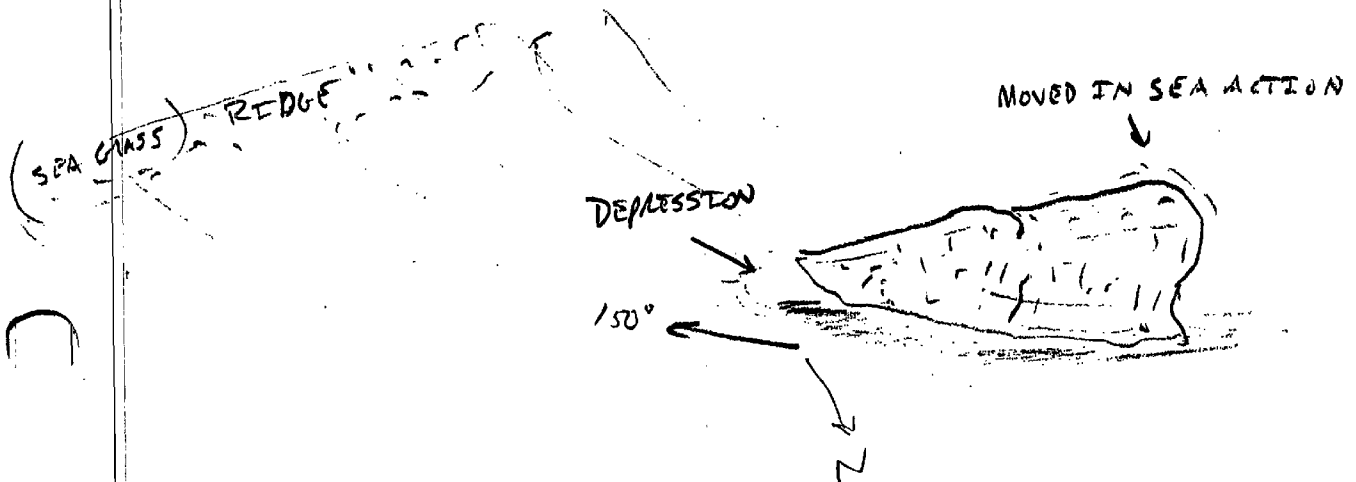
A19

ENTIRE HULL MOVED IN SEA ACTION !!!
