NOAA FORM 77-28 (11-72)	U.S. DEPARTMENT OF COMMERCE NATIONAL OCEANIC AND ATMOSPHERIC ADMINISTRATION	REGISTRY NO. H11023
<p align="center">HYDROGRAPHIC TITLE SHEET</p>		FIELD NO. D
<p>INSTRUCTIONS - The Hydrographic Sheet should be accompanied by this form, filled in as completely as possible, when the sheet is forwarded to the Office.</p> <p>State <u>Delaware –New Jersey</u></p> <p>General locality <u>Delaware River</u></p> <p>Locality <u>Liston Point to New Castle</u></p> <p>Scale <u>1:20,000</u> Date of survey <u>26 March 2001 – 3 December 2001</u></p> <p>Instructions Dated <u>27 October 2000</u> Project No. <u>OPR-D307-KR-00/01</u></p> <p>Vessel <u>R/V OceanExplorer US905425</u></p> <p>Chief of Party <u>WALTER S. SIMMONS</u></p> <p>Surveyed by <u>Walter Simmons, Steven Lemke, Paul Donaldson, Gary Davis, George Ghiorse, Rick Nadeau</u></p> <p>Soundings taken by <u>echo sounder</u> hand lead, pole <u>MULTIBEAM RESON SEABAT 8101</u></p> <p>Graphic record scaled by survey personnel _____</p> <p>Graphic record checked by survey personnel _____</p> <p>Protracted by _____ Automated plot by <u>HP1055CM</u></p> <p>Verification by <u>Atlantic Hydrographic Branch Personnel</u></p> <p>Sound

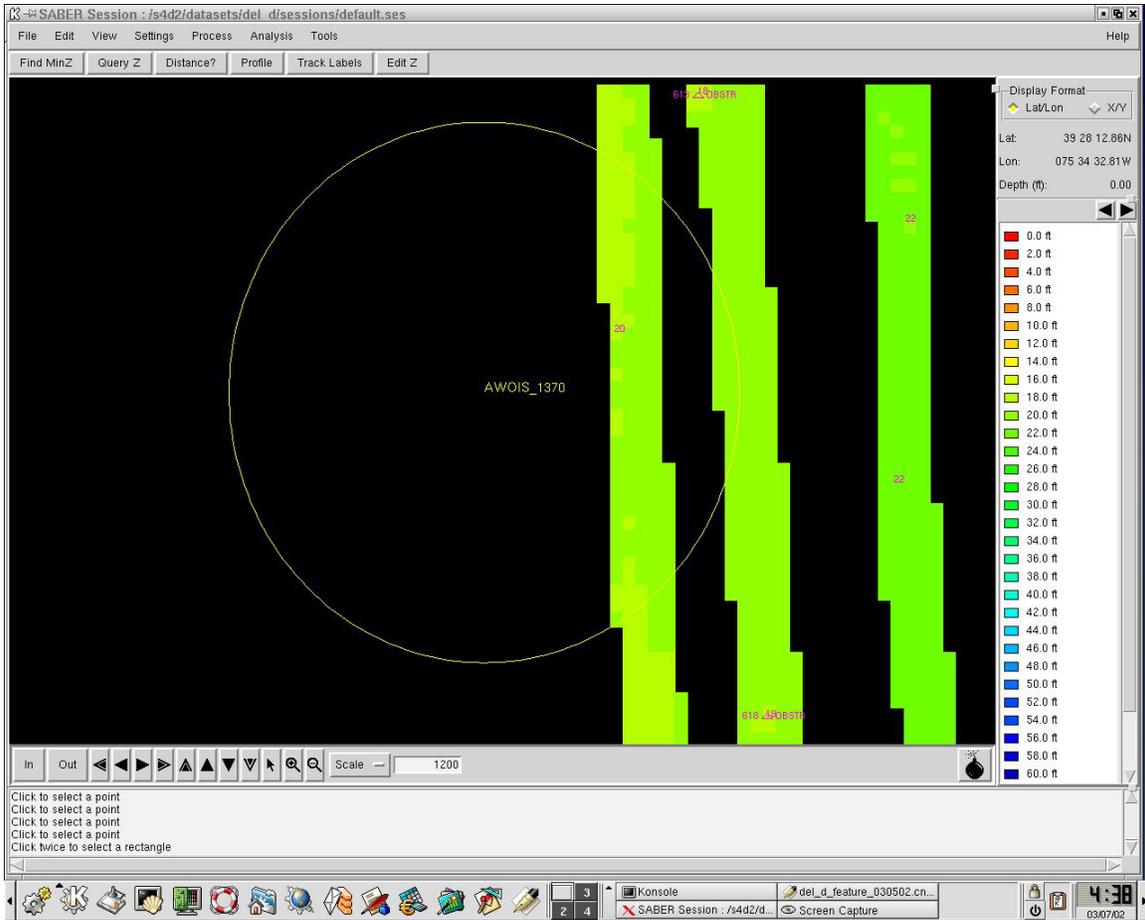
The eastern half of the 100-meter search radius of AWOIS Item 1370 was surveyed with 200% side scan coverage and partial multibeam coverage in H11023. The item was located in the side scan data at 39° 28' 13.83"N 075° 34' 28.69"W, NAD83, was measured to be 1.2 feet high, and identified as contact number 2001/143150213. The wreck is on the east side and at the base of the Reedy Island Dike. There were no visible structures above the water. No multibeam data was collected over the wreck. Recommend removal of charted exposed wreck symbol and chart a submerged wreck symbol (See Chartlet 12311 12). **Presently charted as a dangerous sunken wreck. No change in charting is recommended.**

Figure D-1. Multibeam coverage of AWOIS 1370 search radius.

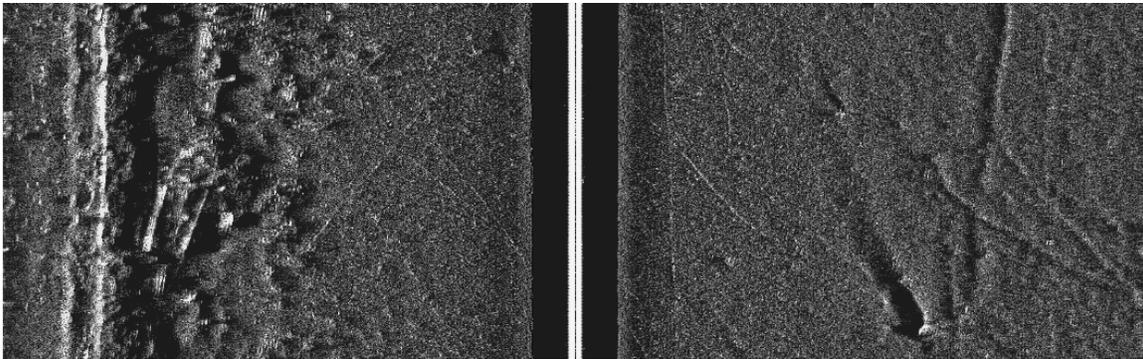
Figure D-2. Side scan image of AWOIS 1370.

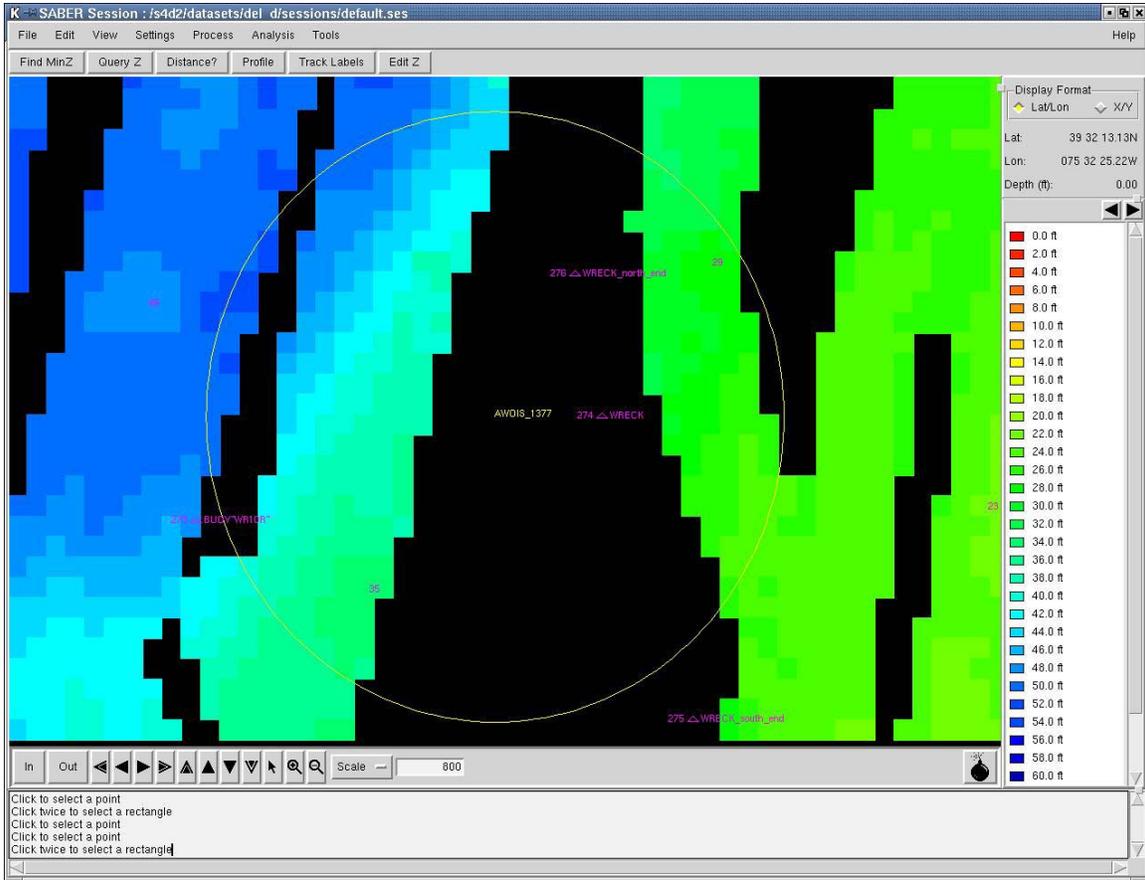
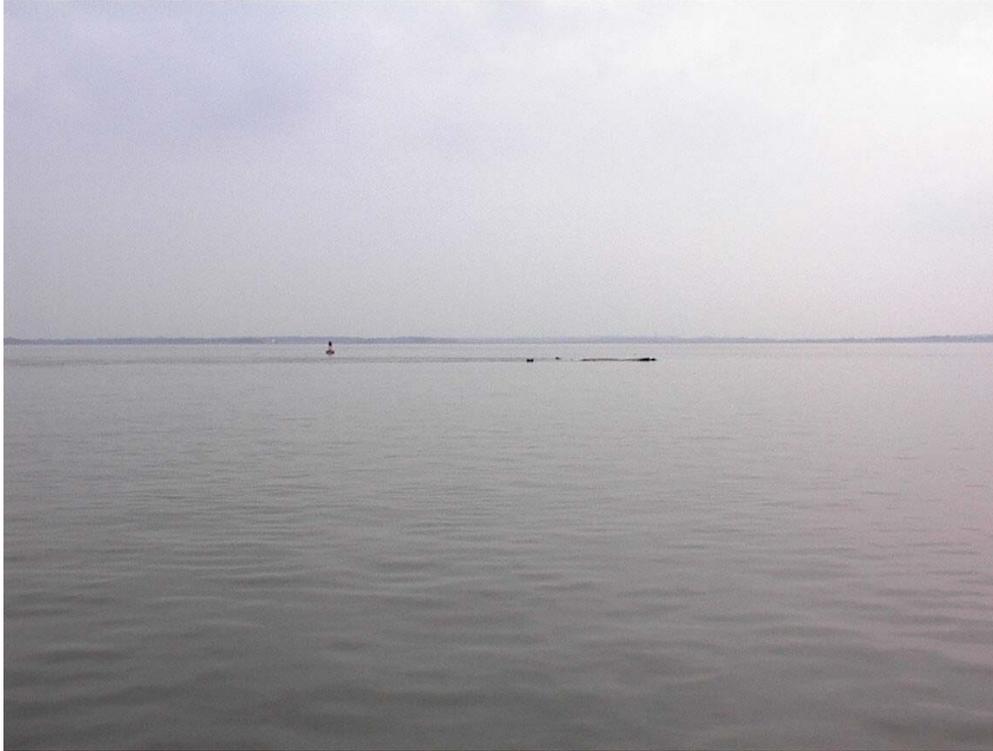
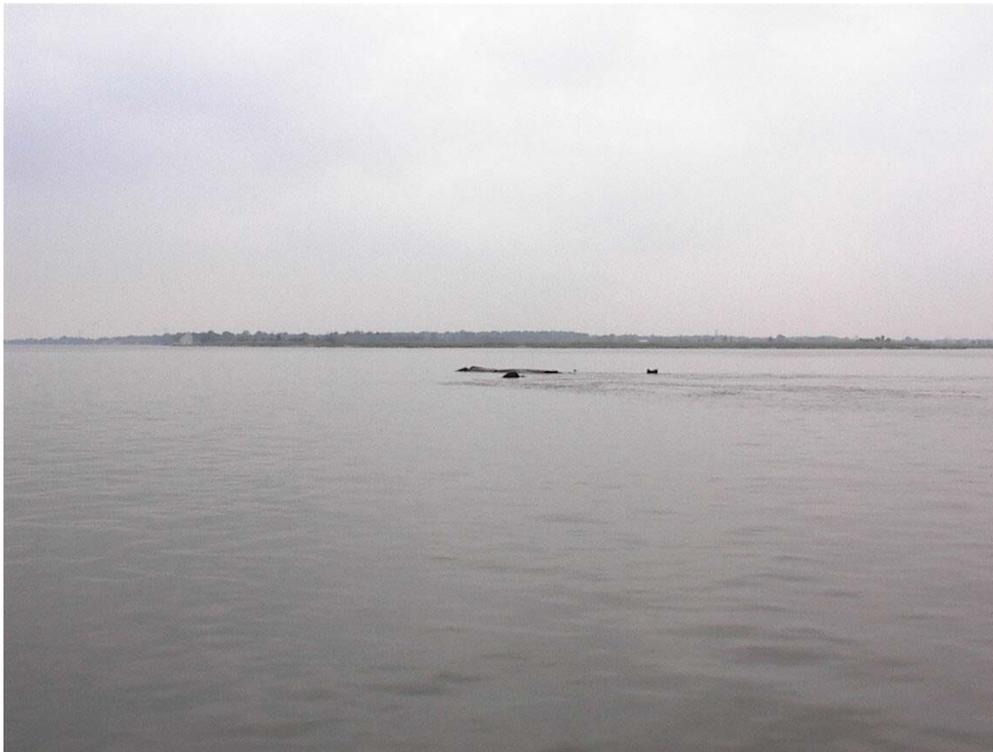
Part of the 75-meter search radius of AWOIS Item 1377 was surveyed with 200% side scan coverage and partial multibeam coverage in H11023. The wreck was still exposed (0.59 – 0.79 meters) at MLLW and was a danger to navigation. It was located and is identified as Features 274, 275, and 276. No multibeam data was collected over the wreck. Recommend removal of charted dangerous submerged wreck, and charting as wreck, uncovers at chart datum symbol at 39° 32' 12.78"N 075° 32' 25.55"W, NAD83 (See Chartlet 12311 9). **Concur. Revise dangerous sunken wreck (PA) to a visible wreck.**

Figure D-3. Multibeam coverage and features of AWOIS 1377 search radius

Figure D-4. Photograph of AWOIS 1377 at tide one foot above MLLW showing Buoy R “WR10R”

Figure D-5. Photograph of AWOIS 1377 at tide one foot above MLLW

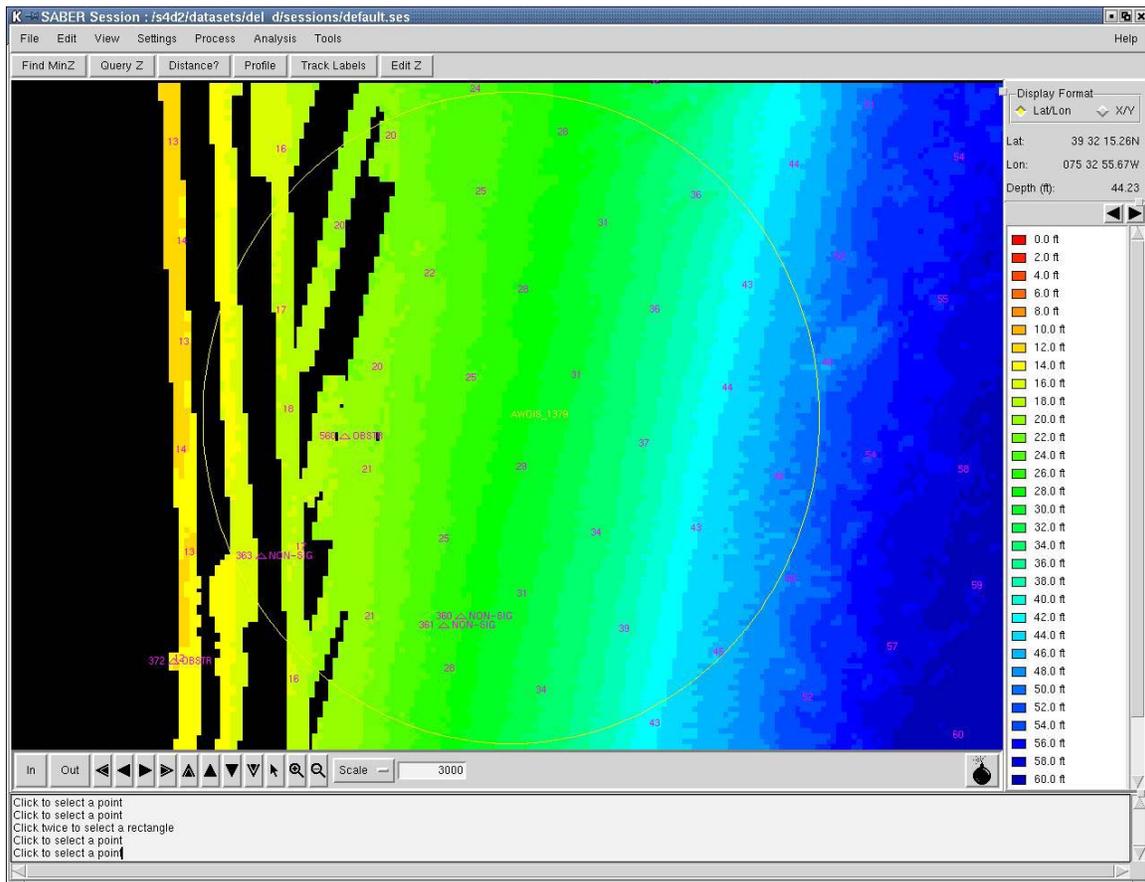
- Features 360 and 361 are a 1.6 foot high linear object with least depth 26.75 feet, located in the vicinity of 39° 32' 15.55"N 075° 33' 05.42"W, NAD83. **Insignificant. Do not chart.**
- Feature 560 is a 2.1 foot high object with least depth 18.04 feet at 39° 32' 20.80"N 075° 33' 09.52"W, NAD83, 163 meters at 263° from the listed position for AWOIS 1379). **Insignificant. Do not chart.**

Figure D-6. Multibeam coverage and features of AWOIS 1379 search radius

The item is not charted on Chart 12311 and based on the results of H11023, recommend that it not be charted (See Chartlet 12311 9). **Concur. No change in charting is recommended.**

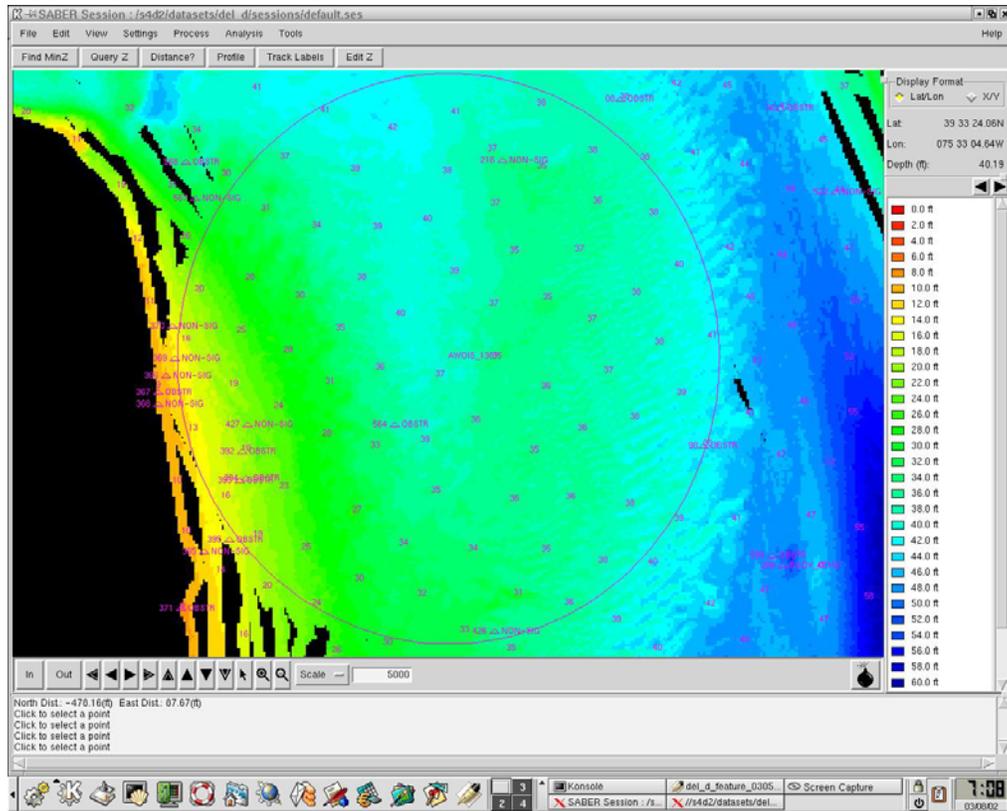
- Feature 564 is a 2.7 foot high object with least depth 36.19 feet at 39° 33' 16.59"N 075° 33' 02.83"W, NAD83, 156 meters at 221° from the listed position for AWOIS 1381). **Concur. Insignificant.**

Figure D-7. Multibeam coverage and features of ~~AWOIS 1817~~ search radius
AWOIS 1381

The item is charted as a reported obstruction on Charts 12311 and ~~12307~~**12277**. Based on the results of H11023, recommend removal of the charted Obstn rep, danger circle, and blue tint (Chartlets 12311 8 & 9, and 12277 7). **Concur. Delete the dangerous Obstn rep.**

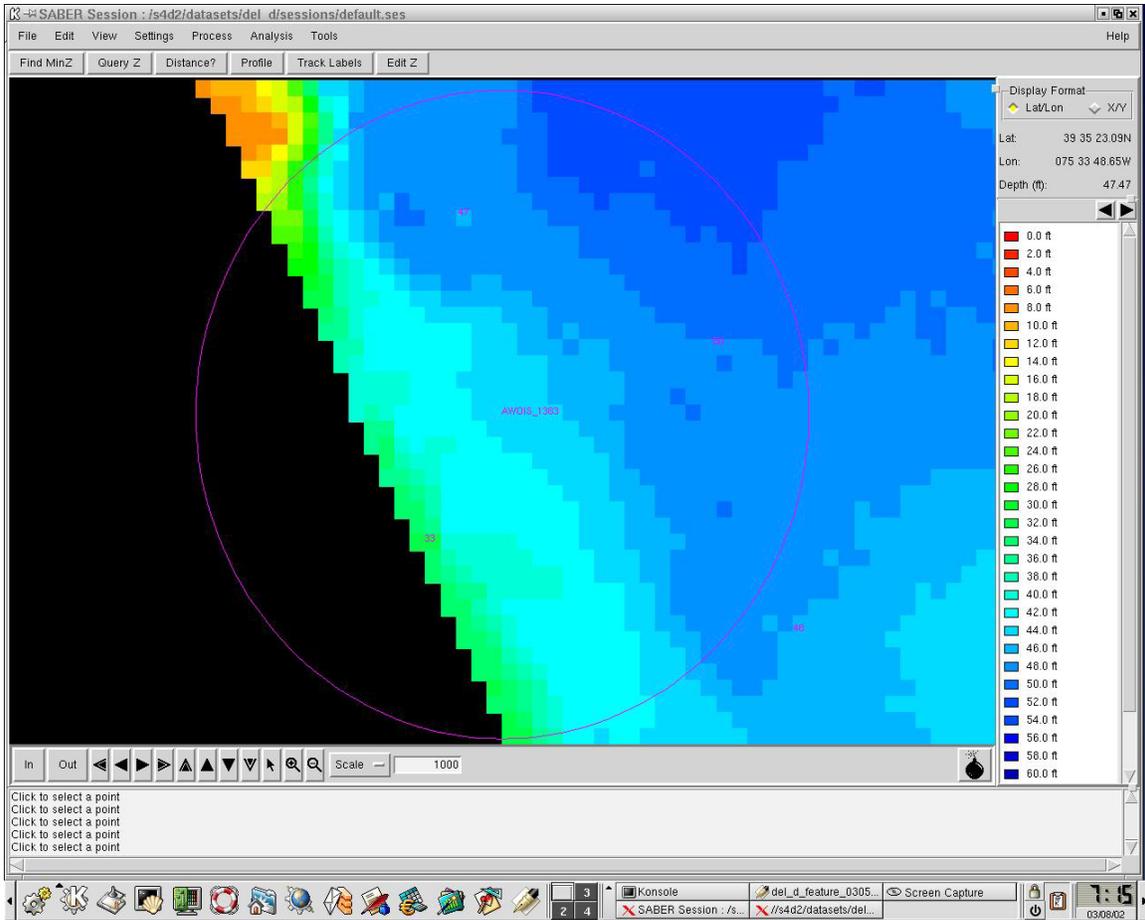
The 100-meter search radius of AWOIS Item 1381³ was surveyed with 200% side scan coverage and 100% multibeam coverage in H11023. The item was not located in either the multibeam or the side scan data. See Chart Correction Letter, (**appended to this report**) Charts 12277 and 12311, dated 3 January 2002 (Appendix V)* for coverage and recommendations.

Figure D-8. Multibeam coverage of AWOIS 1383 search radius

Recommend removal of the charted 24 foot sounding, Rks symbol, danger symbol, and blue tint (see Chartlets 12311 6 and 12277 2). **Latest editions of charts 12277 and 12311 have been updated. No change in charting. Rock notations in the vicinity of Lat. 39/35/23.16N, Long. 75/33/53.34W are to be retained**

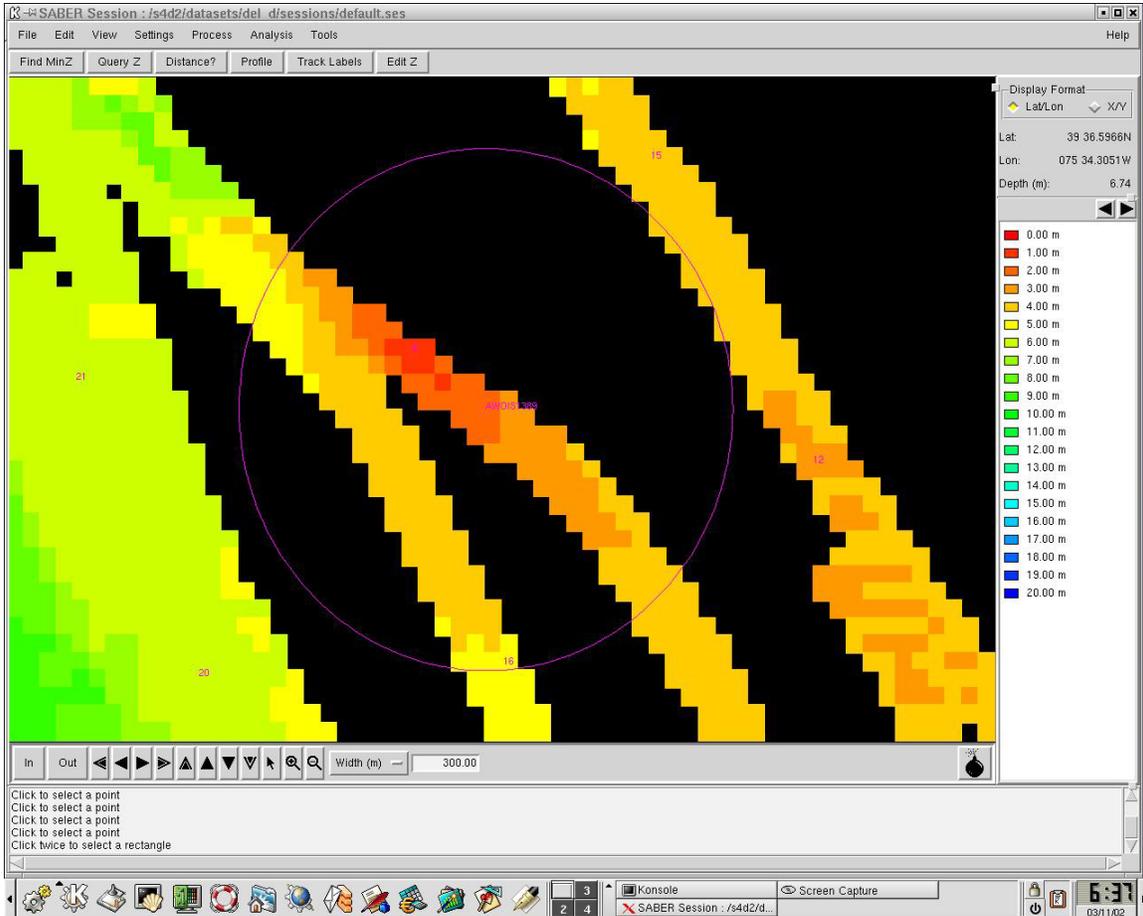
The 150-meter search radius of AWOIS Item 1384⁹ was partially surveyed with side scan coverage and multibeam in H11023. The item was not located in either the multibeam or the side scan data. The item is charted as a submerged dolphin on chart 12311. H11023 did not sufficiently cover the search area to prove or disprove the item. Recommend retaining the item as charted (see Chartlet 12311). **Concur. Retain pile symbol (ED).**

Figure D-9. Multibeam coverage of AWOIS 1389 search radius

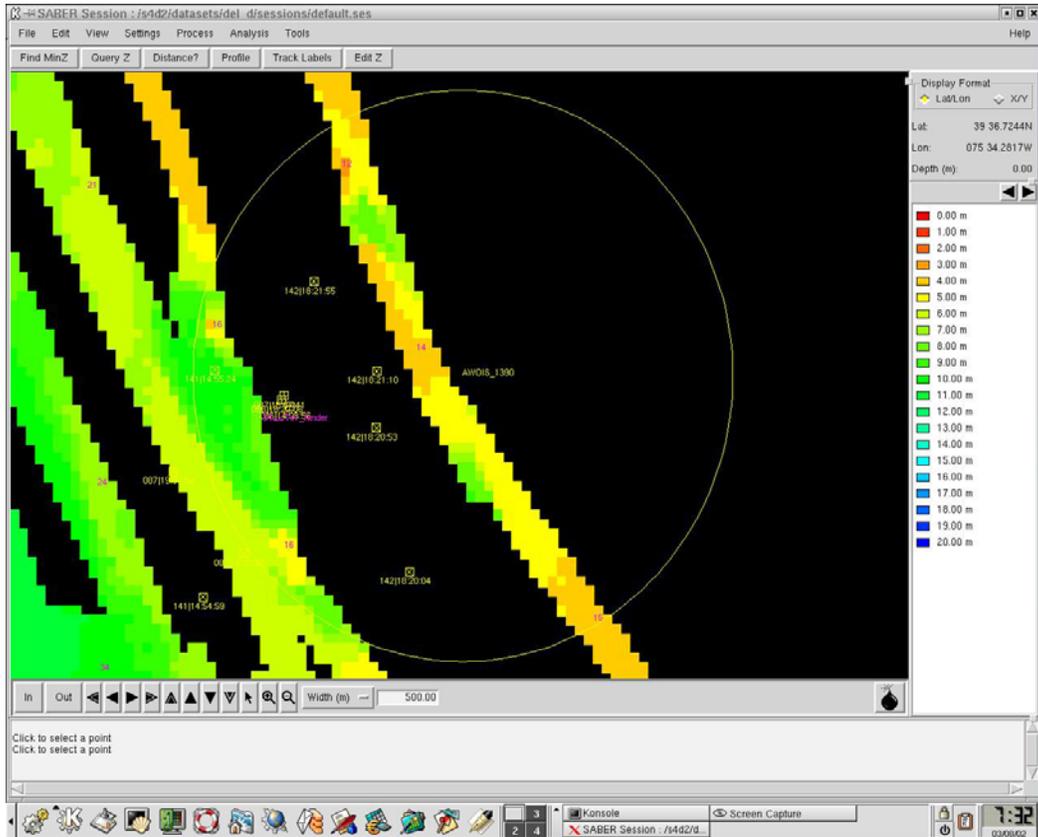
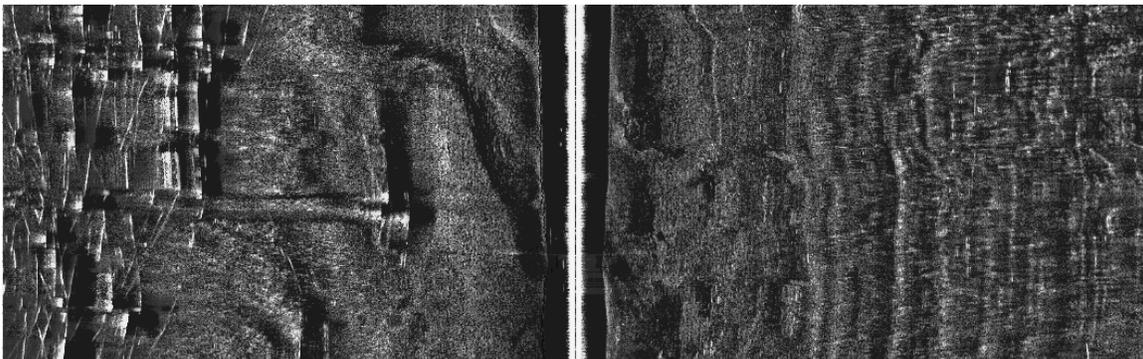
The western half of the 150-meter search radius of AWOIS Item 1390 was surveyed with 200% side scan coverage and partial multibeam coverage in H11023. The item was located at 39° 36' 45.48"N 075° 34' 17.67"W, NAD83, and is identified as side scan contact 142/182110. The item is charted on Chart 12311 as submerged dolphins. Recommend retaining the submerged dolphin description and moving the dolphin symbol to 39° 36' 45.48"N 075° 34' 17.67"W, NAD83 (See Chartlet 12311 5). **Concur in part. Retain Subm dols and symbol as charted. Delete notation "ED".**

Figure D-10. Multibeam coverage and features of AWOIS 1390 search radius

Figure D-11. Side Scan image of AWOIS 1390

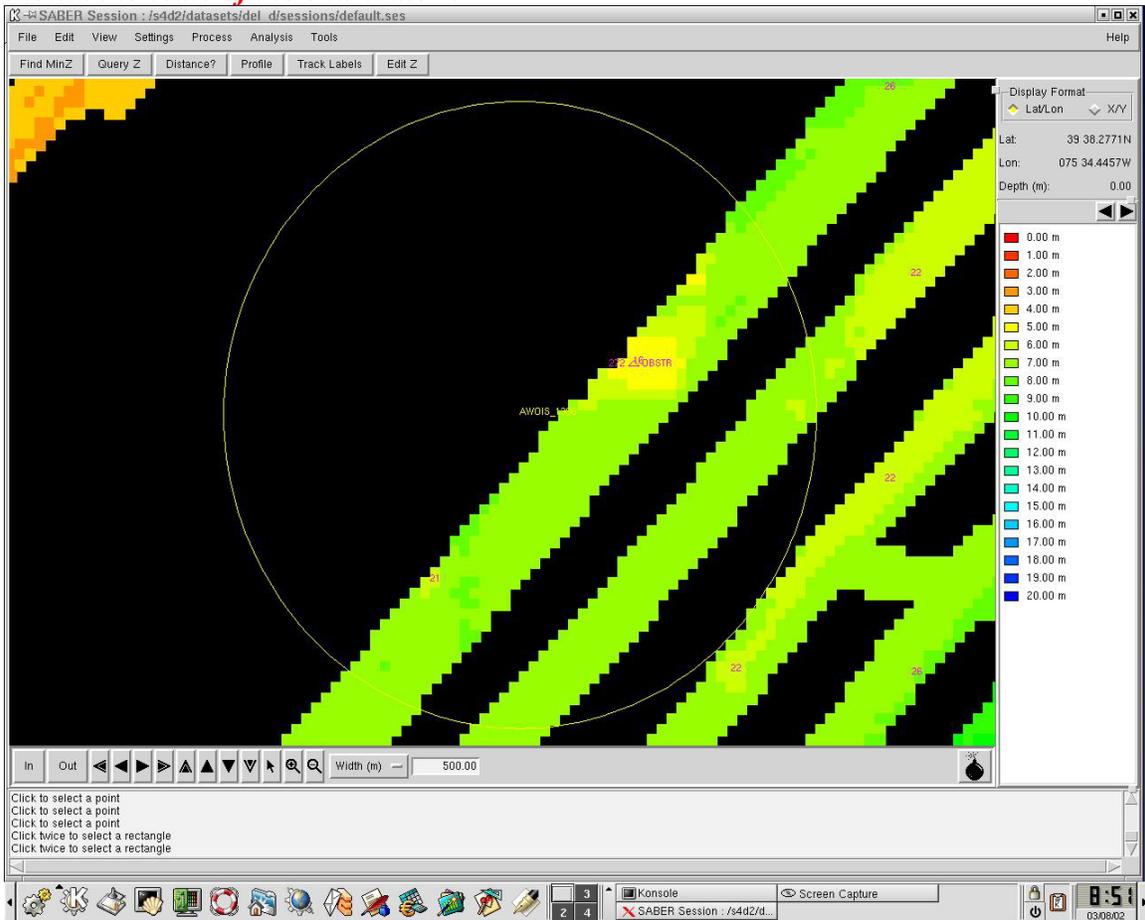
The southeast half of the 150-meter search radius of AWOIS Item 1396 was surveyed with 200% side scan coverage and partial multibeam coverage in H11023. The item was located at 39° 38' 18.09"N 075° 34' 30.92"W, NAD83, with a minimum depth of 16.93 feet and is identified as Feature 272. The item is not charted on Chart 12311.

Figure D-12. Multibeam coverage and features of AWOIS 1396 search radius

Recommend item not be charted. A mound with least depth 16.54 feet is just offshore of feature 272. **Concur. Chart a 16-ft sounding in Lat: 39°38'17.98", Long:75°34'30.92" should the scale of the chart allow.**

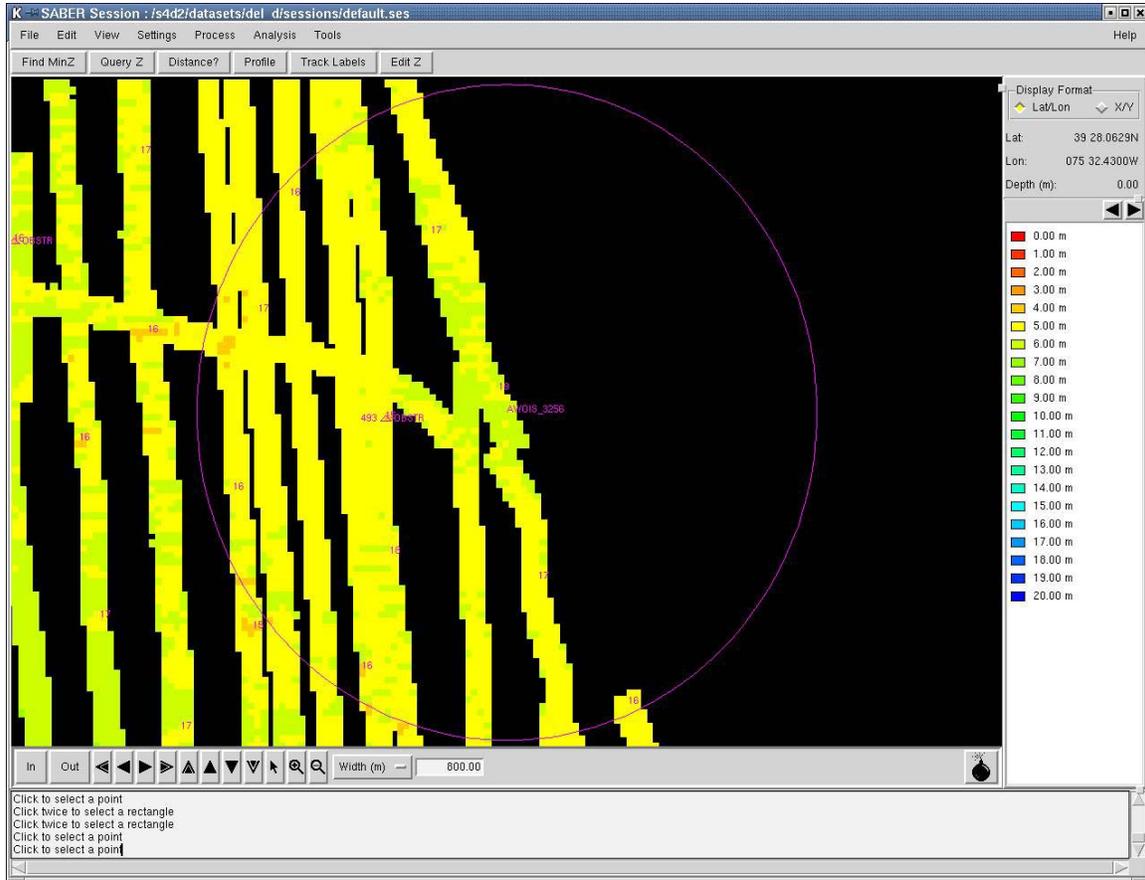
The eastern half of the 250-meter search radius of AWOIS Item 3256 was surveyed with 200% side scan coverage and partial multibeam coverage in H11023. The item was located at 39° 28' 07.23"N 075° 32' 37.79"W, NAD83, with a minimum depth of ~~45~~16 feet and is identified as Feature 493. The item is not charted on Chart 12311. Recommend charting sounding with the symbol "Obstn" (See Chart 12311 12). **Do not concur. Chart present survey soundings.**

Figure D-13. Multibeam coverage and features of AWOIS 3256 search radius

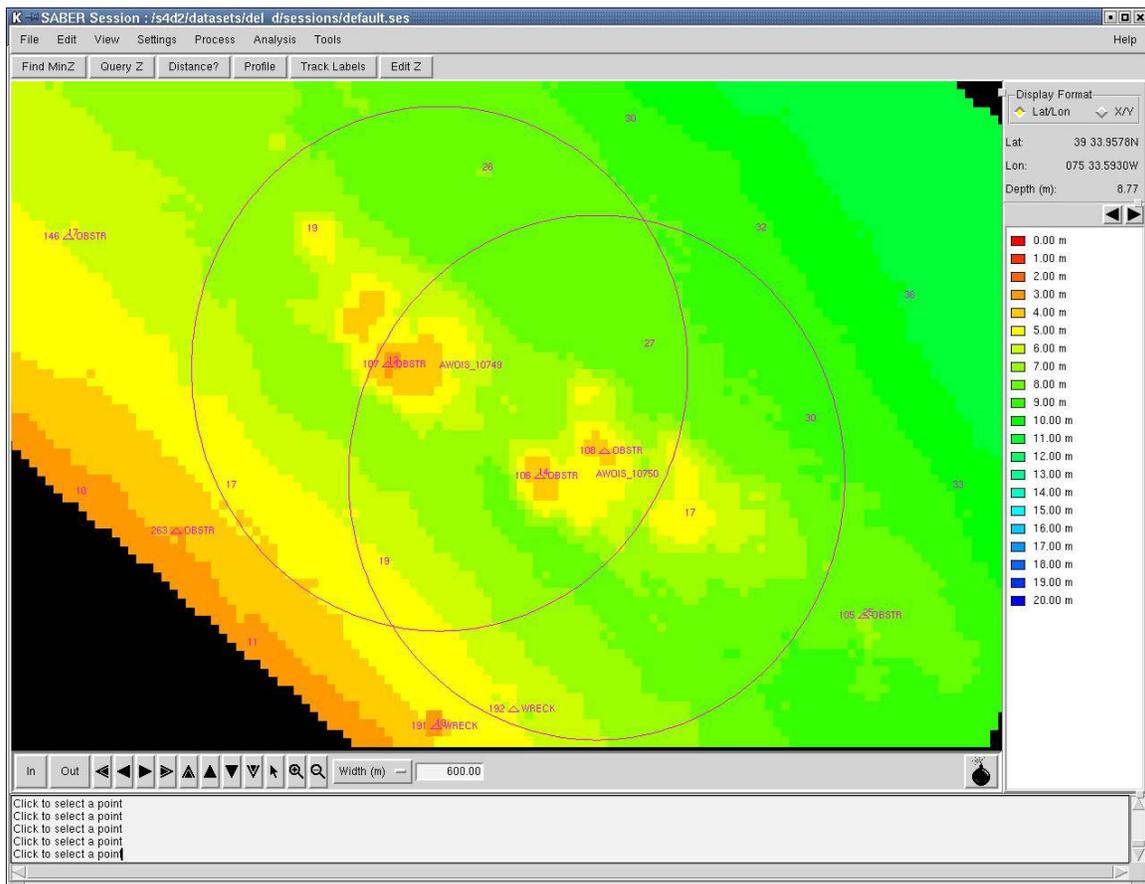
- AWOIS 10749 - 39° 34' 02.47"N 075° 33' 44.02"W, NAD83, with a minimum depth of 12 and is identified as Feature 107. **Concur.**
- AWOIS 10750 - 39° 34' 00.42"N 075° 33' 40.21"W, NAD83, with a minimum depth of 14 feet and is identified as Features 106 and 108. **Concur.**

Figure D-14 .Multibeam coverage and features of AWOIS 10749 and 10750 search radii

The items are charted on Charts 12311 and 12277 as a 14-foot and 15-foot shoal areas in the General Anchorage No. 4. Recommend charting the obstructions, and soundings from H11023 (See Chartlets 12311 8 and 12277 3 & 5). **Concur in part. The items are considered as bottom. Chart as 12-ft and 14-ft depths respectively.**

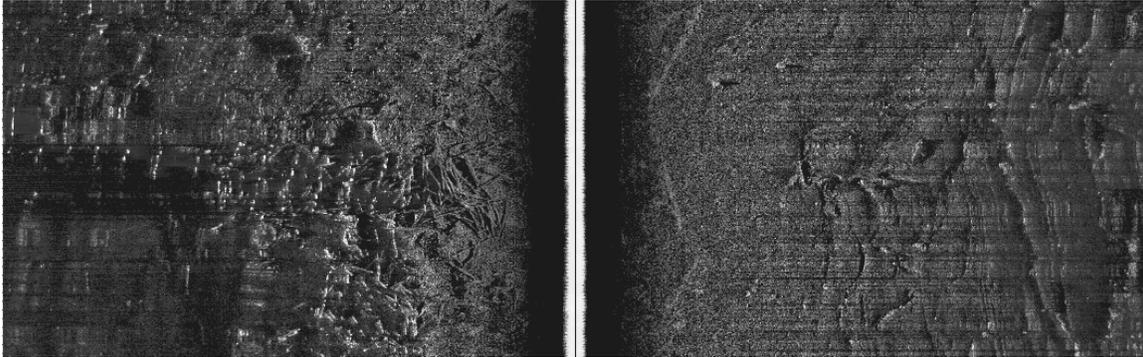
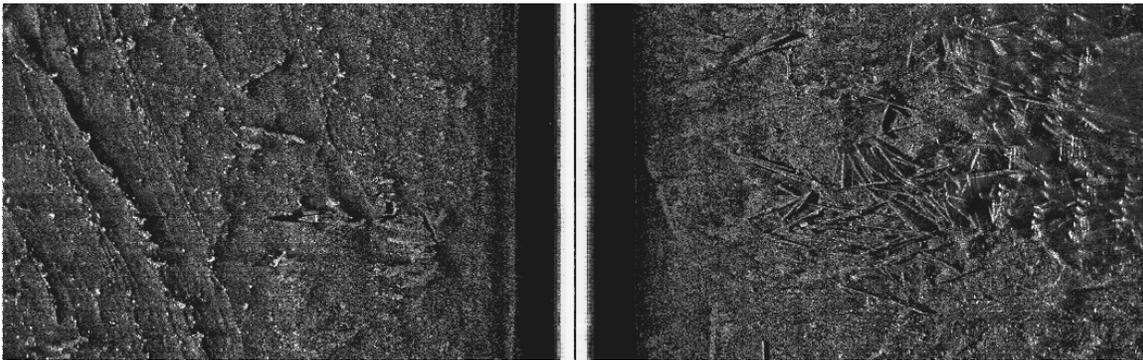
The charted pier ruins in the vicinity of 39° 34' 28.84"N 075° 34' 45.46"W, NAD83, were outside the multibeam coverage but in the side scan data from H11023. The ruins are identified as side scan contacts 091/142520, 091/142522, and 213/145951. It is recommended that they be retained as charted on charts 12311 and 12207 (see Chartlets 12311 6 and 12277 4). **Concur.**

Figure D-15. Side scan image of pier ruins at Delaware City from survey day 091

Figure D-16. Side scan image of pier ruins at Delaware City from survey day 213

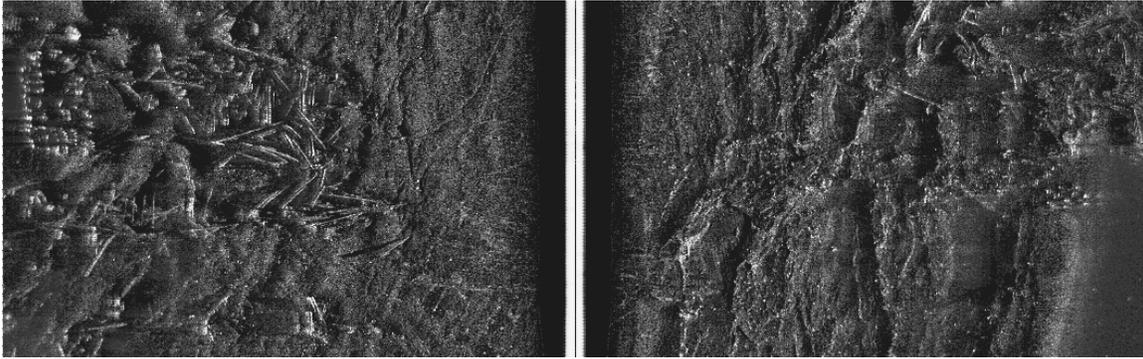
The charted pier ruins in the vicinity of 39° 30' 51.70"N 075° 33' 32.73"W, NAD83, were outside the multibeam coverage but in the side scan data from H11023. The ruins are identified as side scan contacts 143/133822, and 143/133845. It is recommended that they be retained as charted on charts 12311 and 12207. **Concur.**

Figure D-17. Side scan image of pier ruins off Reedy Island from survey day 143

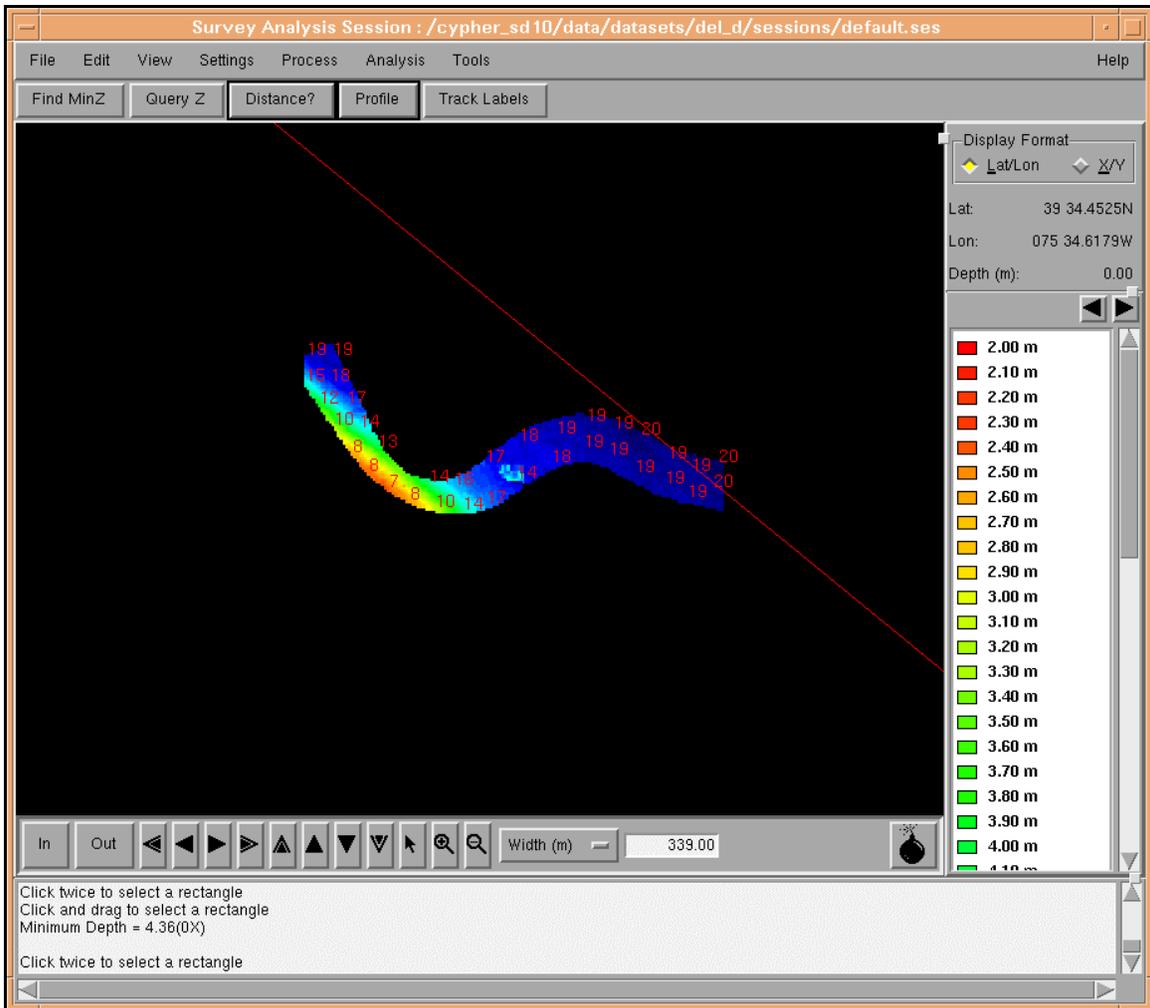
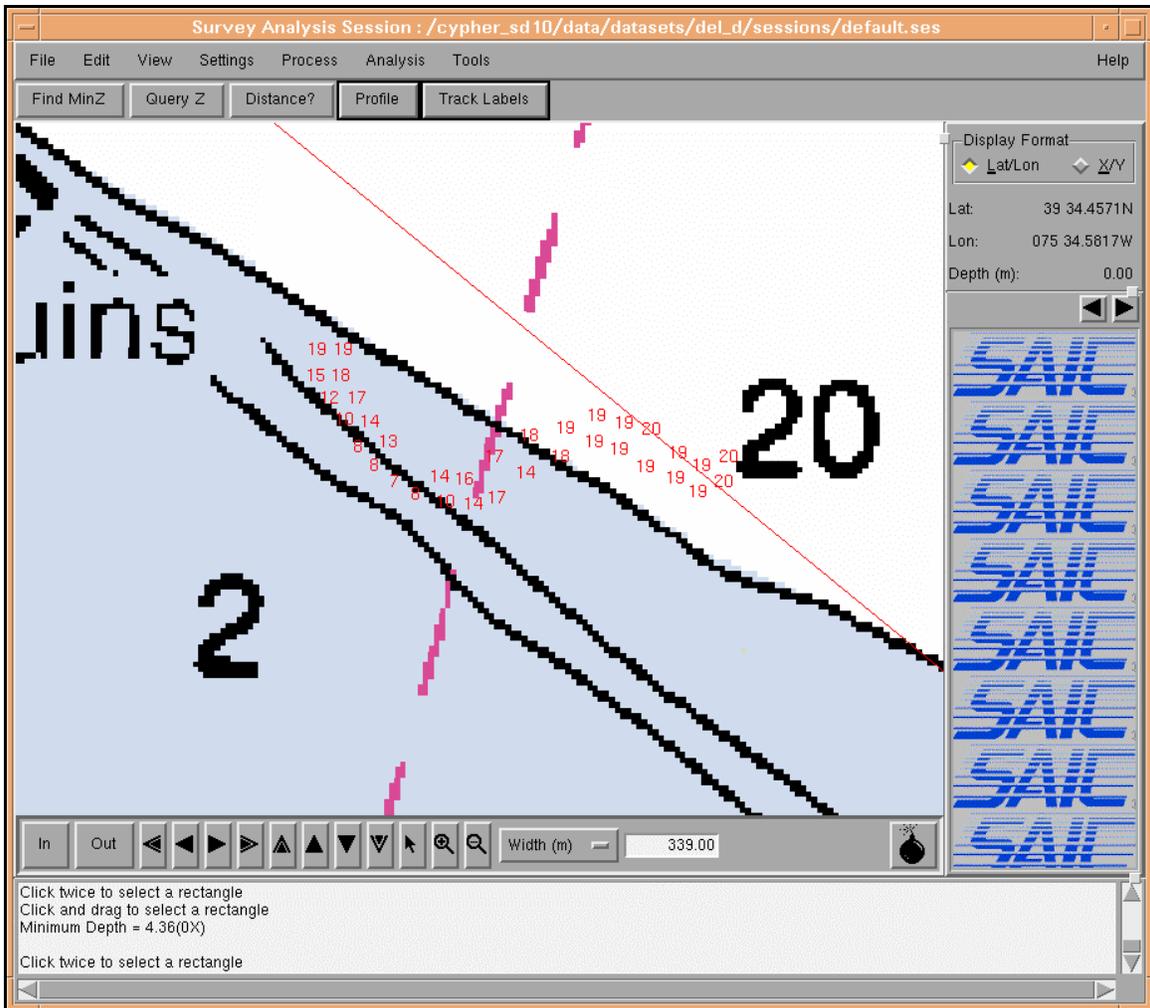
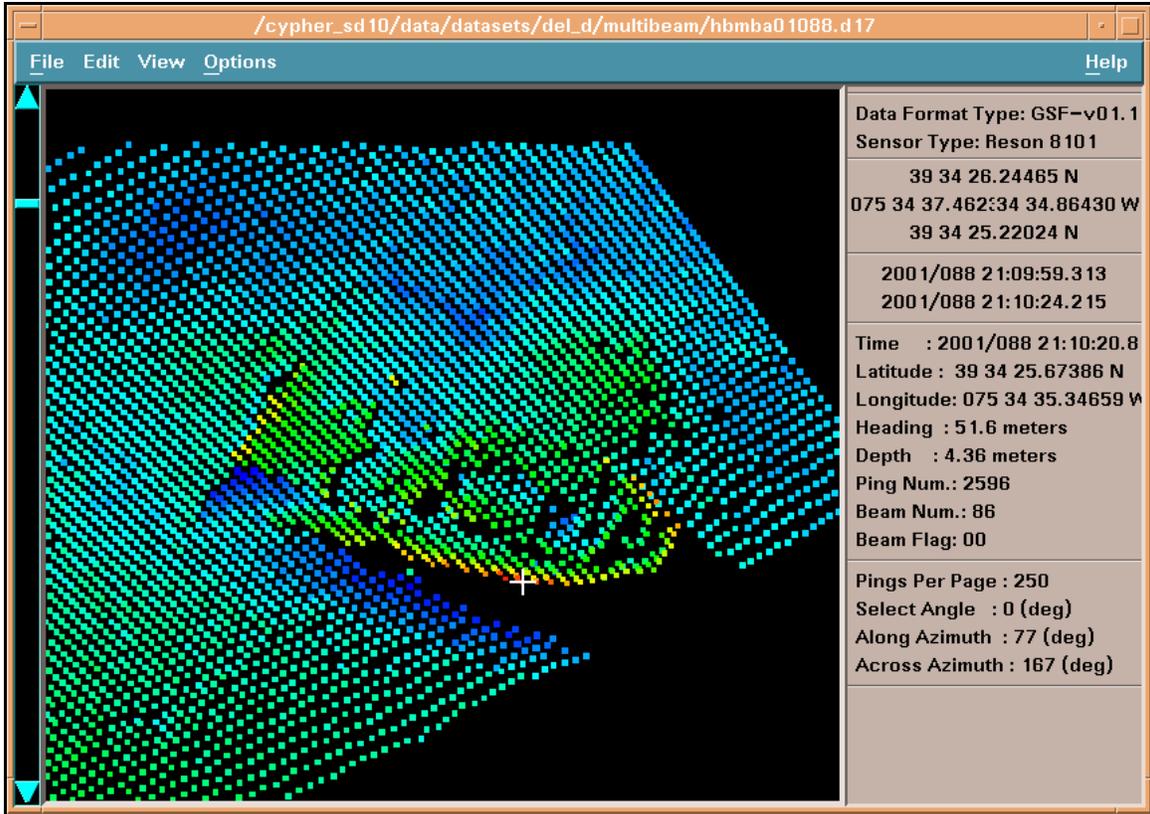
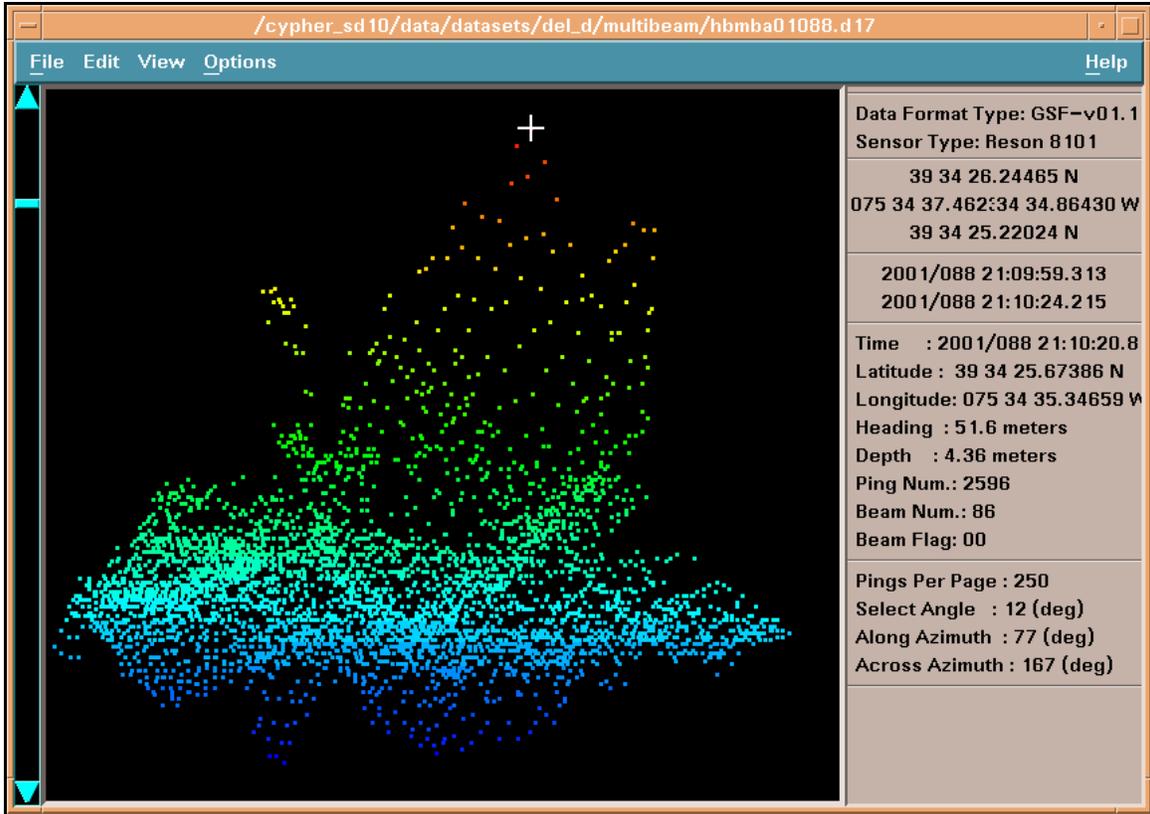
<u>FEATURE</u>	<u>DEPTH (FT)</u>	<u>LATITUDE(N)</u>	<u>LONGITUDE(W)</u>
1. Wreck	44 13	39 34 25.674	075 34 35.347

Figure Appendix I-1. Obstruction *Wreck* with Soundings

Figure Appendix I-2. Soundings over Chart ~~13223~~ 12277

Figure Appendix I-3. Obstruction *Wreck* Top View

Figure Appendix I-4. ~~Obstruction~~ **Wreck** view from the East
