NOAA FORM 77-28 (11-72)	U.S. DEPARTMENT OF COMMERCE NATIONAL OCEANIC AND ATMOSPHERIC ADMINISTRATION	REGISTRY NO. H11023
<p align="center">HYDROGRAPHIC TITLE SHEET</p>		FIELD NO. D
<p>INSTRUCTIONS - The Hydrographic Sheet should be accompanied by this form, filled in as completely as possible, when the sheet is forwarded to the Office.</p> <p>State <u>Delaware –New Jersey</u></p> <p>General locality <u>Delaware River</u></p> <p>Locality <u>Liston Point to New Castle</u></p> <p>Scale <u>1:20,000</u> Date of survey <u>26 March 2001 – 3 December 2001</u></p> <p>Instructions Dated <u>27 October 2000</u> Project No. <u>OPR-D307-KR-00/01</u></p> <p>Vessel <u>R/V OceanExplorer US905425</u></p> <p>Chief of Party <u>WALTER S. SIMMONS</u></p> <p>Surveyed by <u>Walter Simmons, Steven Lemke, Paul Donaldson, Gary Davis, George Ghiorse, Rick Nadeau</u></p> <p>Soundings taken by <u>echo sounder</u> hand lead, pole <u>MULTIBEAM RESON SEABAT 8101</u></p> <p>Graphic record scaled by survey personnel _____</p> <p>Graphic record checked by survey personnel _____</p> <p>Protracted by _____ Automated plot by <u>HP1055CM</u></p> <p>Verification by <u>Atlantic Hydrographic Branch Personnel</u></p> <p>Sound

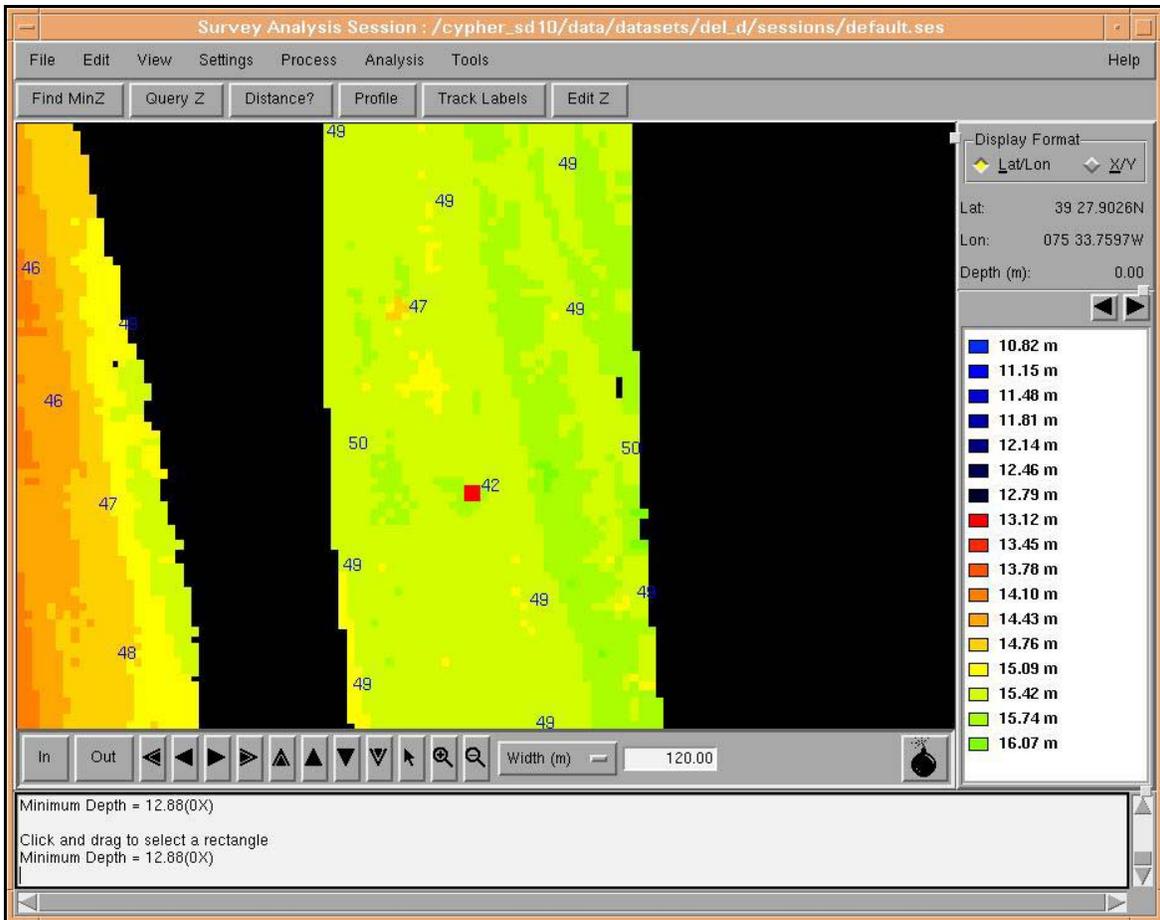
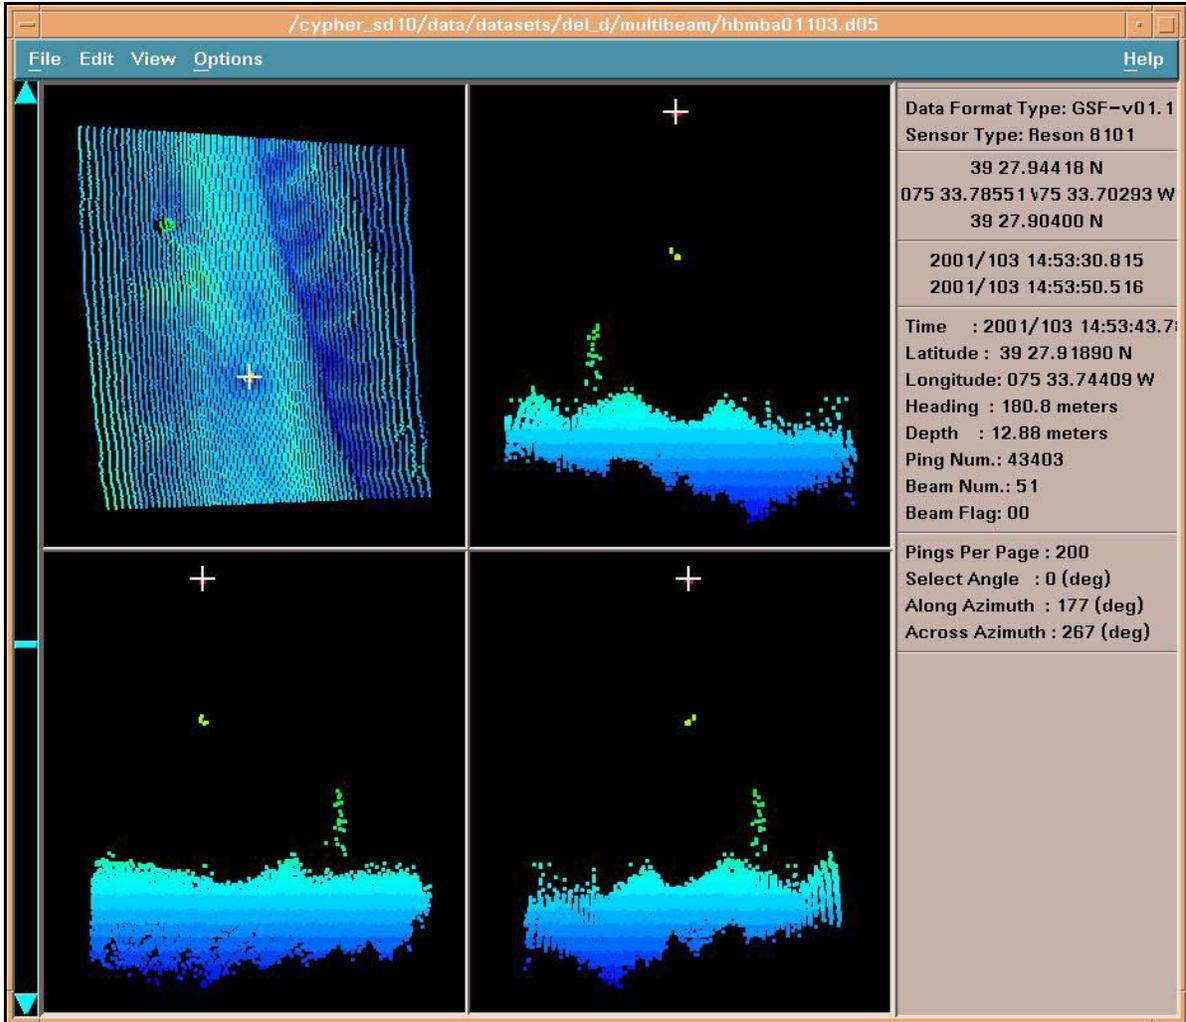
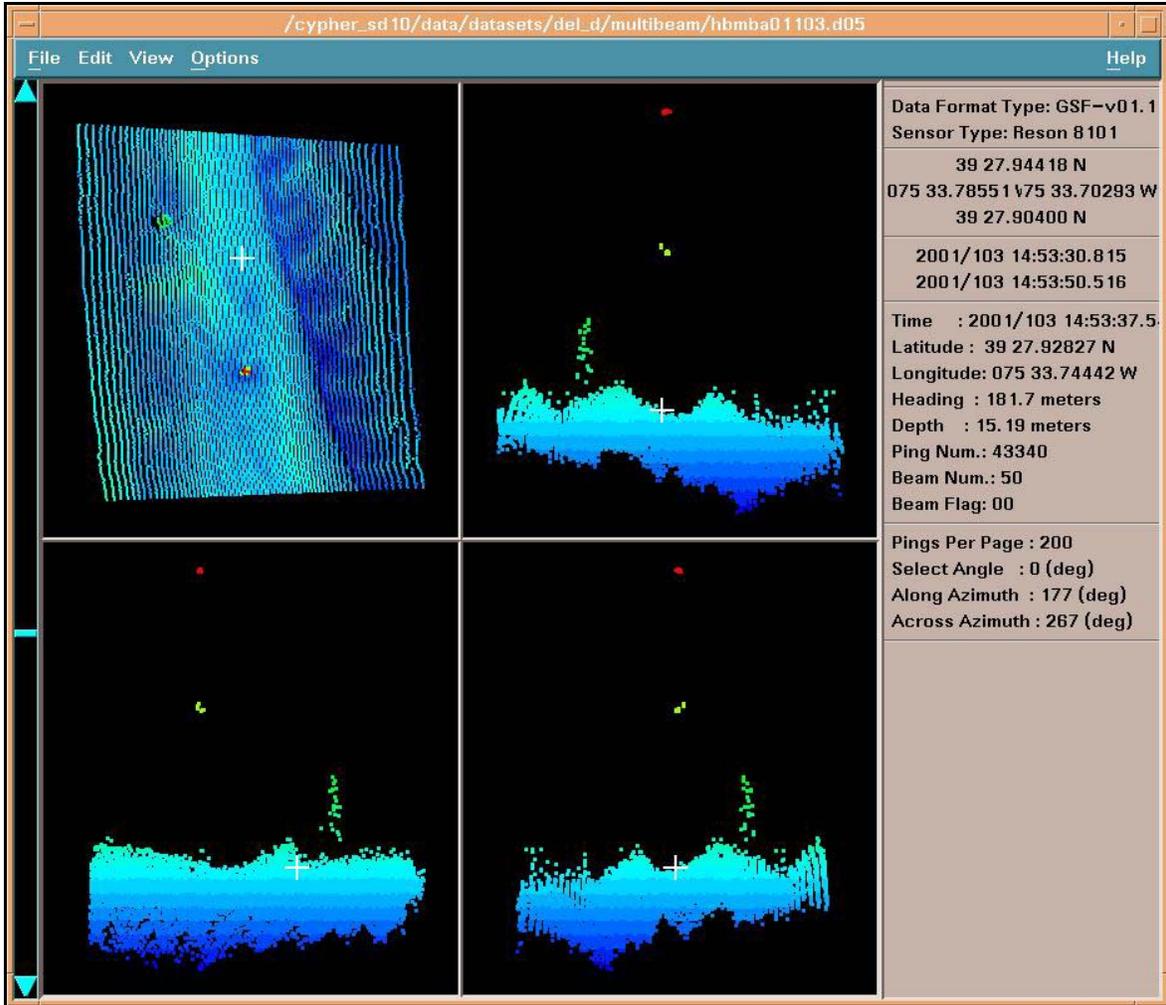
<u>FEATURE</u>	<u>DEPTH (FT)</u>	<u>LATITUDE(N)</u>	<u>LONGITUDE(W)</u>
1. Obstruction	42	39 27 55.13	075 33 44.65

Figure Appendix I-5. Gridded Depth with Soundings

Figure Appendix I-7. Obstruction with Cursor at Top Beam.

Figure Appendix I-8. Obstruction with Cursor at Surrounding Depths.

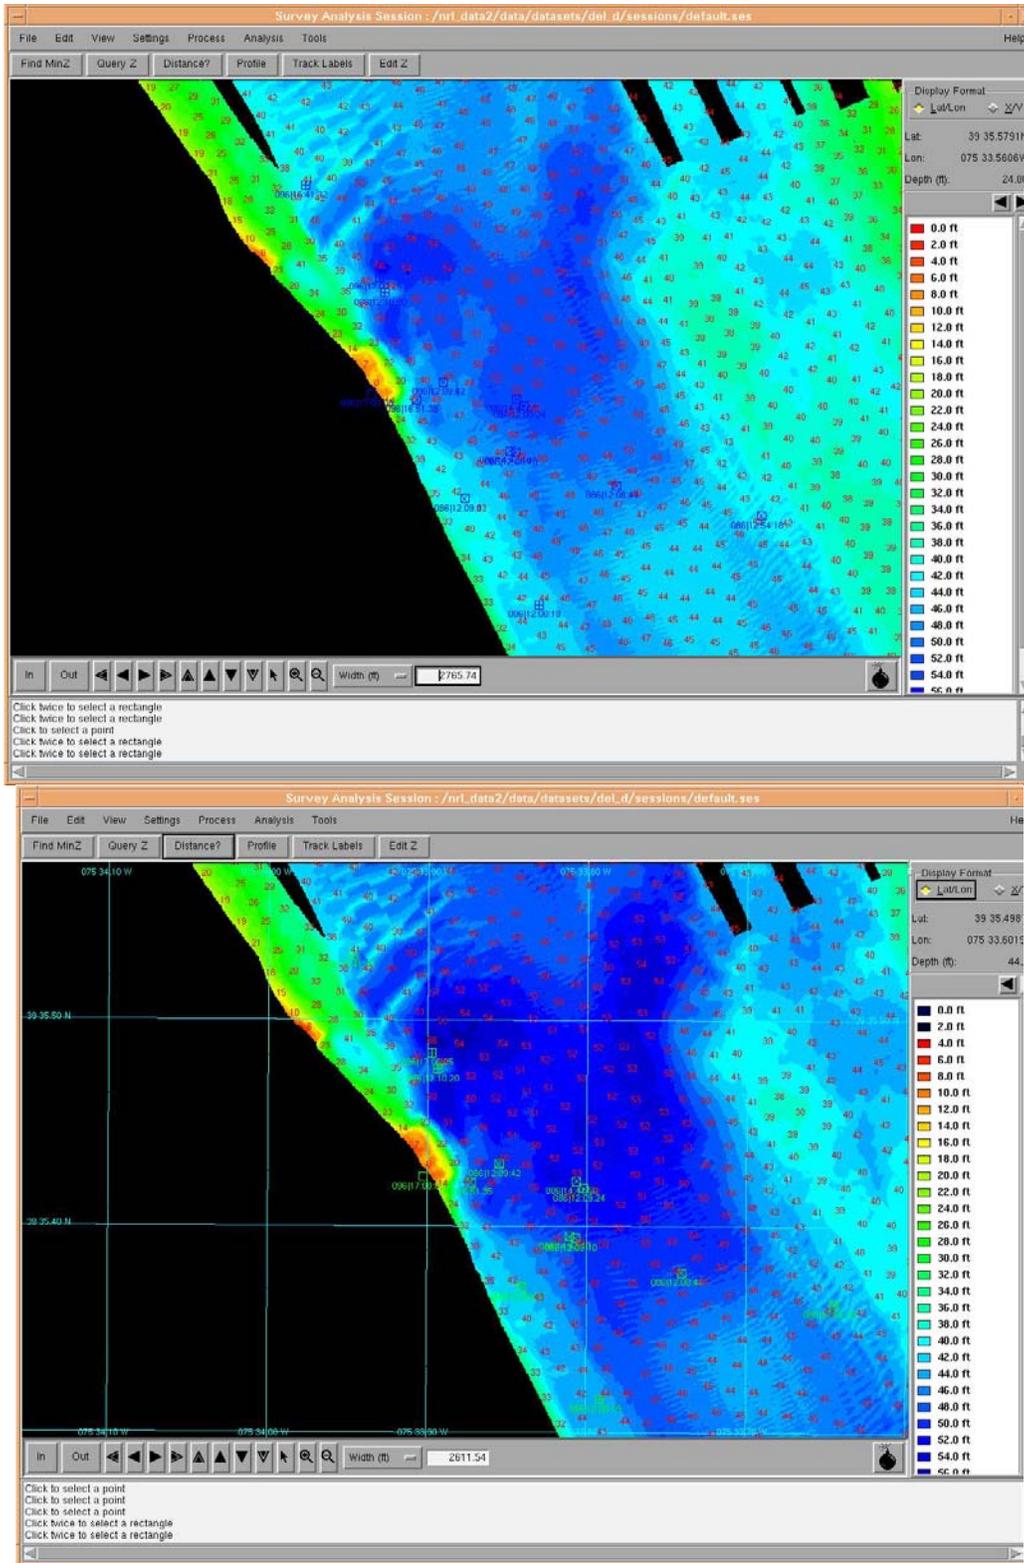
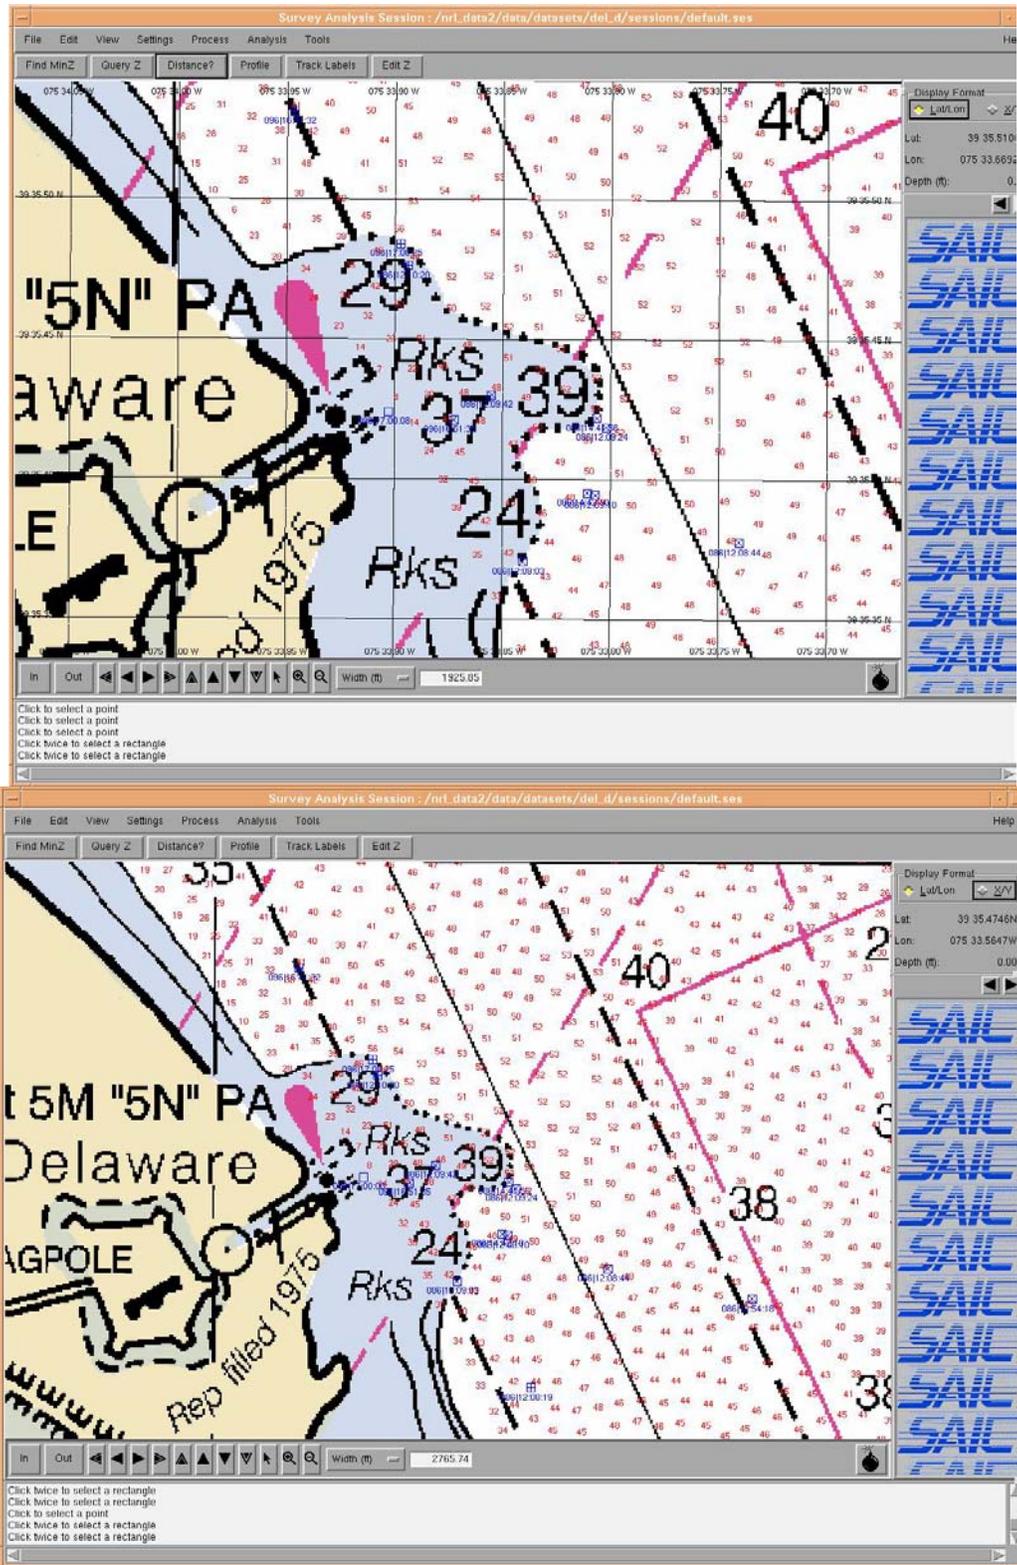
Figure Appendix V-4. Pea Patch Island Multibeam Grid with Soundings and Contacts

Figure Appendix V-5. Pea Patch Island Chart 12277 with Soundings and Contacts

Recommend removal of the 24, 29, 37, and 39 foot Rocks charted in the channel near 39 35 26.5N 075 33 52.6W. ***Concur. Not shown on the latest editions of charts 12277 and 12311.***

Recommend charting the 38 foot sounding in 39 35 32.43N 075 33 55.28W. ***Do not concur. Revision of the tabulation for New Castle Range, left outside quarter, lists a controlling depth of 38 feet.***

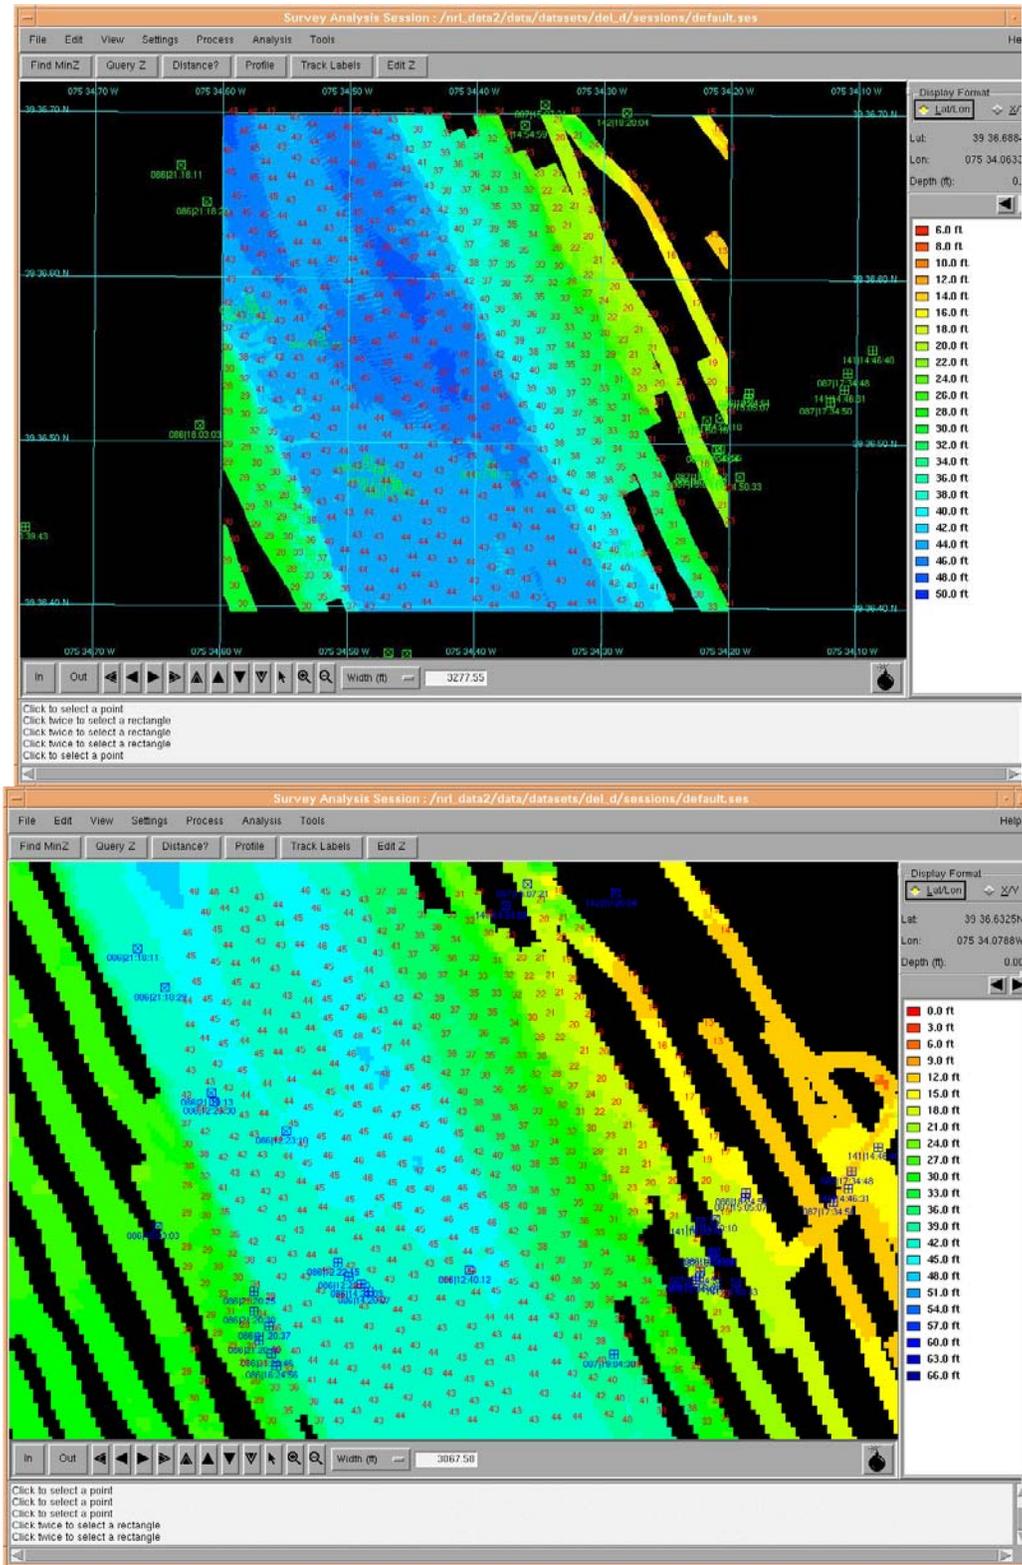
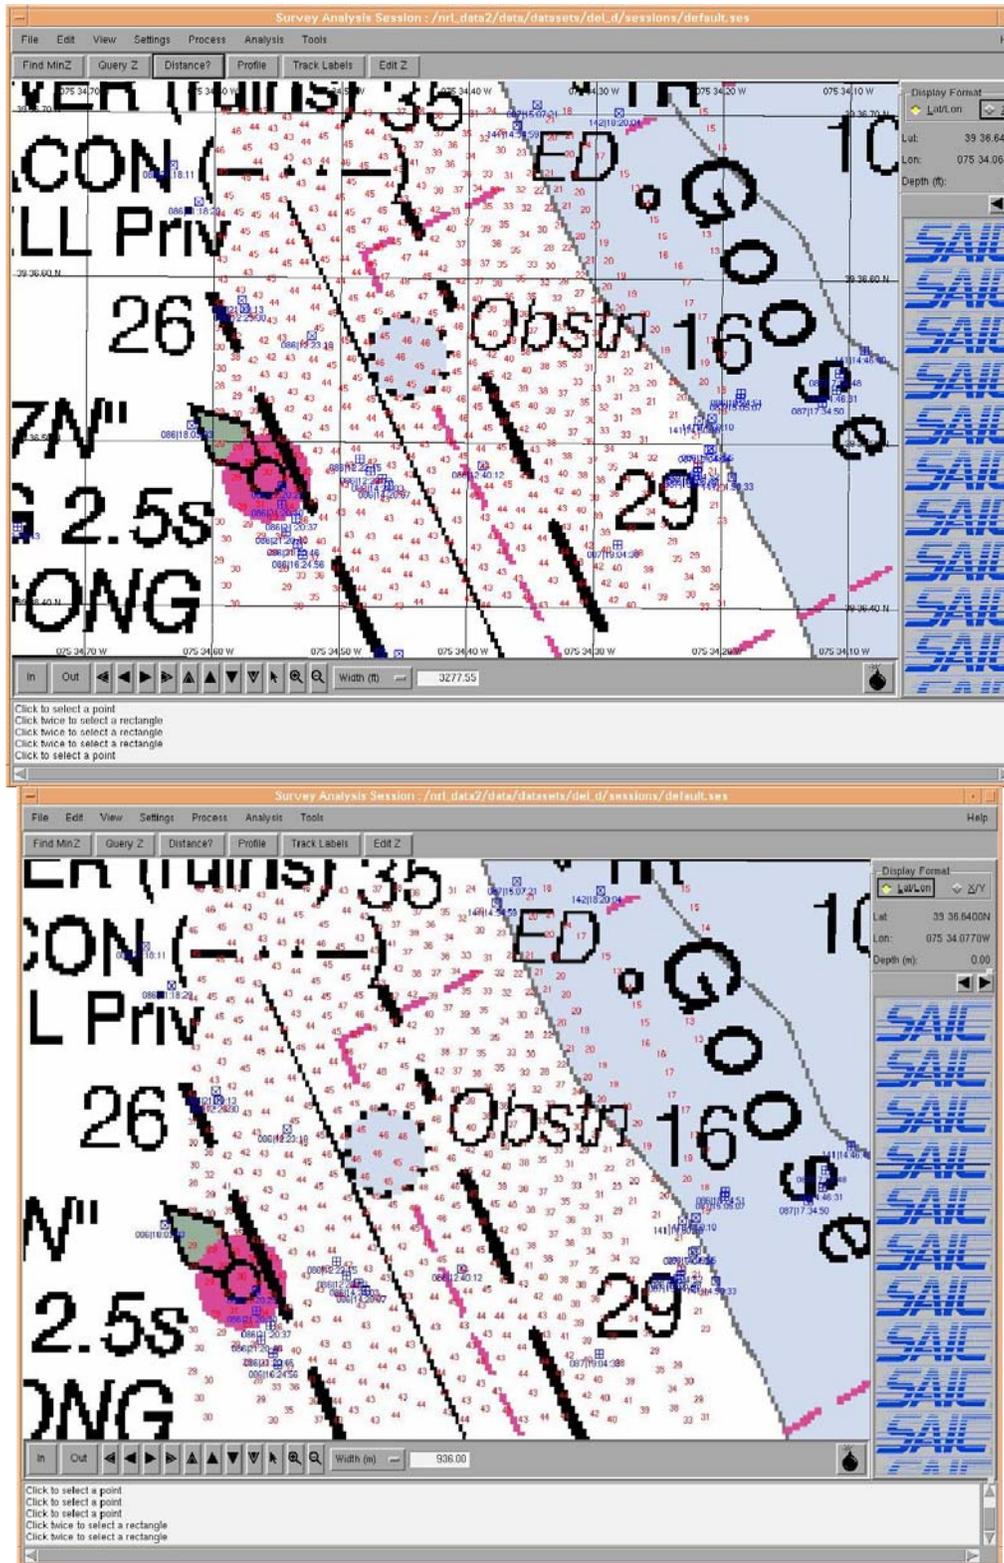
2. The dangerous Obstruction charted in the channel near 39 36 33.1N 075 34 26.9W does not exist. This area was surveyed with 200% side scan and 100% multibeam sounder coverage. Figure Appendix V-6 shows the Multibeam depth grid with an overlay of selected soundings and side scan contacts. Figure Appendix V-7 shows Chart 12311 with the same overlay of selected soundings and side scan contacts. Contact positions are indicated by a blue square. An X through the square indicates the contact was judged to be non-significant. A + in the square indicates the contact was correlated to a multibeam feature.

Figure Appendix V-6. Charted Obstructions, Multibeam Grid with Soundings and Contacts

Figure Appendix V-7. Obstruction, Chart 12311 with Soundings and Contacts

Recommend removal of the dangerous Obstruction charted in the channel near 39 36 33.1N 075 34 26.9W. *CONCUR. HAS BEEN DELETED FROM THE LATEST EDITIONS OF CHARTS 12277 AND 12311.*
