# DESCRIPTIVE REPORT

H11036

Sub-Locality: Bahia de Ponce

### HYDROGRAPHIC SURVEY H11036

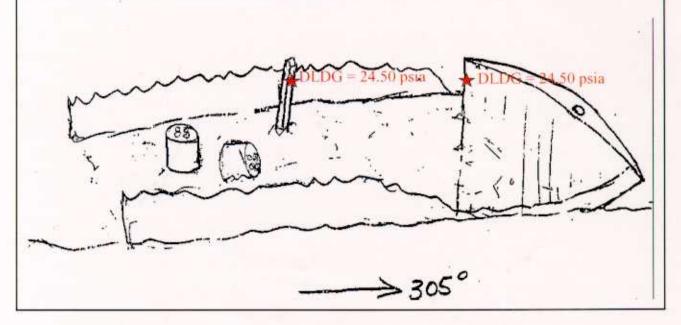
The hydrographer recommends charting a wreck with least depth of 21 ft at position 17° 56' 42:56 32" N, 066" 37' 39:4738.35" W. Concur. Chart a dangerous 21 Wk.

uncharted wreck, estimated length 150-200 feet. Riveted steel vessel w/ bow starboard side down on reef. Interior severely deteriorated. Remainder of hull is keel down with deteriorating plating extending from the bottom. One piece of transverse framing protrudes a significant distance upward. Two boilers are located in what was estimated to be the former engine room area. Least depths are the upward corner of the port bow and the top of the framing.

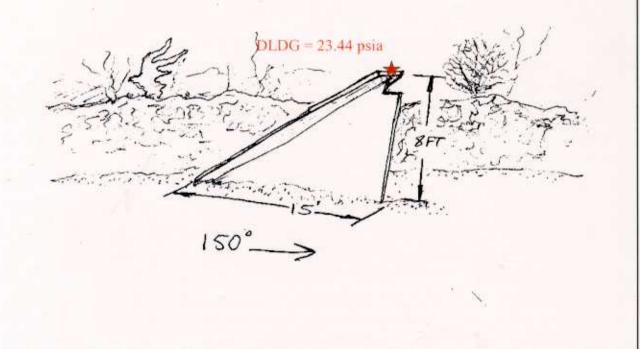
Investigation Summary: Contact 210\_1403\_0006 was identified during SSS processing. A dive performed on this contact identified an upright section of steel, possibly remnants from a ship wreck found on the opposite side of a coral reef (see previous Item Investigation for contact 113\_2138\_0001). A least depth of 5.85 2 m (19 ft), corrected with verified approved tides, was determined in position 17° 56' 30.72" N, 066" 37' 32.71" W by SWMB. A depth of 5.96 m (19 ft) was confirmed by DLDG.

Large piece of steel, possibly from uncharted wreck located on opposite side of coral reef.

The hydrographer recommends charting an obstruction (steel debris) with least depth of 19 ft at position 17° 56' 30.72" N, 066° 37' 32.71" W. Concur. Chart a dangerous 19 Obstn.
