## DESCRIPTIVE REPORT

*Registry No.* H11061

*Locality* Galveston to San Luis Pass

Instructions Dated: August, 2001 Project Number: OPR-K379-KR

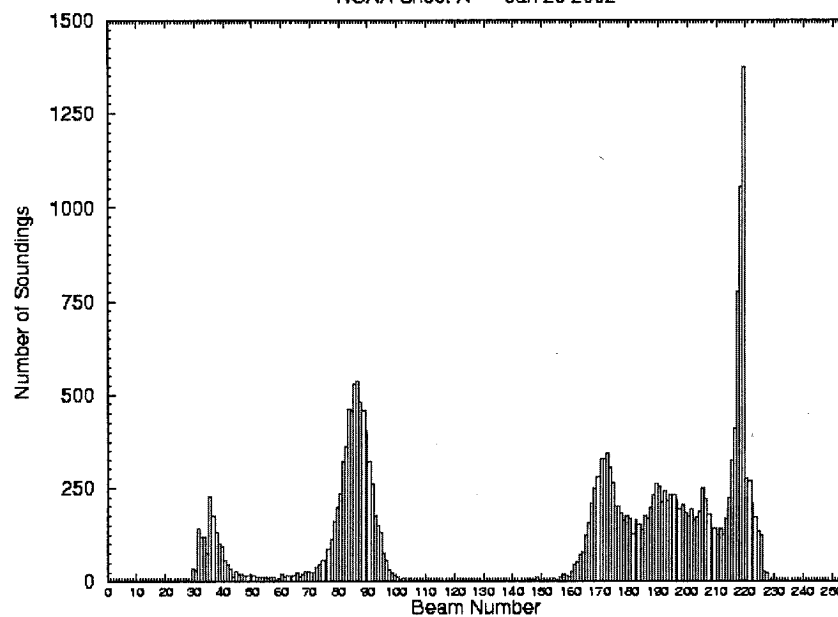
Beam Count vs Beam Number

The sounding distribution on the starboard head is more complex. An outstanding peak appears near beam 218, caused by a consistent 2 - 3 cm shoal bias in that portion of the swath in conjunction with extremely flat seafloor topography. Because only the shoalest of the shoals are selected for the smooth sheet, very minor biases in areas of swath data can lead to uneven beam distributions.

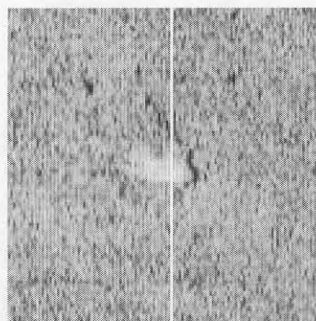
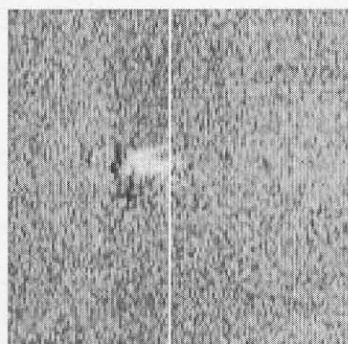
- (1) Sonar contacts 207/070210P and 207/035556S are located at 28°58'49"N, 94°36'07"W. The target lays outside of the multibeam swath coverage. Surrounding water depth are 57 feet.

It is recommended that four multibeam lines be run over the target to determine an accurate least depth. As the target size may approach the detection limits of the system, it is recommended that diver investigation be performed to determine the least depth if needed.

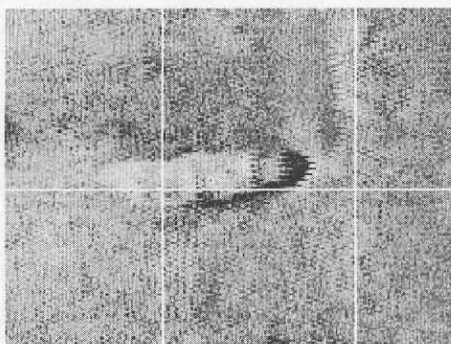
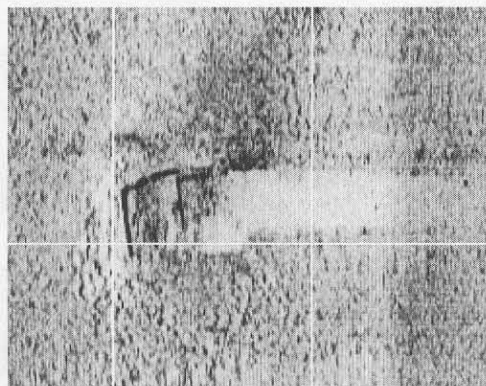
- (2) Sonar contacts 209/093338P and 209/054751S are located at 28°58'09"N, 94°39'40"W and correspond to AWOIS item 10,939 (F/V *Sea Gull*). The item has dimensions of 22 m by 10 m with 2 to 6 meters of relief as calculated from the shadow on the side scan sonar record. The surrounding water depths are 54 feet. The item lies outside of the multibeam swath coverage and an accurate least depth could not be determined.

It is recommended that a set of four lines be run over the target with the multibeam in order to attain a least depth.

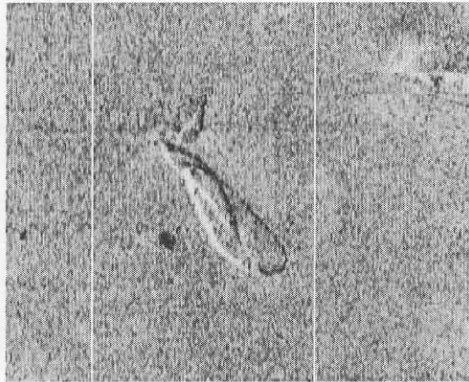
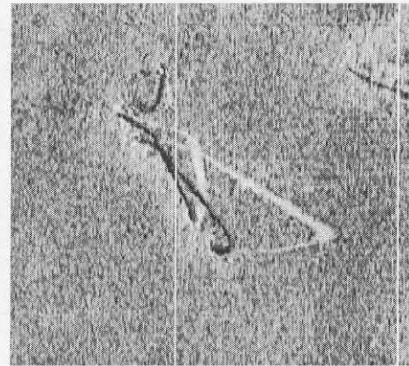
- (3) Sonar contacts 212/204629P and 212/185136S are located at  $28^{\circ}51'53''\text{N}$ ,  $94^{\circ}42'27''\text{W}$ . The item appears to be a floating rope that is attached to an anchor of some sort. The surrounding water depths are 67 feet. The rope is about 40 meters long and is folded in half. If extended vertically by the water column the top of the rope would be close to the water surface.

It is recommended that item be recovered as it is in an area of high vessel traffic due to its proximity to oil/gas platforms. This would likely be best done by diver operations.

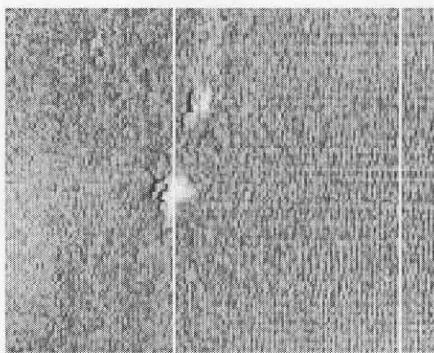
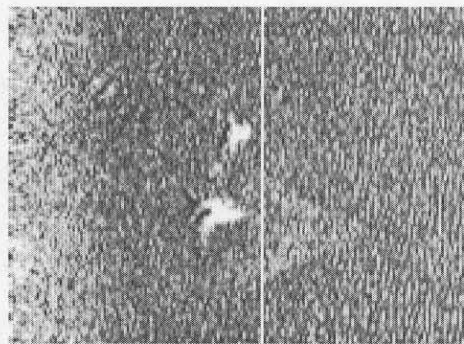
- (4) Sonar contacts 215/183627S and 225/174301S are located at  $28^{\circ}55'27.27''\text{N}$ ,  $94^{\circ}45'56.69''\text{W}$  and correspond to the location of AWOIS item 2653. There are two targets at the location. The targets lay outside of the multibeam swath coverage. Surrounding water depth are 57 feet. The target lies fairly close to the safety fairway.

It is recommended that four multibeam lines be run over the target to determine an accurate least depth. As the target size may approach the detection limits of the system, it is recommended that diver investigation be performed to determine the least depth if needed.

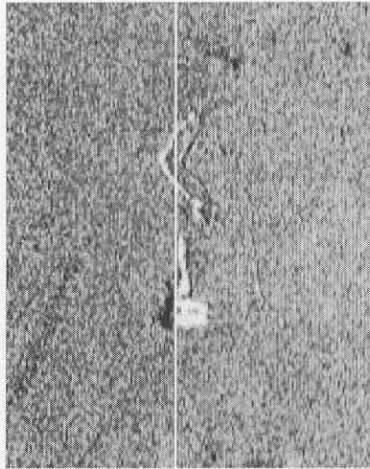
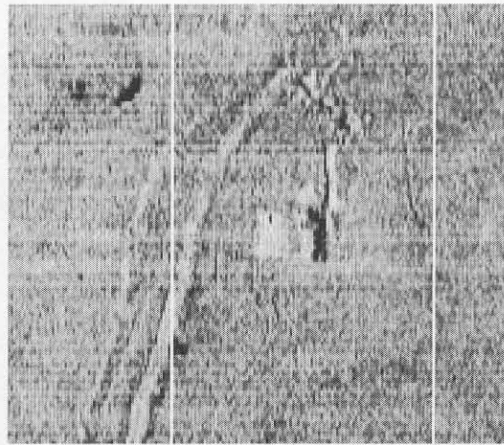
- (5) Sonar contacts 221/011158S and 221/035718P are located at  $28^{\circ}51'25''\text{N}$ ,  $94^{\circ}55'32''\text{W}$ . The target lies within the safety fairway and surrounding depths are 61 feet. The target is at the end of a large drag scar and may be an anchor block. There may be some rope or chain extending from the target. A relief of 1.7 meters was calculated from the shadow on the side scan sonar record. The item lies outside of the multibeam swath coverage.

It is recommended that four multibeam lines be run over the target in order to determine an accurate least depth.

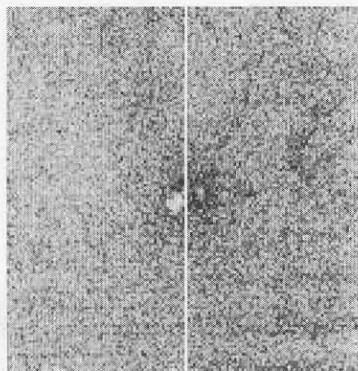
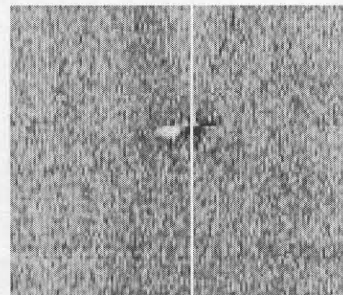
- (6) Sonar contacts 223/004948P and 232/225658P are located at  $28^{\circ}59'10''\text{N}$ ,  $94^{\circ}45'41.28''\text{W}$ . The target is a circular object that expresses up to 2 meters of relief as calculated from the side scan sonar shadow length. The object did not fall within the multibeam swath coverage. Surrounding depths are 59 feet.

It is recommended that four multibeam lines be run over the target to determine an accurate least depth. As the target size may approach the detection limits of the system, it is recommended that diver investigation be performed to determine the least depth if needed.

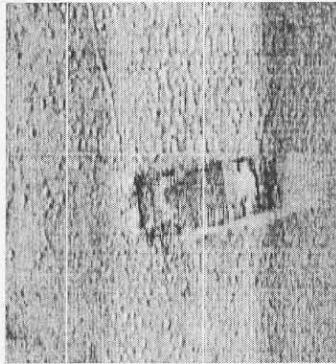
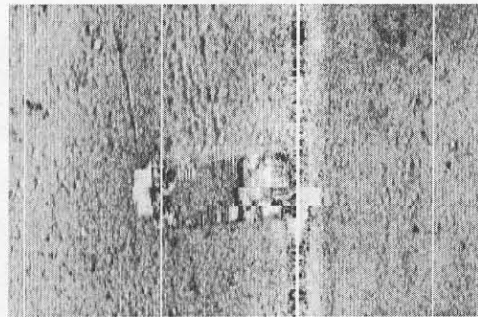
- (7) Sonar contact numbers 233/071128P and 233/063149S are located at  $29^{\circ}02'36''\text{N}$ ,  $94^{\circ}41'50''\text{W}$ . The item appears to be a sunken barge with dimensions of 27 m by 18 m with at least 3 meters of relief as calculated from the shadow on the side scan sonar record. The surrounding water depth is 60 to 61 feet. The multibeam swath does not cover the entire object therefore an accurate least depth could not be determined.

It is recommended that a set of four lines be run over the target with the multibeam in order to attain a least depth.

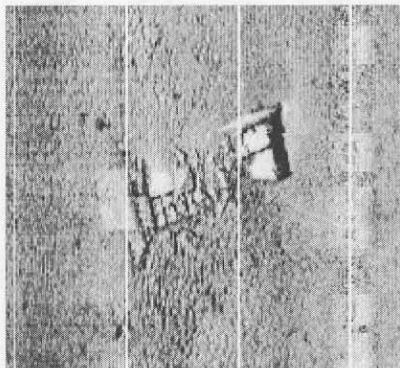
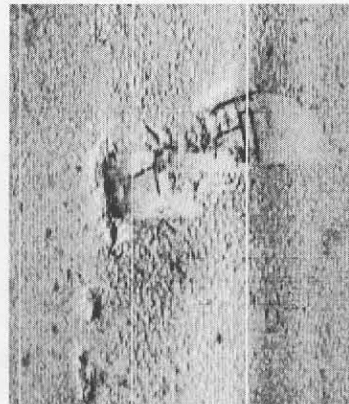
- (8) Sonar contacts 233/064352P and 233/072322S are located at  $29^{\circ}02'32''\text{N}$ ,  $94^{\circ}41'30''\text{W}$ . The item is a rectangular object with linear features along both axes. The item has dimensions of 37 m by 16 m with at least 3 meters of relief as calculated from the shadow on the side scan sonar record. The surrounding water depth is 60 feet. The multibeam swath does not cover the entire object therefore an accurate least depth could not be determined.

It is recommended that a set of four lines be run over the target with the multibeam in order to attain a least depth.

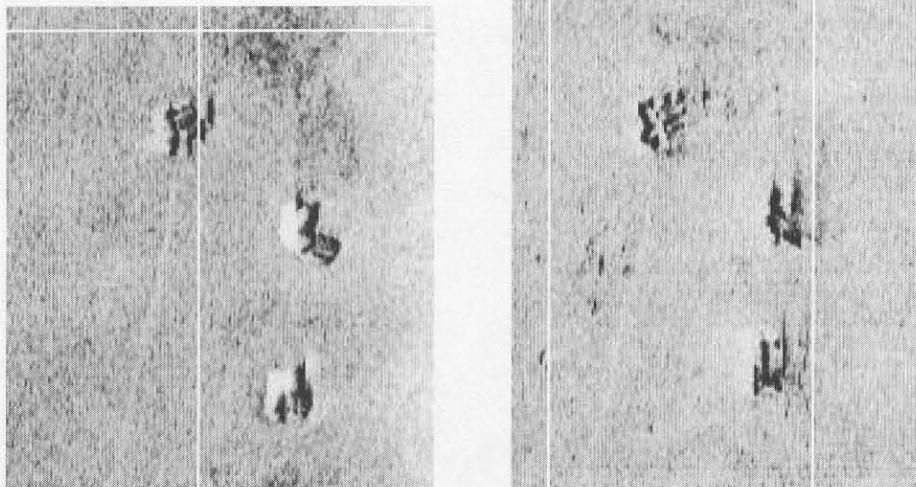
- (9) Sonar contacts 296/195648P, 296/195651P, 296/195654P, 296/213409S, 296/213413S, and 296/213415S, located at 29°08'24"N, 94°42'19"W, represent a cluster of three targets. The items are roughly 5 meters by 5 meters in dimension each. As calculated from the side scan sonar shadow lengths, heights of the targets range from 1.6 meters to 2.7 meters. The items did not lie within the multibeam swath coverage and therefore accurate least depths could not be determined. Surrounding water depths are 57 feet.

It is recommended that a set of four to six lines be run with the multibeam sonar to determine least depths over the targets.

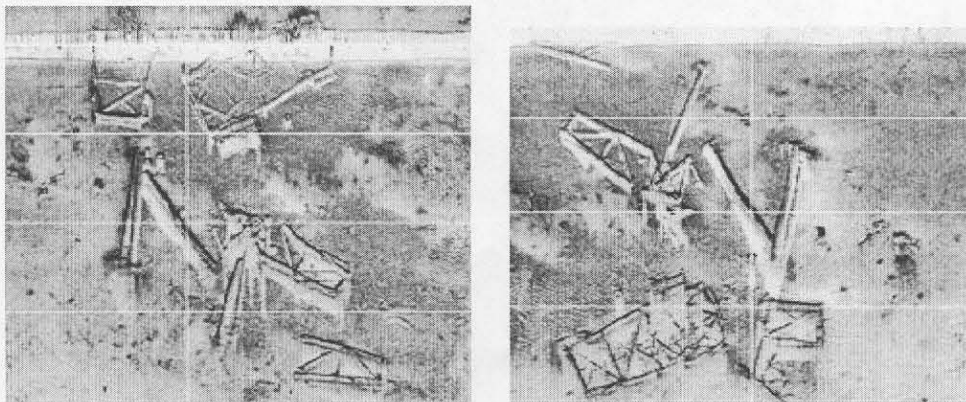
- (10) AWOIS item 10974, a fish haven, was imaged on several side scan sonar and multibeam lines. However, since 100% multibeam coverage was not achieved it is impossible to say whether an accurate least depth was attained.

It is recommended that 100% multibeam coverage is collected for a 200-meter square block centered on the target. It is proposed that side scan sonar data also be collected for extra data.

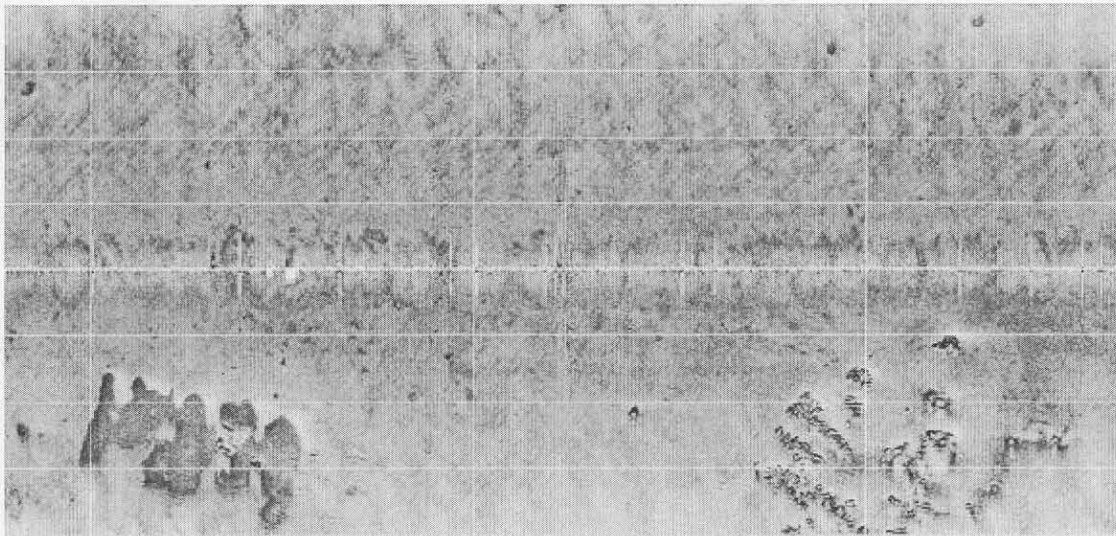
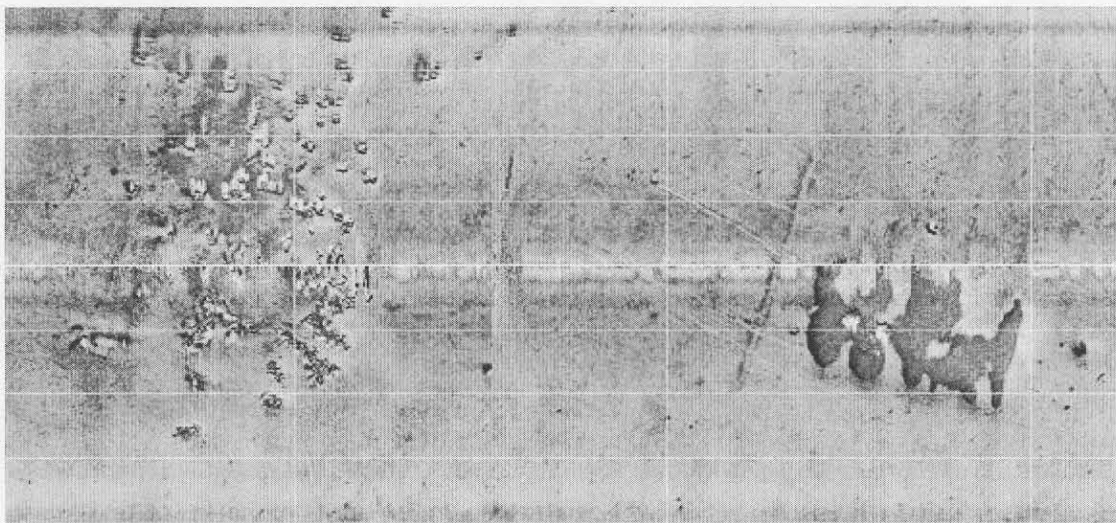
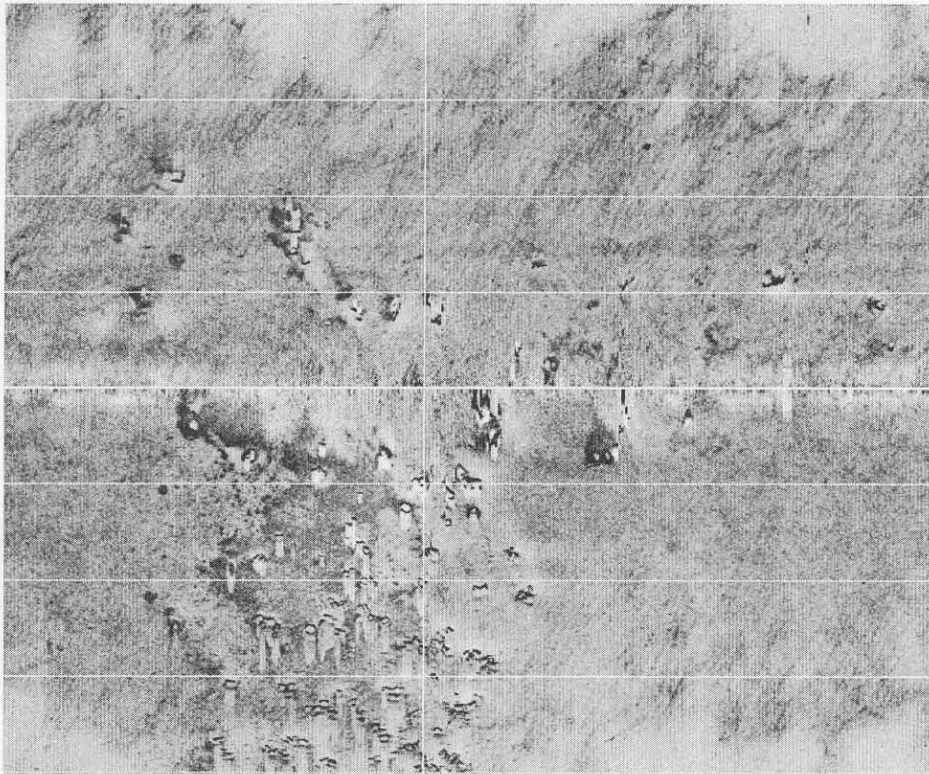
- (11) AWOIS item 10940 is charted as a fish haven. The AWOIS listing states that this item is not longer visible and should be considered for removal from the chart. During the survey this was found not to be the case. There is a cluttered area of very highly concentrated pinnacles of some sort. There is also a zone of three to four fairly hard contacts in an area of different sediment type.

It is recommended that a four line multibeam survey, possible followed by a dive investigation be performed on the items which lay in the area of different sediment type and that a 100% multibeam survey of a 300 meter square block surrounding the pinnacle-like area be performed to determine depths in the area.

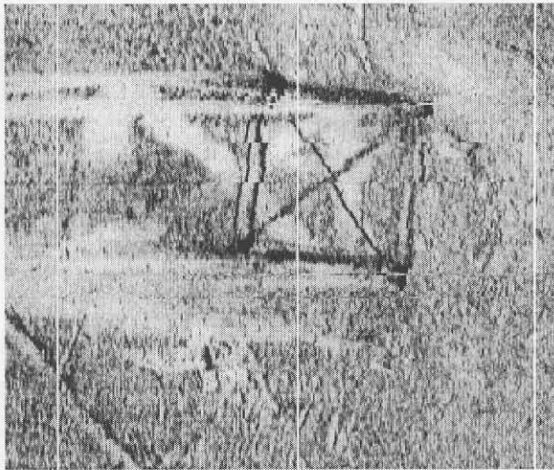
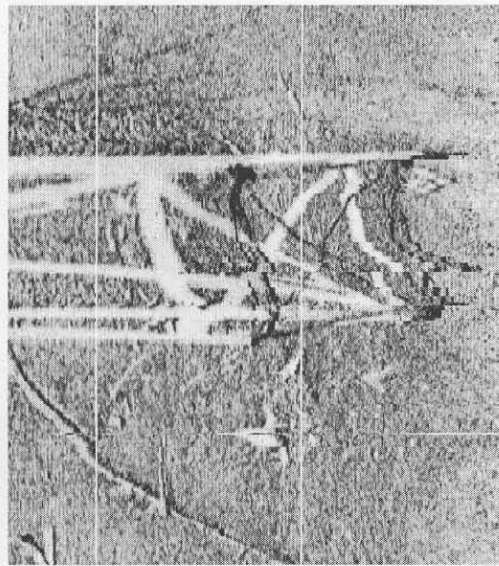
- (14) Sonar contacts 211/235211P and 212/014053P, located at  $28^{\circ}52'01''N$ ,  $94^{\circ}41'50''W$ , represent a piece of debris which exhibits approximately 3 meters of relief. The target is located 20 to 25 meters away from a oil/gas platform and the debris is likely associated with those operations. The surrounding water depths are 68 feet. *ITEM 53, pg 27*

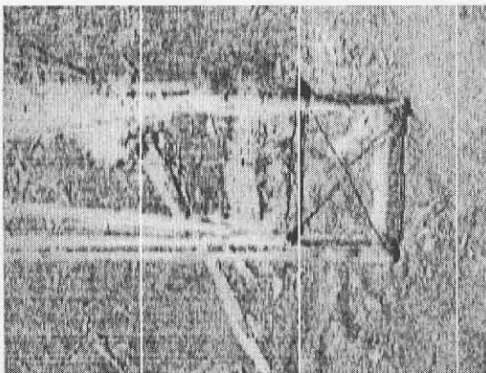
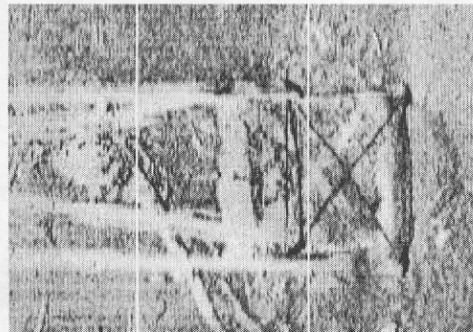
- (15) Sonar contacts 214/162757P and 214/180651P(a), located at  $28^{\circ}53'27''N$ ,  $94^{\circ}41'39''W$ , represent a hard contact approximately 45 meters away from an oil/gas platform. The surrounding water depths are 69 feet. *ITEM 52, pg 27*
