H11621

NOAA FORM 76-35A	
U.S. DEPARTMENT OF COMMERCE NATIONAL OCEANIC AND ATMOSPHERIC ADMINISTRATION NATIONAL OCEAN SURVEY	
DESCRIPTIVE REPORT	
Type of Survey	Hydrographic
Registry No.	H11621
LOCALITY	
State	Alabama
General Locality	Mississippi Sound
Sub-locality	Grand Bay to Petit Bois Pass
2006	
CHIEF OF PARTY Dean Moyles FUGRO PELAGOS, Inc	
DATE	LIBRARY & ARCHIVES

**Title Sheet (NOAA Form 77-28)**

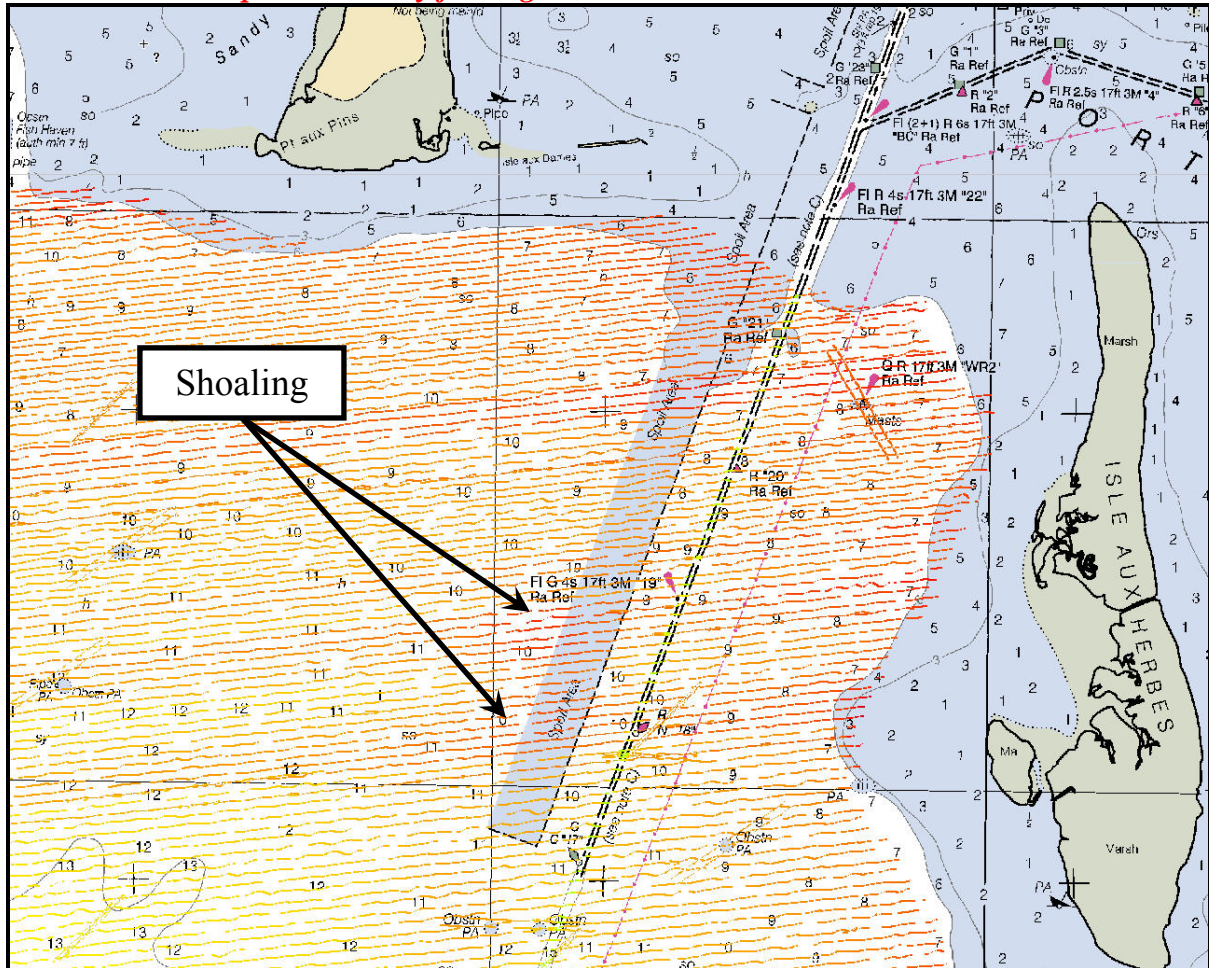
Figure 3 H11621 Chart Comparison 1

- Hydrographic survey H11621 revealed a depth of 5 feet in the vicinity of a 10 foot sounding on chart 11374 located at 30° 20' 14.98" N, 088° 17' 56.75" W. This area was surveyed with single beam sonar. The shoaling is centered in the area depicted

below. **Do not concur. Ten foot present survey depths found in vicinity. Update chart with present survey findings.**

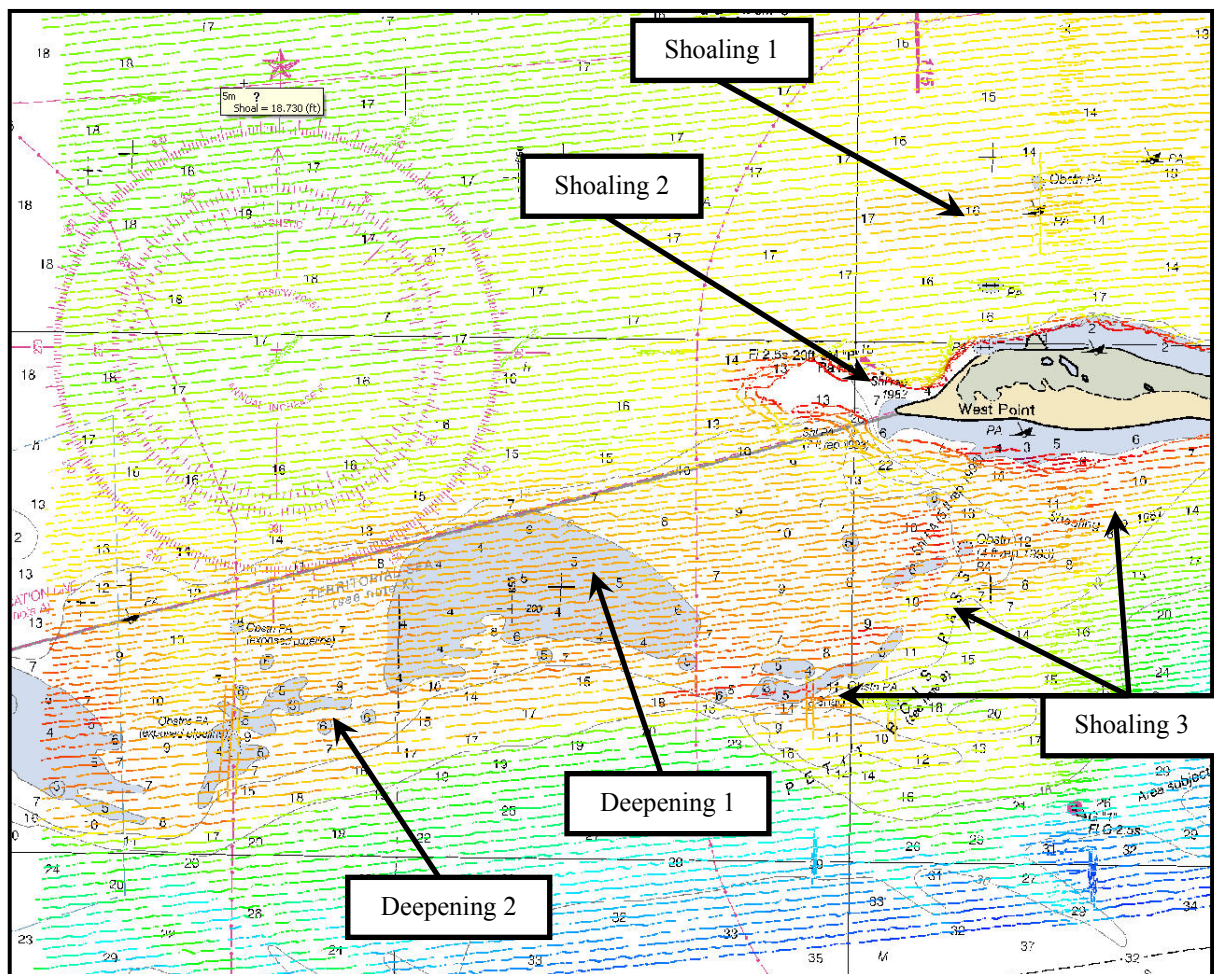
Figure 4 H11621 Chart Comparison 2

- Hydrographic survey H11621 revealed a depth of 12 feet in the vicinity of a 17 foot sounding on chart 11374 located at 30° 14'26.20" N, 088° 19'45.16" W. This area was surveyed with single beam sonar. The shoaling is centered in the area depicted below as Shoaling 1. **Do not concur. Data was rejected. Retain area as charted.**

- Hydrographic survey H11621 revealed a depth of 4-3 feet in the vicinity of a 10 foot sounding on chart 11374 located at 30° 12'56.61" N, 088° 19'53.12" W. This area was surveyed with single beam sonar. The shoaling is centered in the area depicted below as Shoaling 3. **Concur. Update area with present survey data.**

- Hydrographic survey H11621 revealed a depth of 10 feet in the vicinity of a 4 foot sounding on chart 11374 located at 30° 13'03.61" N, 088° 21'27.35" W . This area was surveyed with single beam sonar. The deepening is centered in the area depicted below as Deepening 1. **Concur. Update area with present survey data.**
- Hydrographic survey H11621 revealed a depth of 10 feet in the vicinity of a 3 foot sounding on chart 11374 located at 30° 12'31.88" N, 088° 22'38.26" W . This area was surveyed with single beam sonar. The deepening is centered in the area depicted below as Deepening 2. **Concur. Update area with present survey data.**

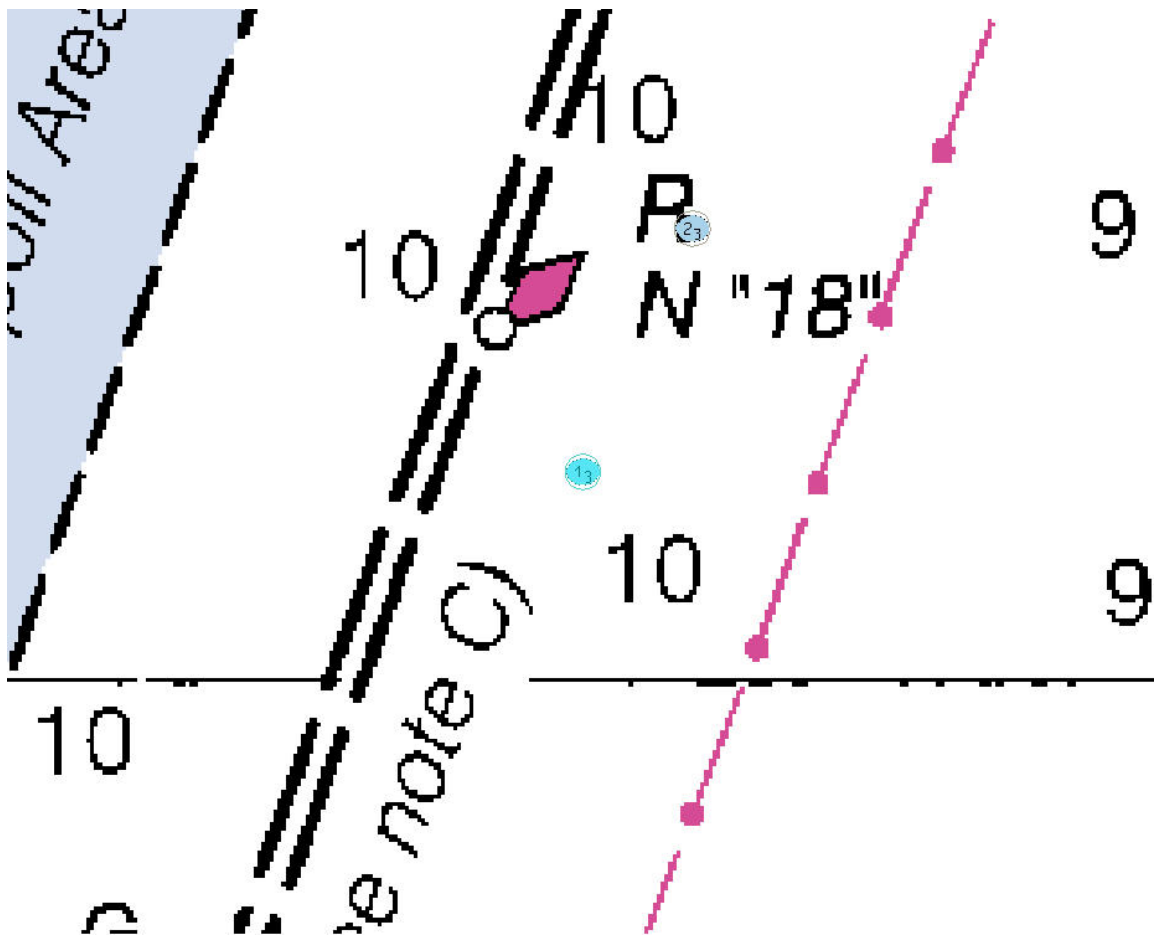
Feature 45-3 located at 30.33523750 N (***30° 20' 06.86"N***) 88.28939427 W (***88° 17' 21.82"N***) was submitted as a DToN to MCD.

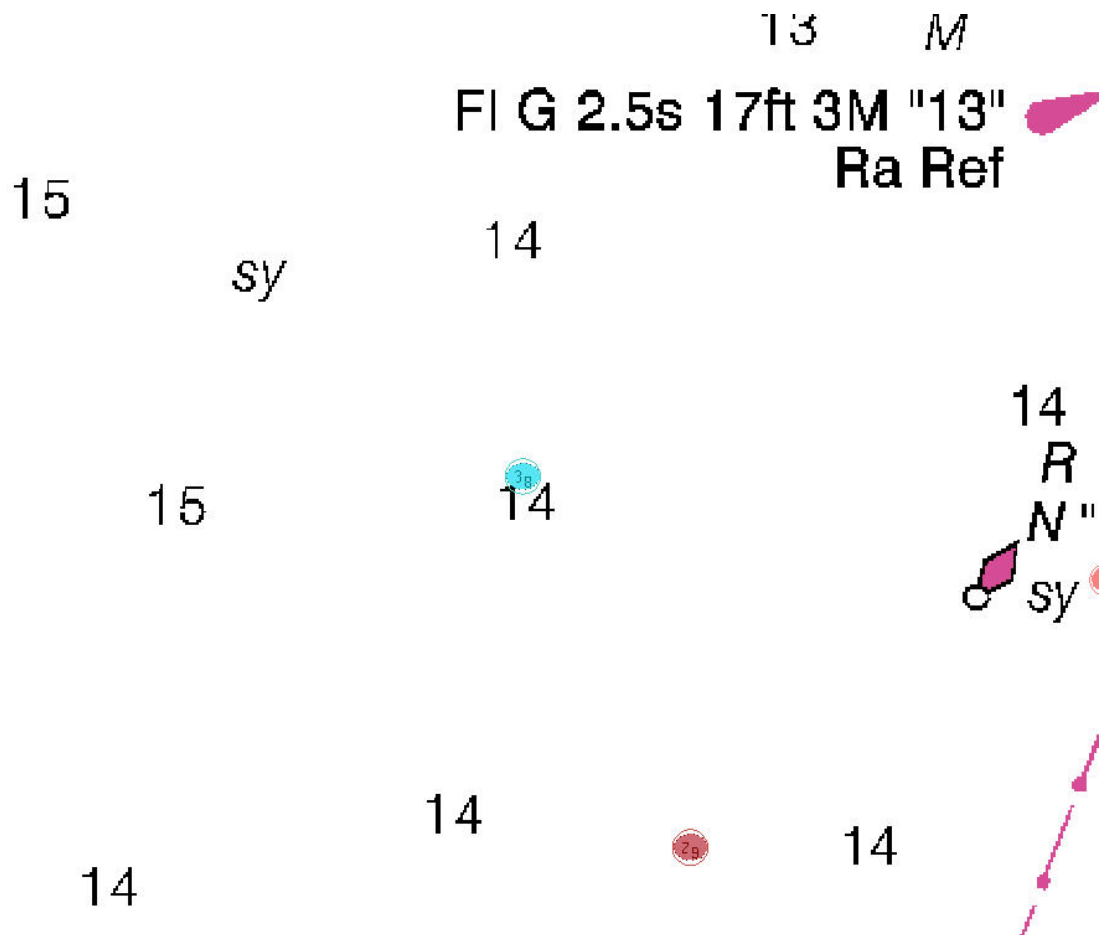
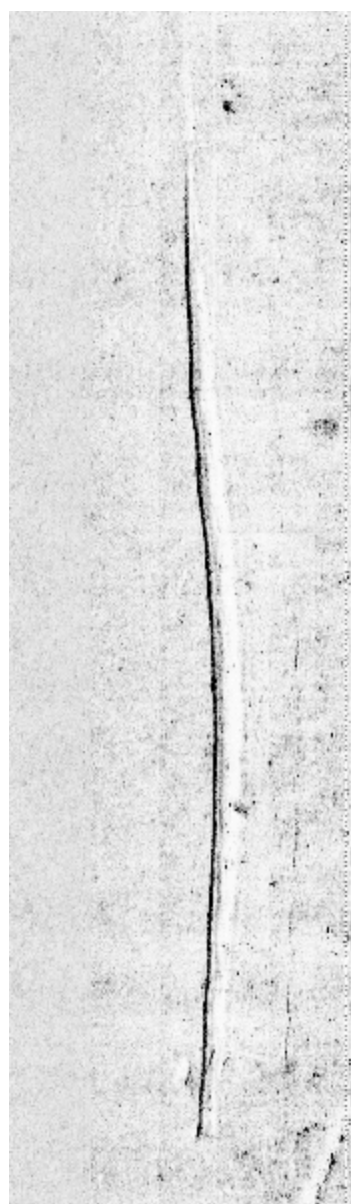
Feature 39-2 located at 30.29198513 N(**30° 17' 31.15"N**) 88.31775217 W (**88° 19' 03.91"N**) was not submitted as a DToN. It appears to be an exposed pipe and the owner should be notified.

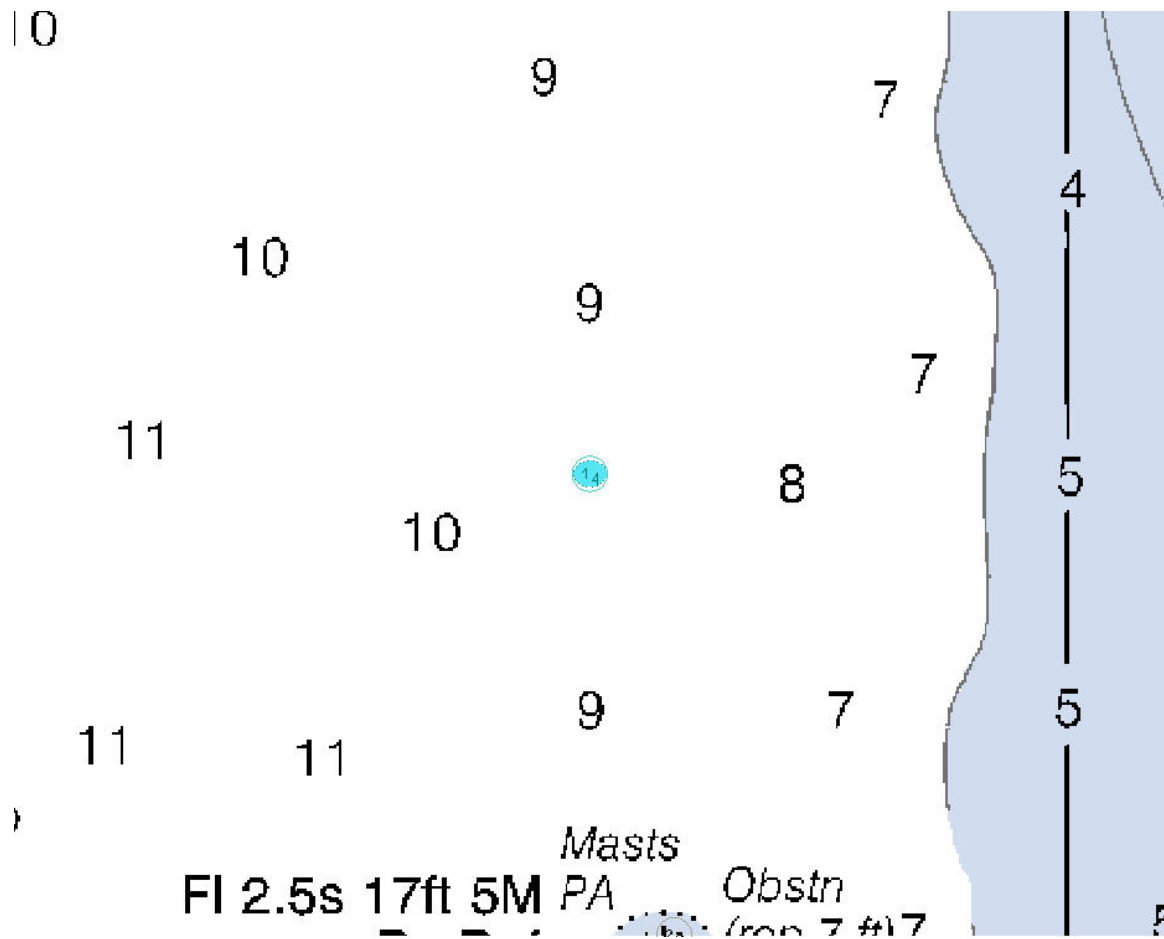
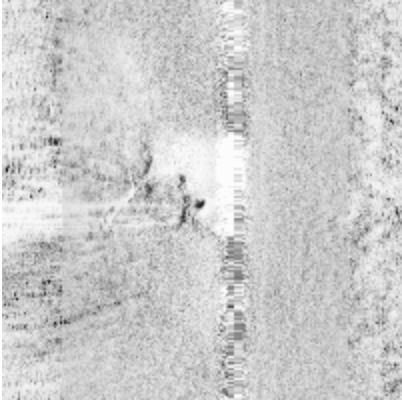
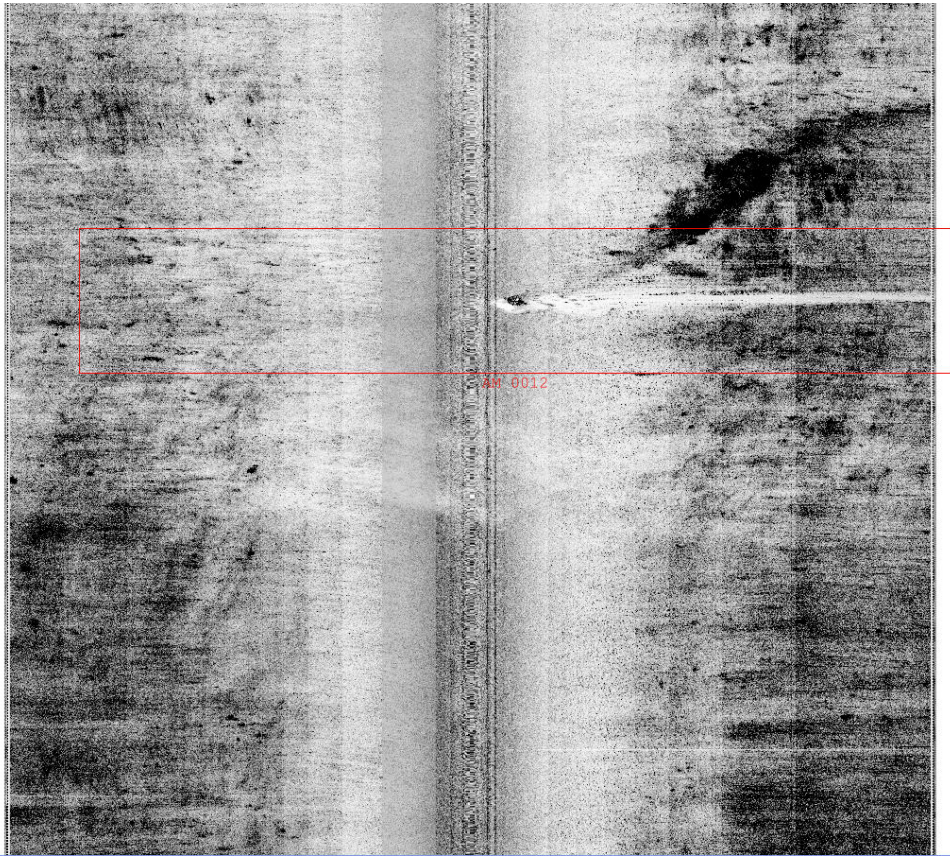
Figure 41-3 located at 30.31306333 N **30° 18' 47.03"N** 88.27528920W **88° 16' 31.04"N** appears to be a gas leak in the SSS. It is difficult to believe that the images are a real feature, rather are the result of the sonar being deflected by a gas plume in the water.

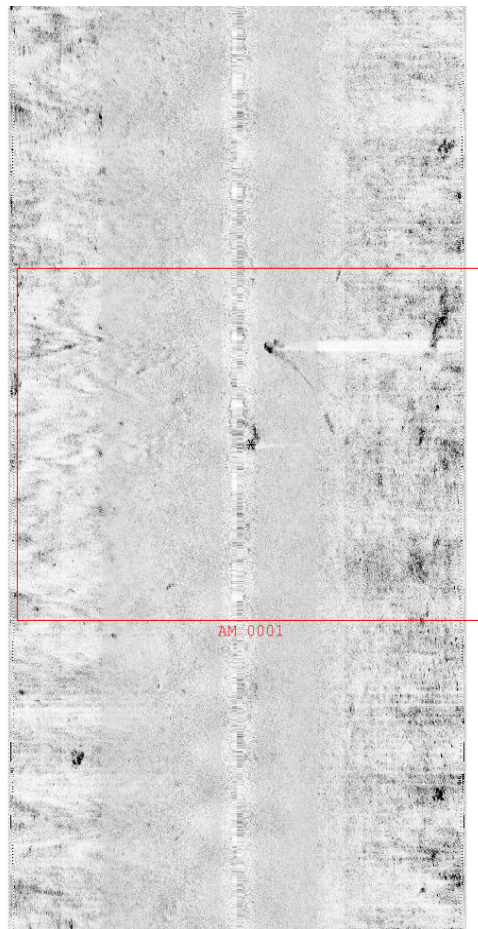
Figure 42-3 located at 30.31355977 N, **30° 18' 48.82"N**, 88.30676600 W **88° 18' 24.36"N** also appears to be a gas leak and not an actual feature.

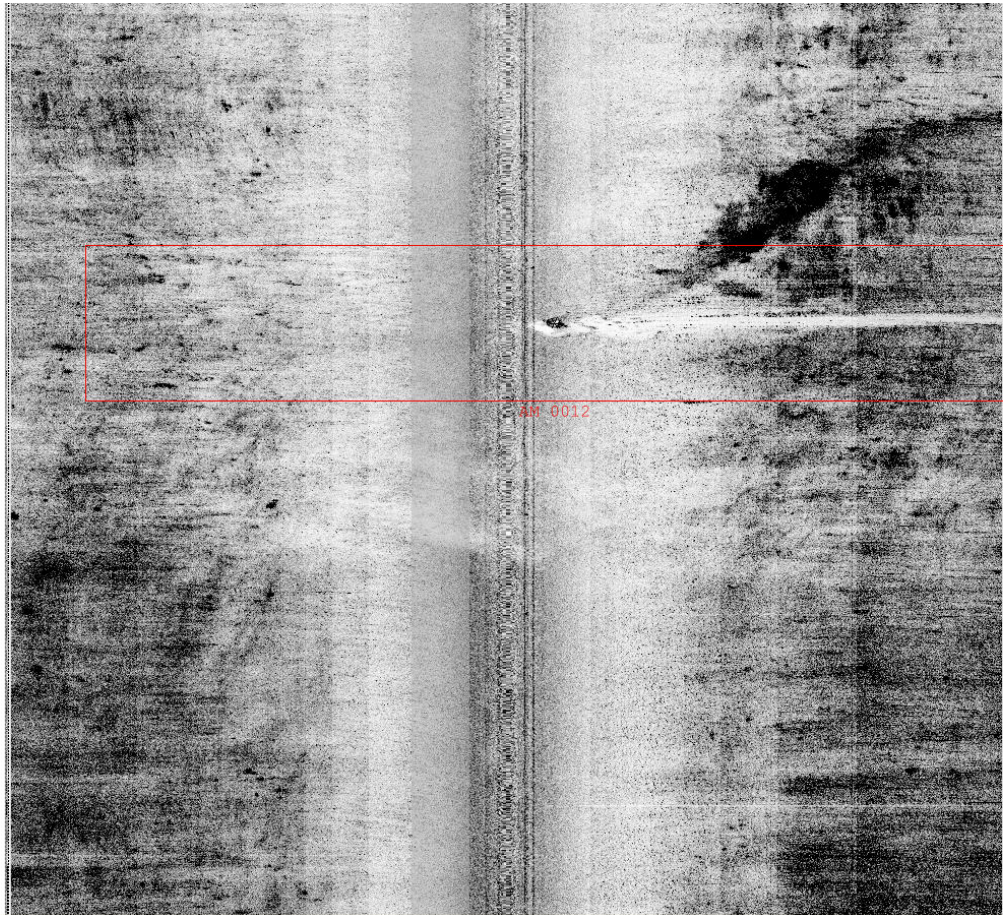
- Feature 41-3 looks like a gas leak, not a 1.23m obstruction. Should it be charted as an obstruction least depth unknown and take off the depth altogether? Should it be removed from the feature file? 30-18-47.03N 088-16-31.04W

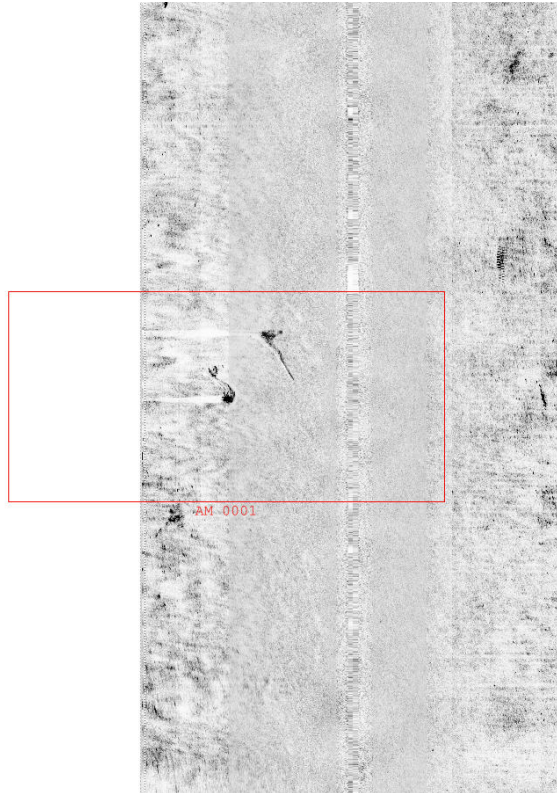
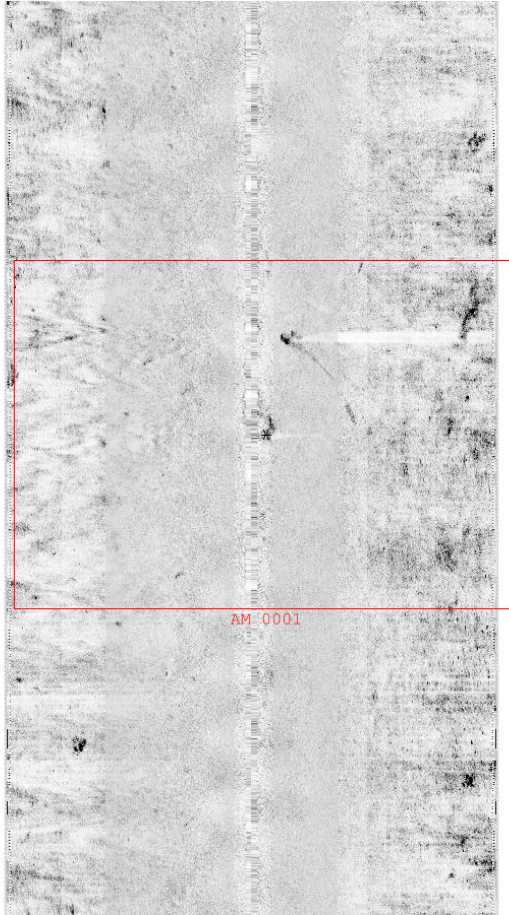
- Feature 42-3 again looks like a gas leak not a DToN contact. They have the positioning from 4 sss contacts and ran a single beam line over the contact. There is nothing in the single beam but a small hole, possibly where the seabed is being scoured under the pipe. Unsure if should be charted as a feature or submitted as DToN.
