DESCRIPTIVE REPORT

REPORT
to accompany
RECONNAISSANCE SHEET
Chart 8802
BRISTOL BAY - ALASKA
1947

USC&GS Ship PATHFINDER

PROJECT GS-327

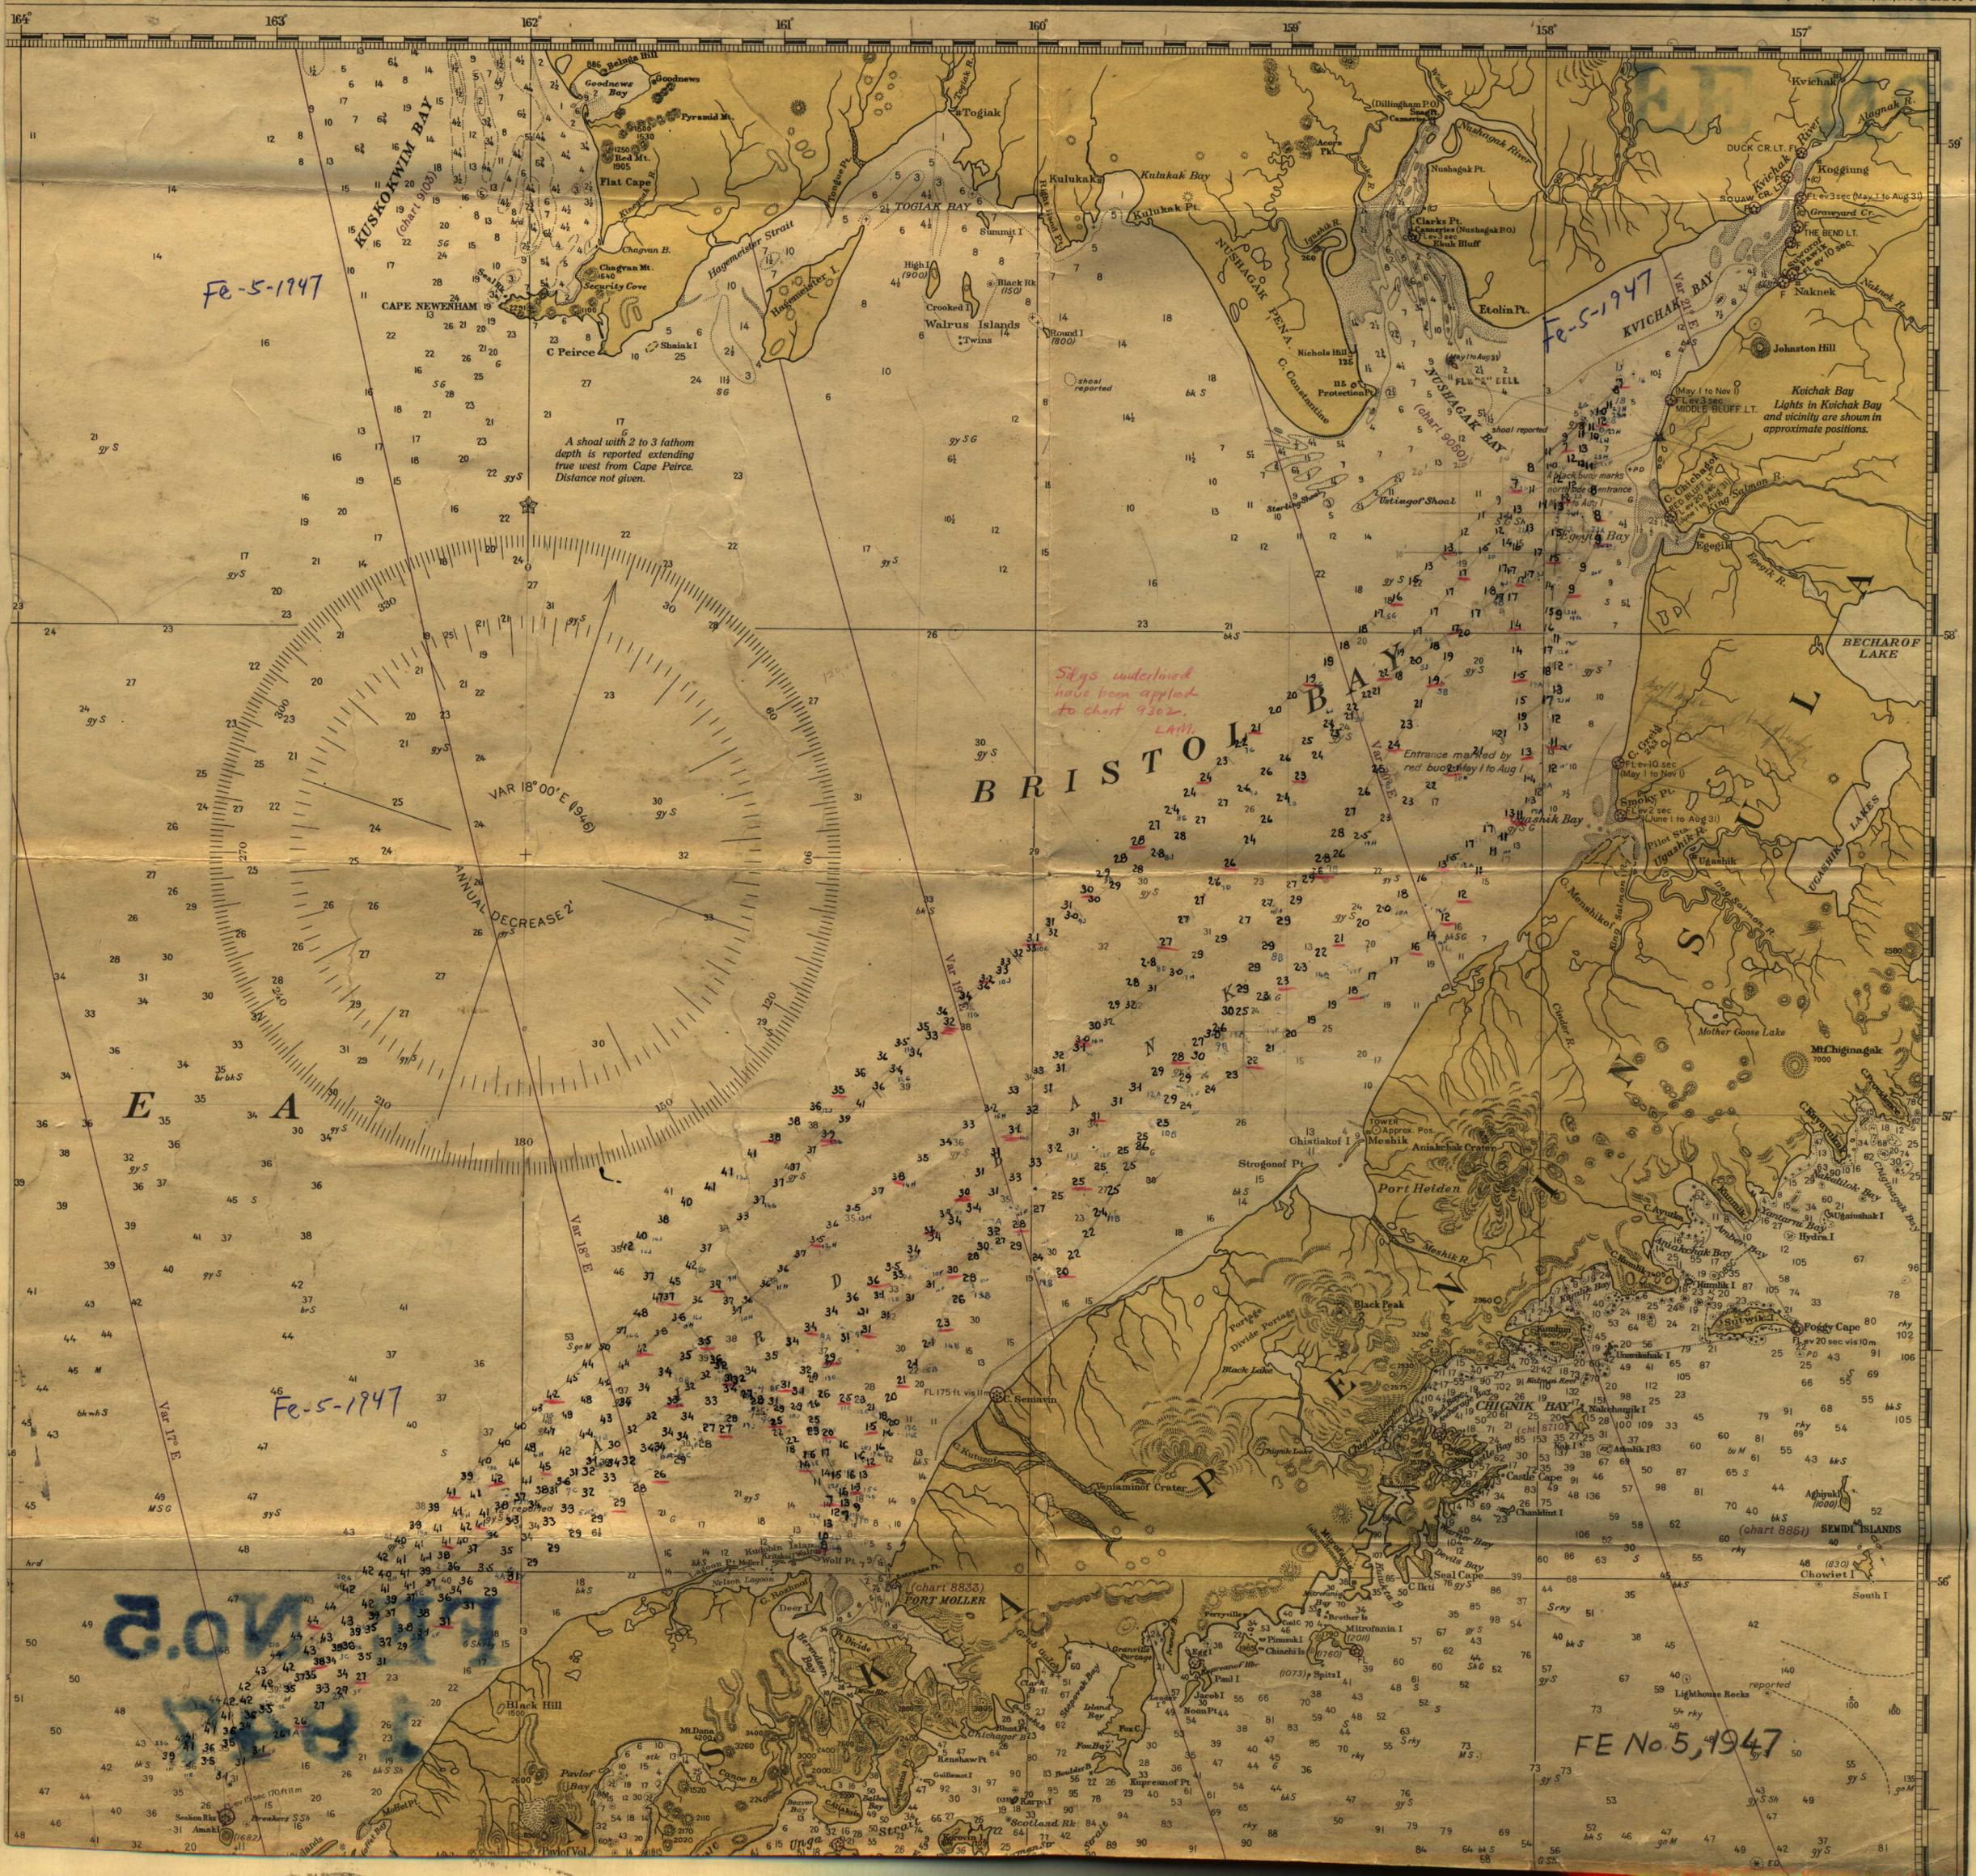
FE No. 5, 1947

A shoal with 2 to 3 fathom depth is reported extending true west from Cape Peirce. Distance not given.

Kutchak Bay Lights in Kutchak Bay and vicinity are shown in approximate positions.
