## DESCRIPTIVE REPORT (HYDROGRAPHIC)

Type of Survey ... Field Examination.....  
Field No. .... PF-10-1-61.....  
Office No..... FE-182 (1961).....

State ..... Alaska.....  
General Locality ... Alaska South Coast.....  
Locality ..... Resurrection Bay, Seward.....

F.E.#1,1962  
HYDROGRAPHIC SURVEY # (PF-10-1-61)

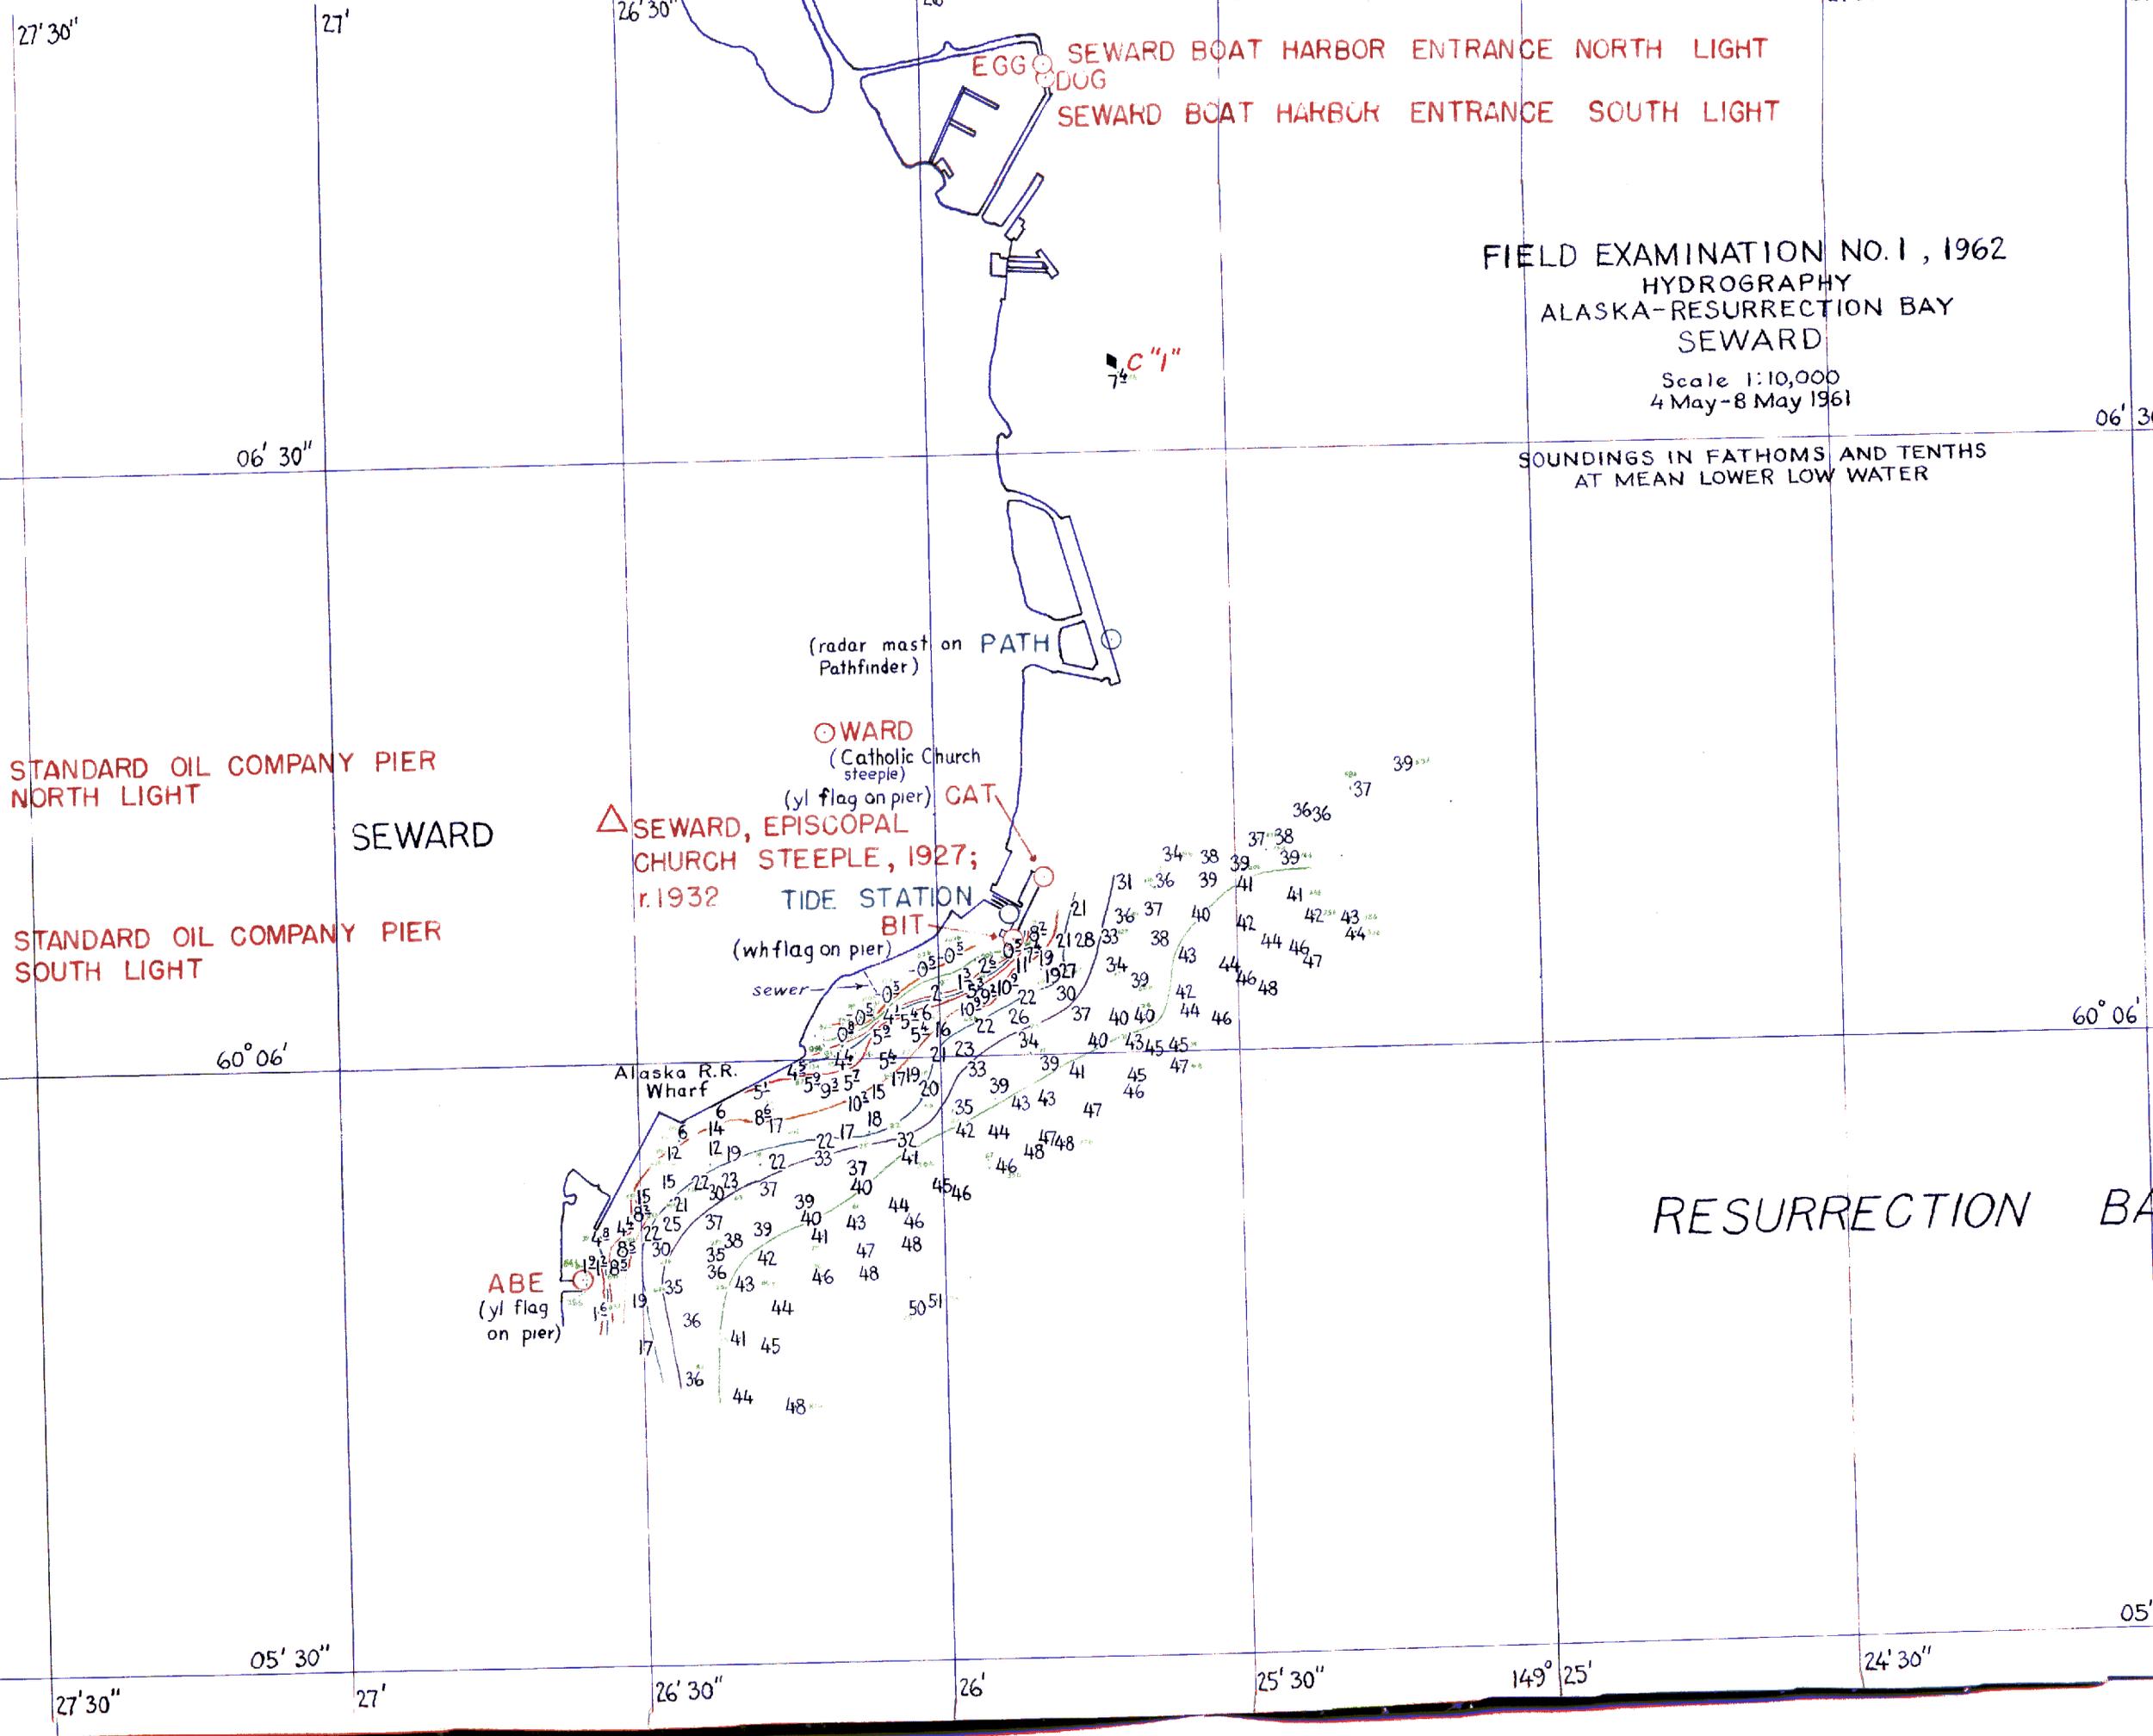
FIELD EXAMINATION NO. 1, 1962  
HYDROGRAPHY  
ALASKA-RESURRECTION BAY  
SEWARD  
Scale 1:10,000  
4 May-8 May 1961

The soundings from the "1961 Investigation" indicates shoaling along the face of the Alaska Railroad Wharf and northeast of the wharf where the sewer empties into the bay.

The survey was compared with the inset (1:10,000) of Chart 8529 (1:81,847) 25 April 1949, revised 19 January 1959. Shoaling was found along the east approach to the Alaska Railroad Wharf at latitude 60°06'02"N and longitude 149°26'05"W. A sounding of 2.3 fathoms was found very close to a charted 6 3/4 fathoms.

There was found to be silting in the area where the sewer empties into the Bay. It appears that this is a continuation of the shoaling found in the area by previous surveys.

The field examination did not locate a shoal depth of 3 1/2-fms. in the reported position, but does show that considerable shoaling had taken place since the after-dredging survey. General shoal depths of 3-4 fathoms are shown to the seaward of the extended wharf face, NE of the wharf. It is possible that the S. S. ILIAMNA was close enough to this shoal bank to have registered 3 1/2-fms.

It is recommended that the shoal mentioned in the Comparison with the Chart section be checked in the future to see if shoaling continues. Any additional shoaling will necessitate the dredging of this area and an alteration of the sewer outlet.
