FE-232 W.D.

DESCRIPTIVE REPORT

Type of Survey ..Wire Drag.....
Field No.R/H-5-1-80.W.D.....
Office No.....FE 232 W.D.....

State New York-New Jersey
General Locality ..New York Harbor
Locality Upper and Lower Bays

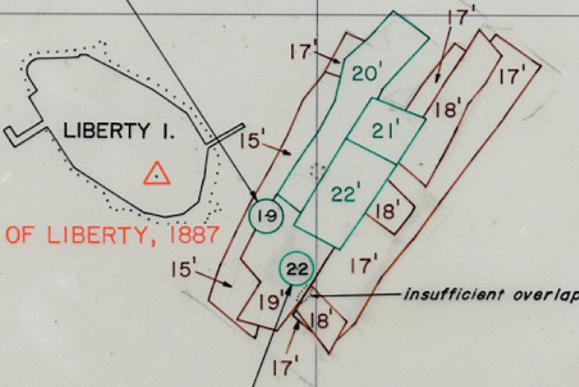
Hang at 19 ft.
Cleared by 15 ft.
Shoal

Temporary hang at 22' (estimated) - position approximate
Cleared by 19 ft.
Temporary hang not investigated - suspected as small debris

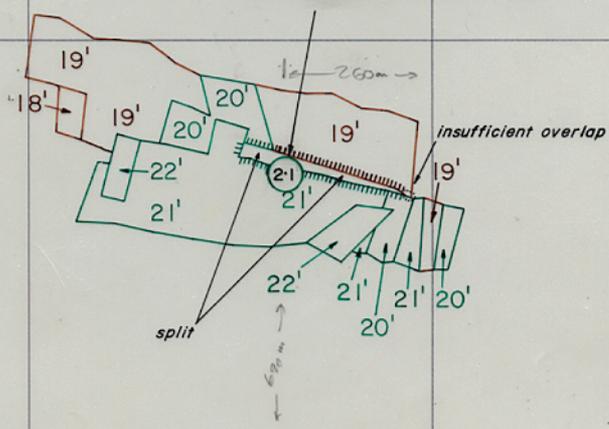
FE -232 WD
ITEM 31 ✓
NOVEMBER, 1980
SCALE : 1: 10,000
SOUNDINGS IN FEET AT MLW

Temporary hang at 21' (estimated) - position approximate
Cleared by 21 ft. - insufficient overlap
Temporary hang not investigated
