WIRE DRAG

DESCRIPTIVE REPORT

Type of Survey Wire Drag
Field No. R/H-20-1-83
Office No..... FE-243WD

State Louisiana
General Locality Gulf of Mexico
Locality Approach to Calcasieu Pass

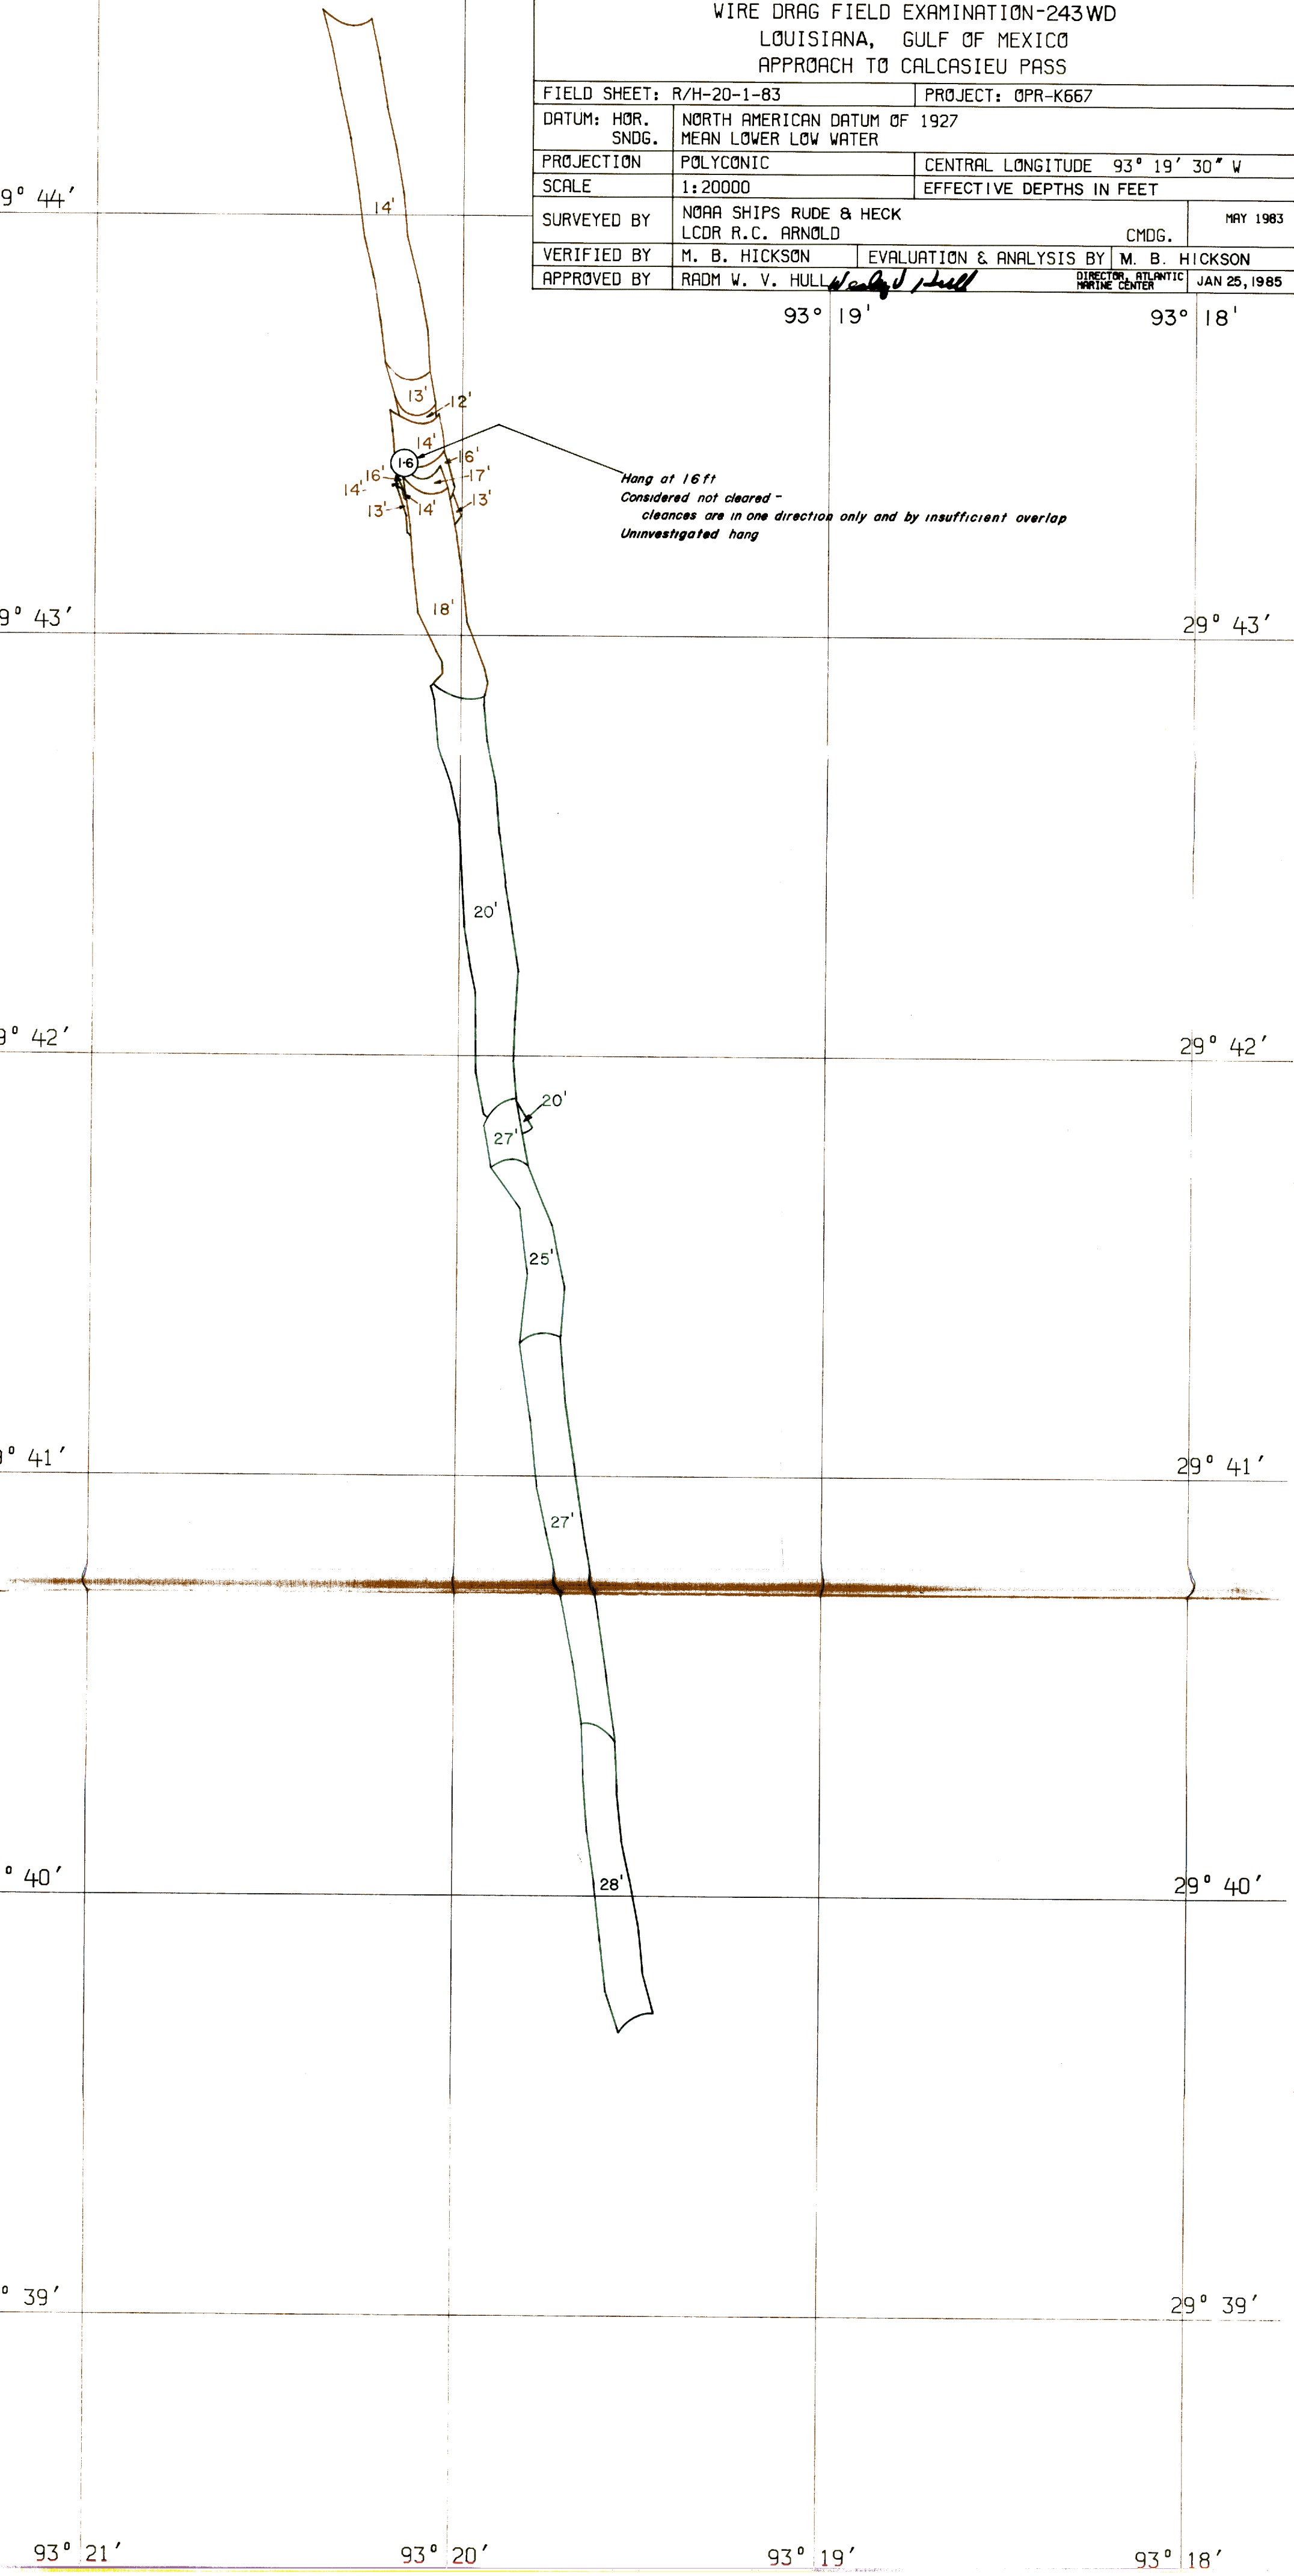
WIRE DRAG FIELD EXAMINATION-243WD
 LOUISIANA, GULF OF MEXICO
 APPROACH TO CALCASIEU PASS

1) One unidentified obstruction was located by wire drag at Latitude 29°43'24.7", Longitude 93°20'09.5". This obstruction is within 30 meters of the charted pile. This obstruction is not considered cleared as clearance was in one direction only and by insufficient overlap. It is recommended that this obstruction be charted as a dangerous submerged obstruction in the location determined by the present survey.

Hang at 16ft
 Considered not cleared -
 clearances are in one direction only and by insufficient overlap
 Uninvestigated hang

4) It is recommended that all the charted piling and submerged piling be retained as charted as dangerous submerged piling (this survey adequately disproves the existence of any visible piles) except the one obstruction that was located by this survey. All of these pilings (steel) originated with the U.S. Army Corps of Engineers Blueprint 42984 which generated Chart Letter 290 of 1942. No documentation from the Corps of Engineers or Chart Letters exist that states that any of these piles were removed. The appropriate district was contacted and no documentation exists within the Corps of Engineers about the removal of these piles.
