FE 285

WIRE DRAG

DESCRIPTIVE REPORT

Type of Survey Hydrographic
Field No. R/H-20-5-77
Registry No. FE-285WD

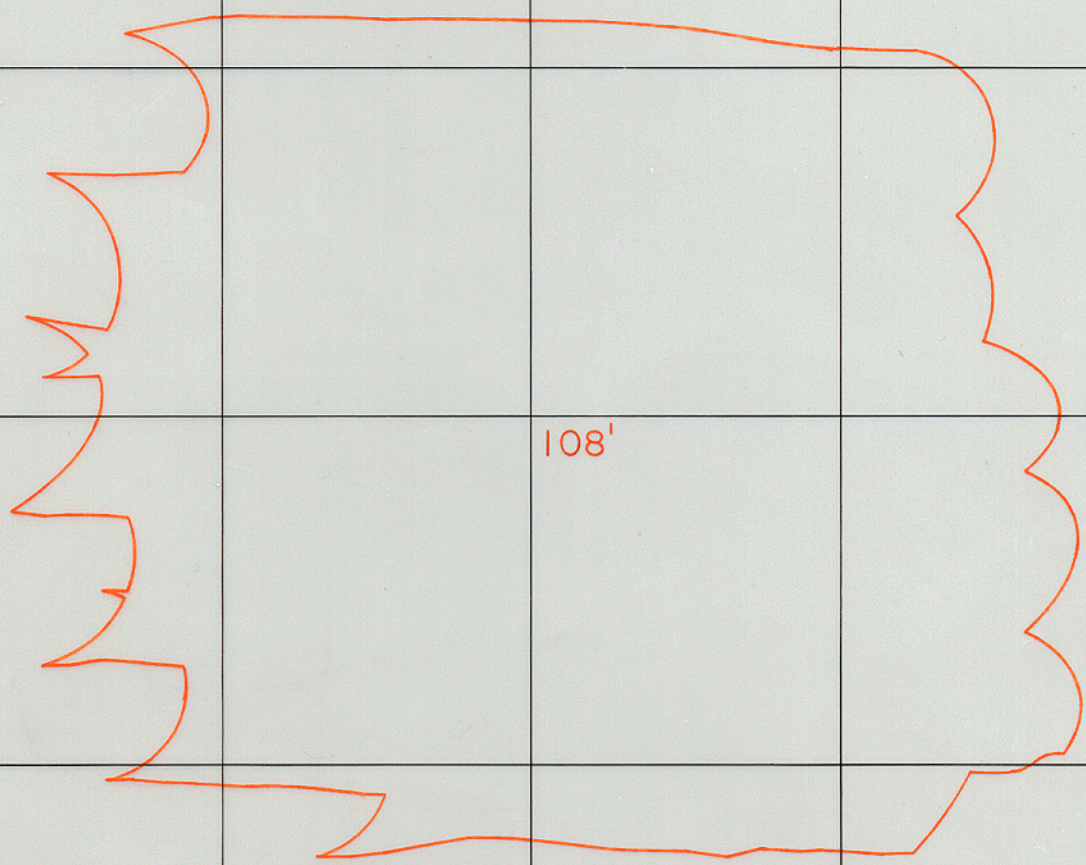
FE-285WD
 TEXAS
 GULF OF MEXICO
 OFFSHORE FREEPORT
 JUN 9 - OCT 29, 1977
 SCALE = 1:40,000
 EFFECTIVE DEPTHS IN FEET AT
 GULF COAST LOW WATER DATUM
 SHEET 2 OF 4
 INVESTIGATION AND CLEARANCE OF ITEM 3
 (AWOIS ITEM 00245)

Item 3 was reported to be a dangerous wreck, the F/V "Sadie S", located at Lat. 28°30'N, Long. 94°54'W. ✓

As was the case for Item 5, this item has a "Sunken wreck dangerous to surface Navigation" symbol on the present chart. Since it was found that the least effective depth over the item was 10~~3~~⁸ feet, it seems reasonable that this wreck can also be charted as a non-dangerous wreck. — *Concur - See section 7. a. 2) of the Modified Evaluation Report.* ✓

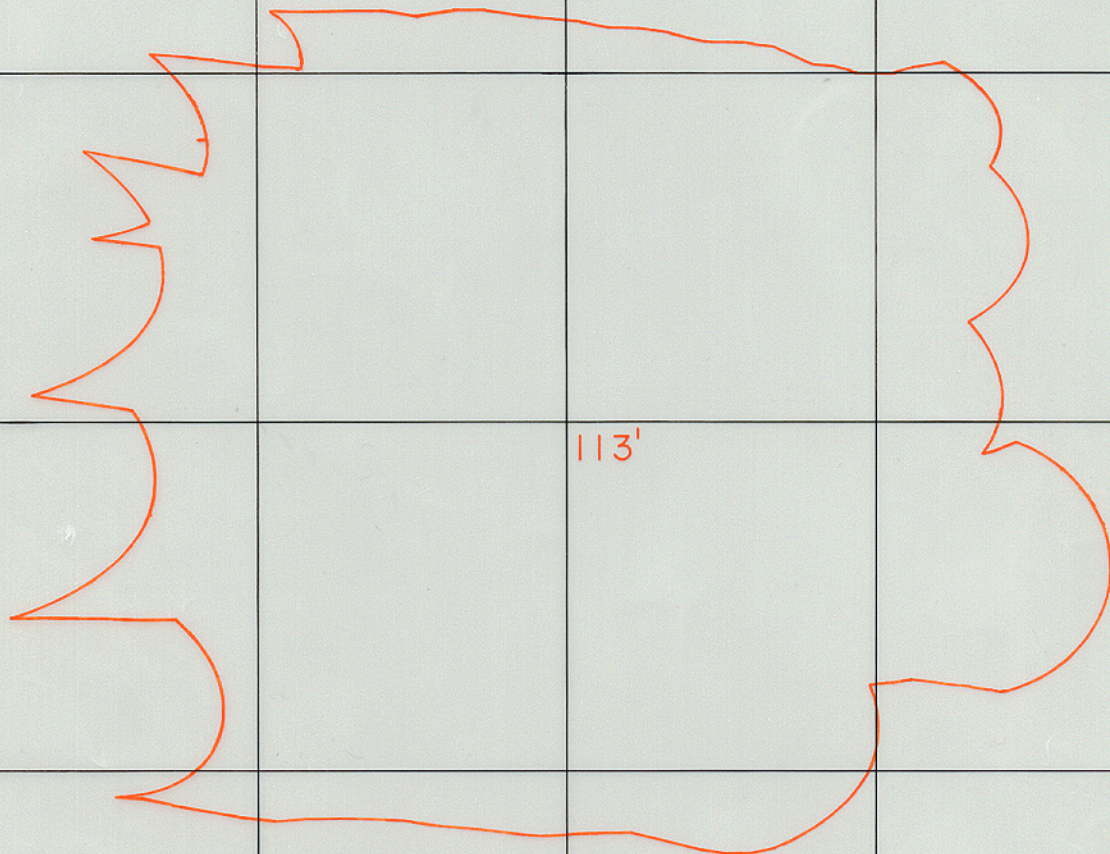
FE-285 WD
 TEXAS
 GULF OF MEXICO
 OFFSHORE FREEPORT
 JUN 9 - OCT 29, 1977
 SCALE = 1:40,000
 EFFECTIVE DEPTHS IN FEET AT
 GULF COAST LOW WATER DATUM
 SHEET 3 OF 4
 INVESTIGATION AND CLEARANCE OF ITEM 5
 (AWOIS ITEM 00236)

Item 5 was the wreck of the 55-foot trawler "SINTPAT" reportedly burned and sunk in 80 feet of water at Lat. 28°24'N, Long. 94°54'W. Since the reported depth of 80 feet is inconsistent with the hydrography in the area, the position or depth may be in error. *Concur.* ✓

Item 5 was covered to a one mile radius circle about the given position of the wreck. There was no evidence of a hang throughout the ~~drag~~ investigation. ✓

At the present time, the item is denoted on the chart as a sunken wreck dangerous to surface navigation with a "Position Approximate" symbol attached. Again, clearing an item by wire drag does not disprove the existance of a wreck. However, the least effective depth ^{obtained} ~~found~~ over the area in question was 115³ feet, corrected ^{for Smith} to predicted tides. This fact could warrant the removal of the "Dangerous to surface Navigation" symbol. Also, the area was swept in a one-mile radius so that a "Position Doubtful" (PD) symbol could be considered adequate for this item. ✓

3) Presurvey review Item #5 (AWOIS #00236), a charted dangerous sunken wreck, position approximate in Latitude 28°24'N, Longitude 94°54'W originated with Local Notice to Mariners No. 87 of 1966 and is identified as the wreck of the SINTPAT, a 55-foot long trawler which burned and sank in July of 1966. The wreck was reported as being sunk in 80 feet of water and the depths in the area of the reported position are 122 to 129 feet which indicates the strong possibility of an erroneous reported position. This wreck is presently charted (the 1985 editions of the charts) as a nondangerous wreck, position doubtful in the previously reported position from advance information from the present survey (FE-285WD). This wreck was not found by the present survey. The present survey cleared a search area exceeding the required one nautical mile radius circle of search around the reported position by a minimum effective depth of 113 feet. As the clearance depth ranges from 9 to 16 feet shoaler than the hydrography within the common area, this wreck is not considered disproved. It is recommended that this item be charted as a nondangerous sunken wreck, position doubtful, with a label in parentheses: (cleared 113 feet). 113 wk PD
