HYDROGRAPHIC TITLE SHEET

FE-310

General locality San Francisco Bay

Locality Vicinity of Hunters Point to Oakland Inner Harbor

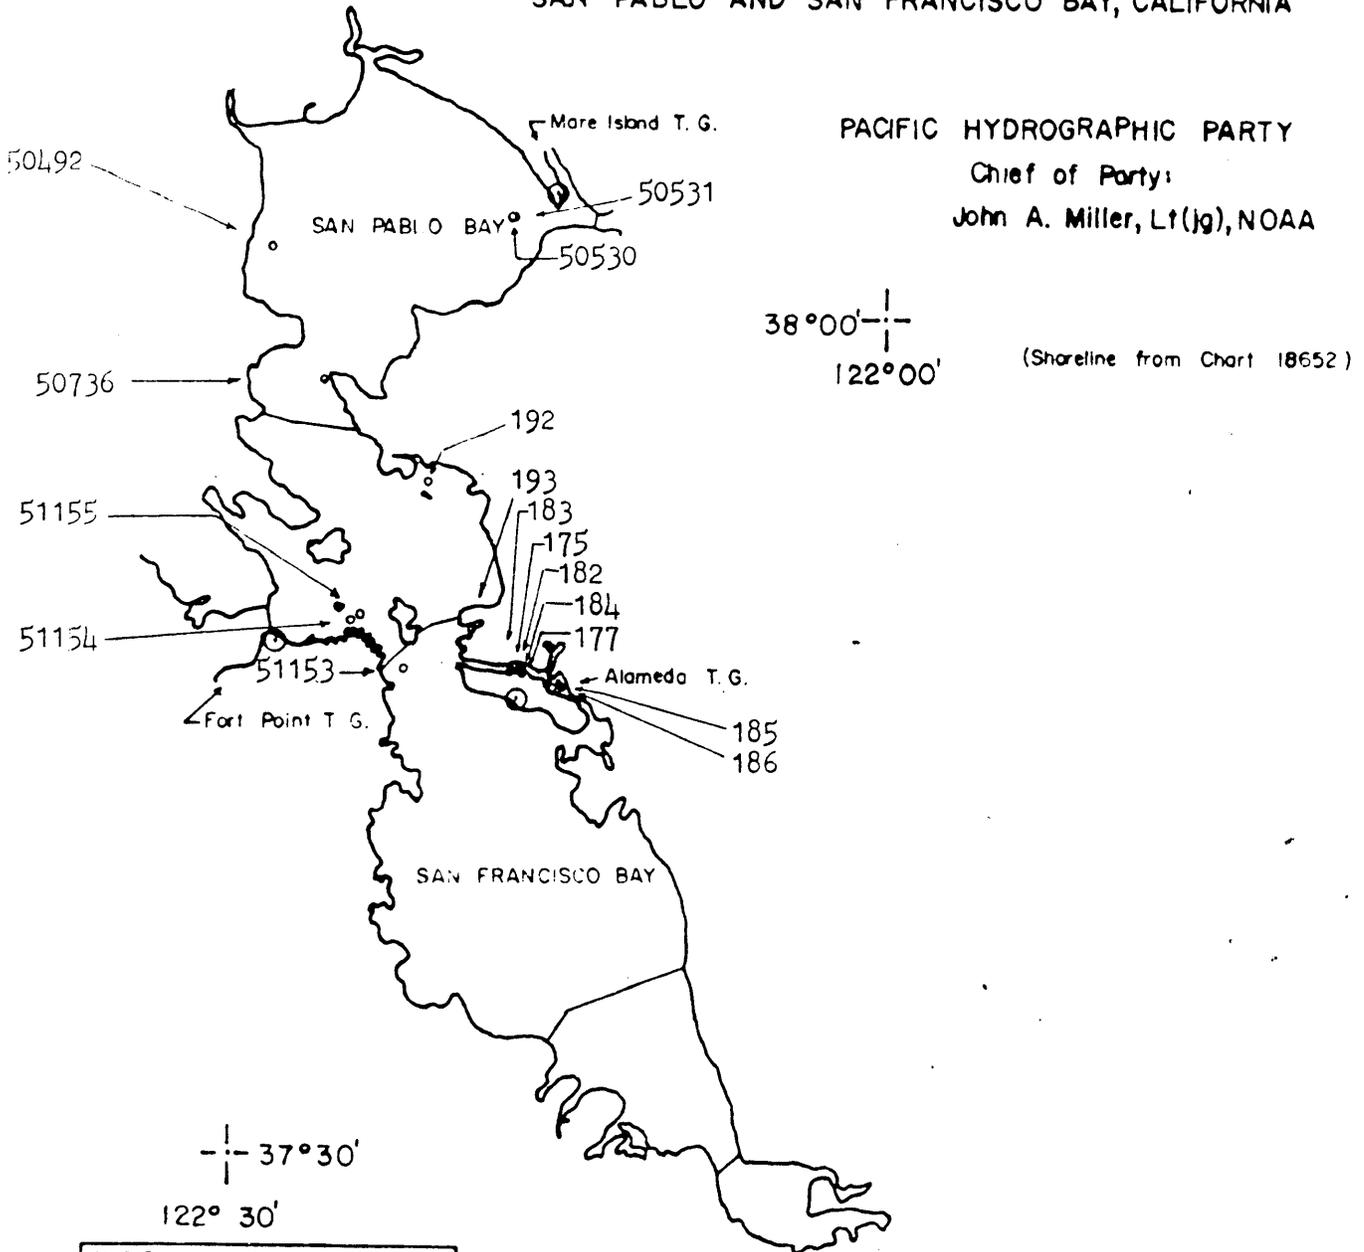
AWOIS Item Numbers		Month	Year
STATUS OF INVESTIGATION		MAY	1987
DISPROVED	192, 50531, 50492, 177		
VERIFIED	50530, 175, 182		
IN PROGRESS	183, 184, 185, 186, 193		
RESOLUTION NOT FEASIBLE

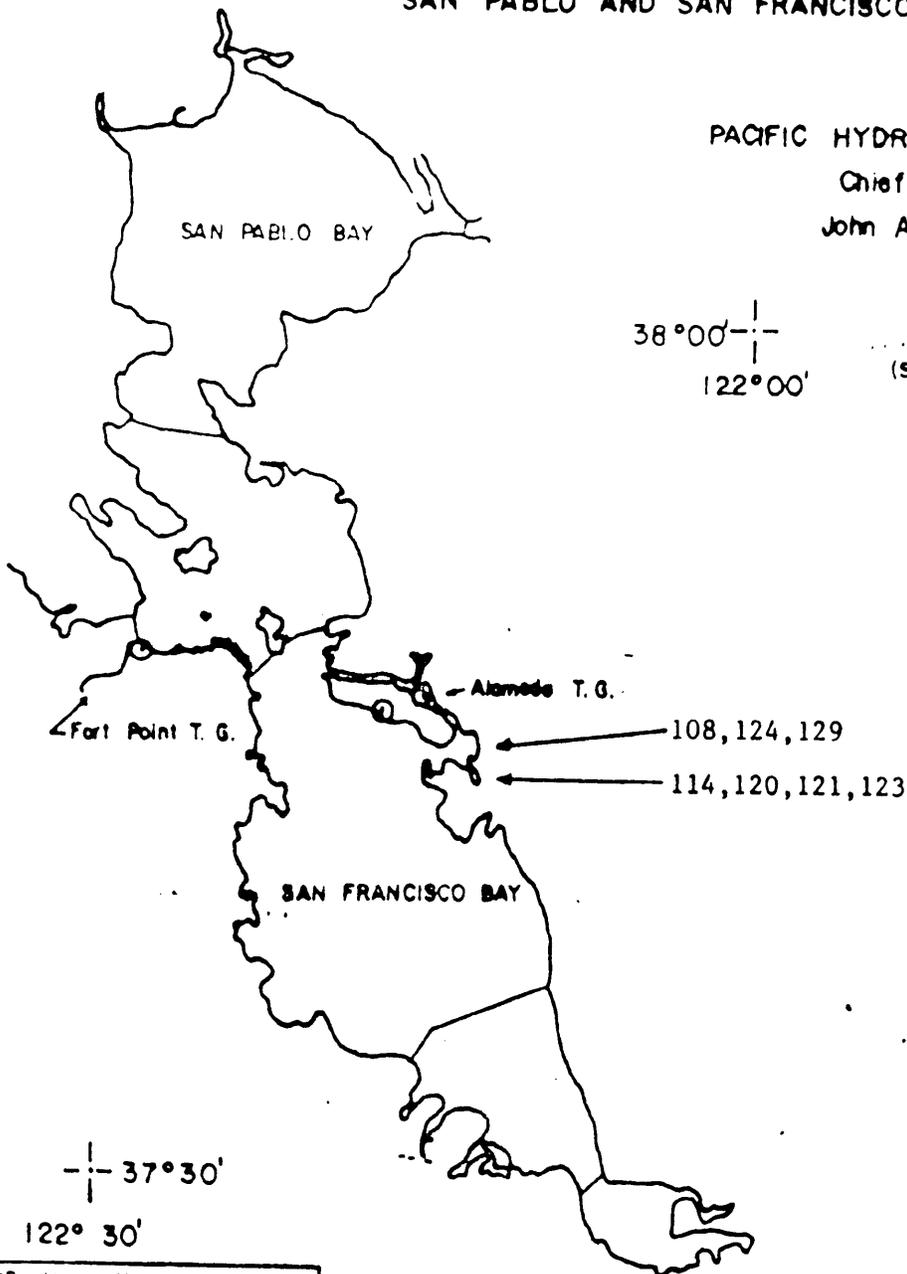
AWOIS Item Numbers		Month	Year
STATUS OF INVESTIGATION		OCTOBER	1987
DISPROVED			
VERIFIED	108, 114, 120, 121, 123, 124, 129		
IN PROGRESS			
RESOLUTION NOT FEASIBLE

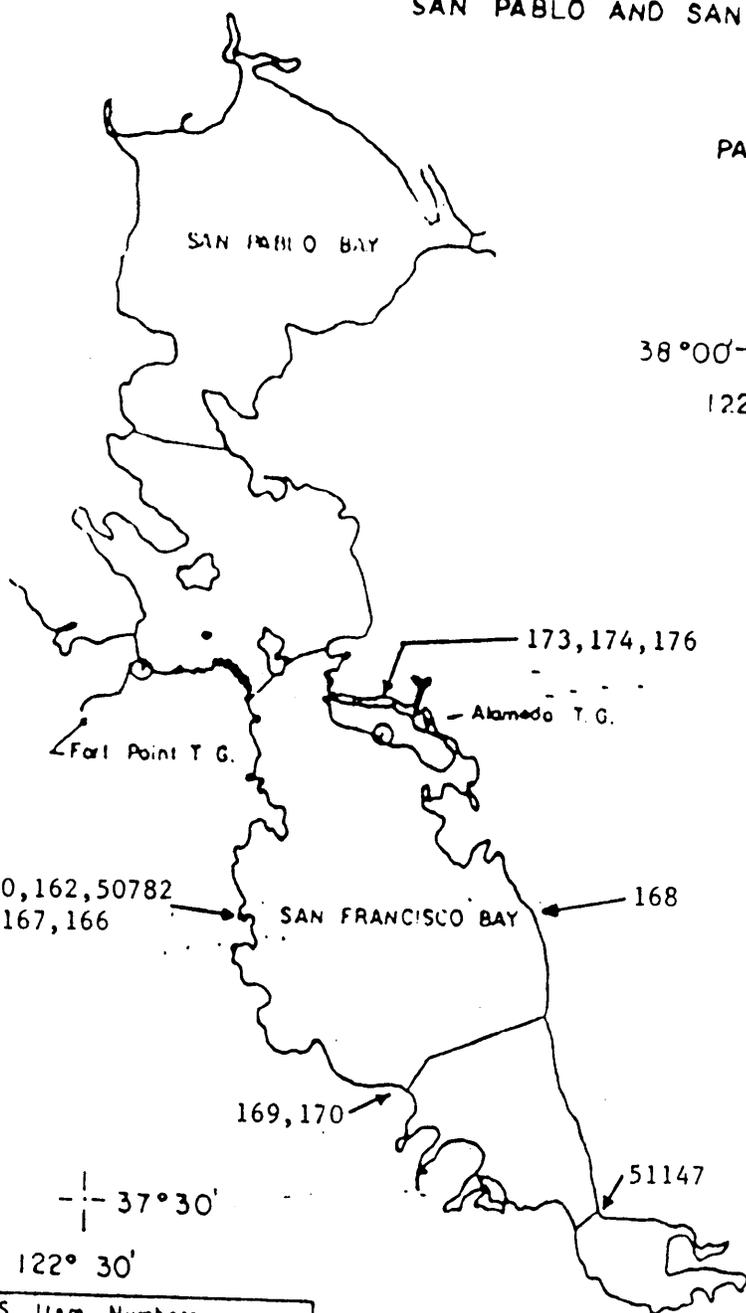
AWOS Item Numbers		Month	Year
STATUS OF INVESTIGATION		November	1967
DISPROVED	173, 50782, 50781, 151, 160, 162, 166, 167, , 170		
VERIFIED	51147, 174, 176, 168, 169		
IN PROGRESS			
RESOLUTION NOT FEASIBLE

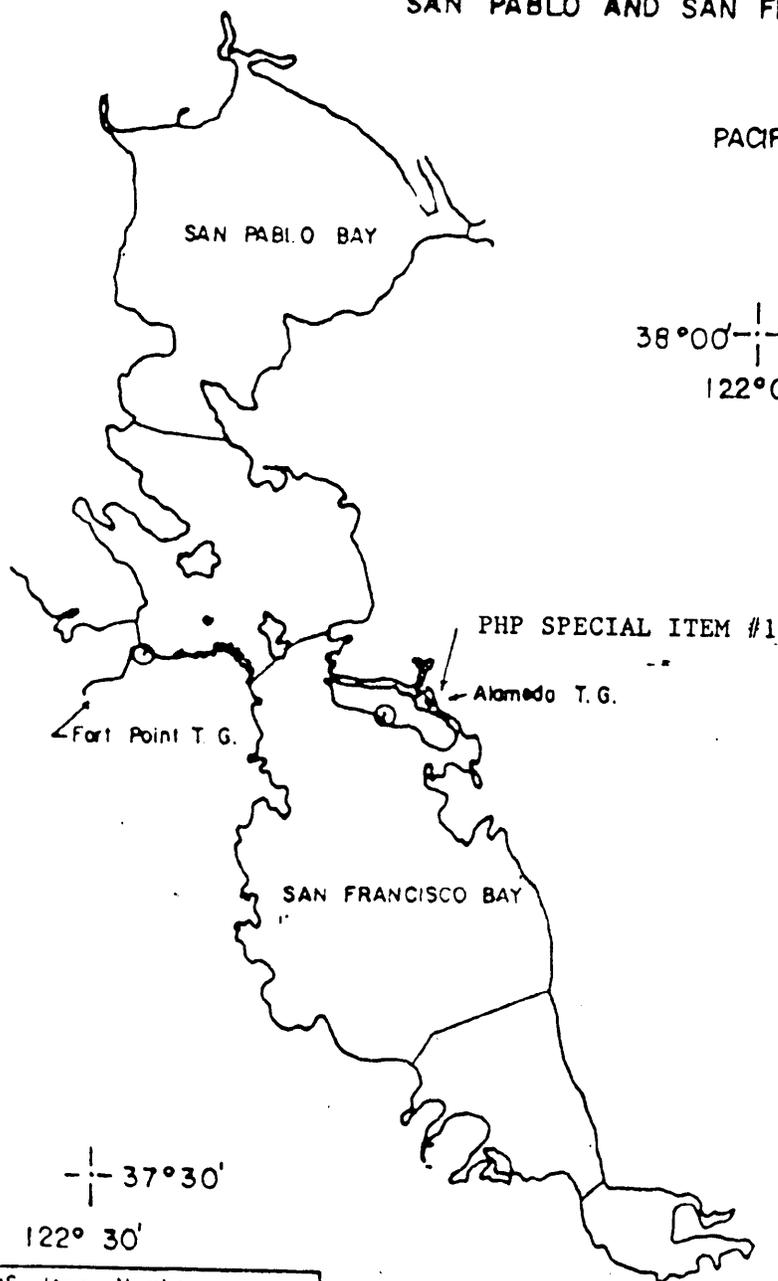
AWOS Item Numbers		Month	Year
STATUS OF INVESTIGATION		DECEMBER	1987
DISPROVED			
VERIFIED	PHP SPECIAL ITEM #1		
IN PROGRESS			
RESOLUTION NOT FEASIBLE

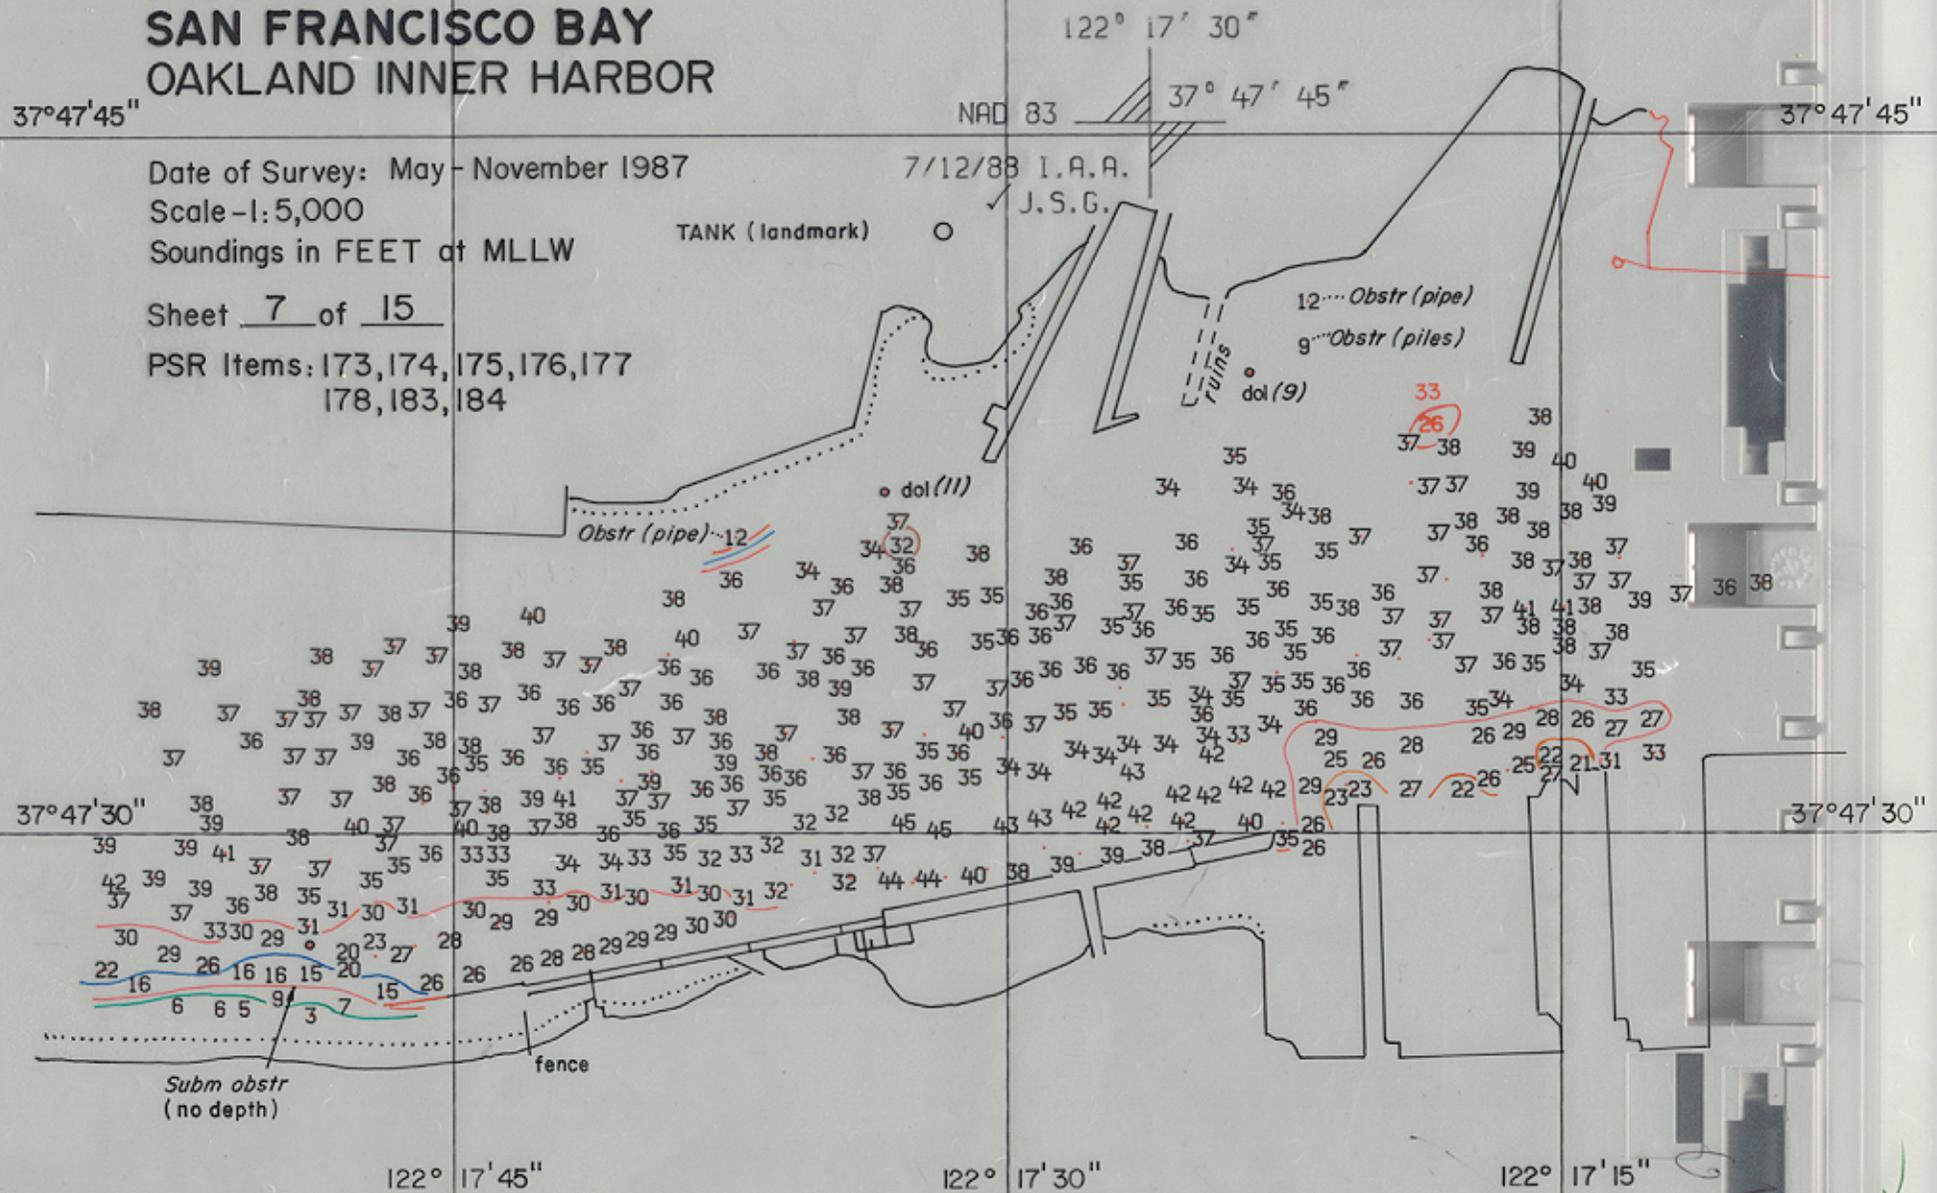
PSR Items: 173, 174, 175, 176, 177  
178, 183, 184

*Detached soundings in red from H-9873(1980-81)*

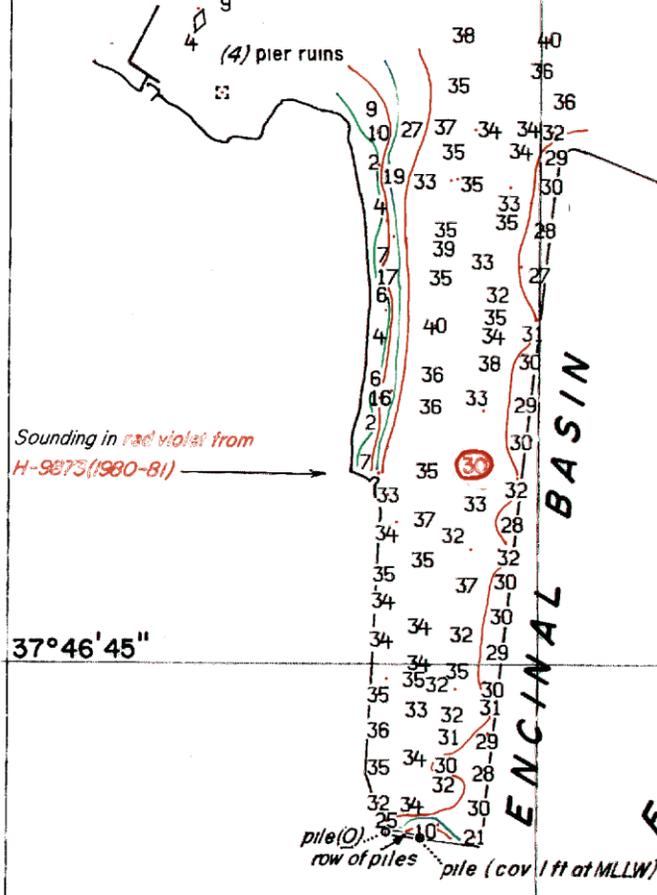
*Obstr (concrete and rebar)*
