DESCRIPTIVE REPORT

Type of Survey ... Field Examination
Field No. RU-10-6-91
Registry No. FE-365SS

State Rhode Island
General Locality .. Rhode Island Sound
Sublocality Zero Point Five to Eleven
..... NM East of Block Island
.....
..... 1991
.....
CHIEF OF PARTY
..... LCDR N.E. Perugini

Locality Zero Point Five to Eleven Nautical Miles East of Block Island

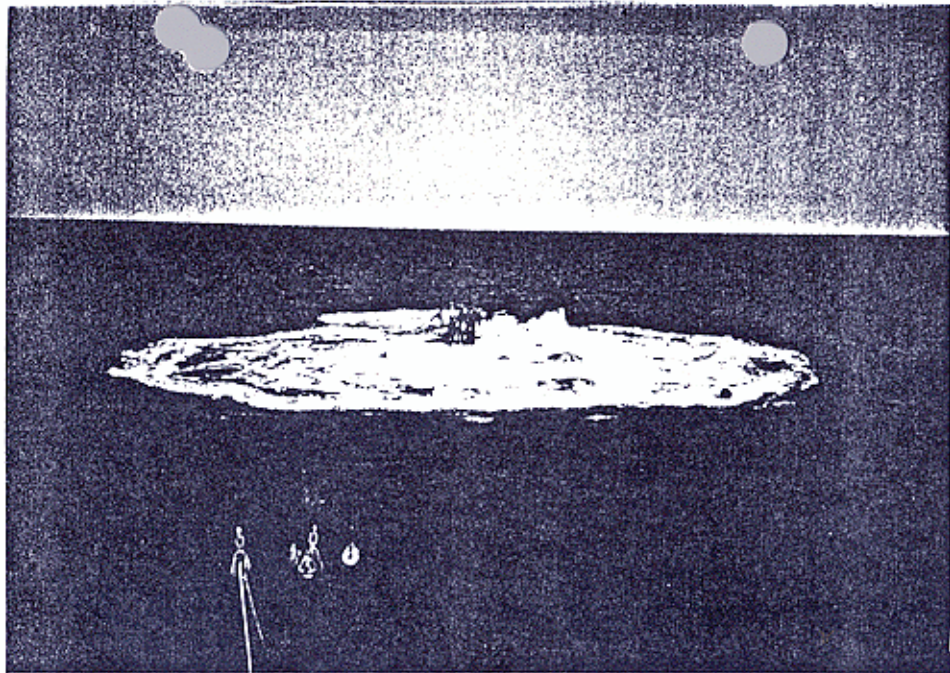
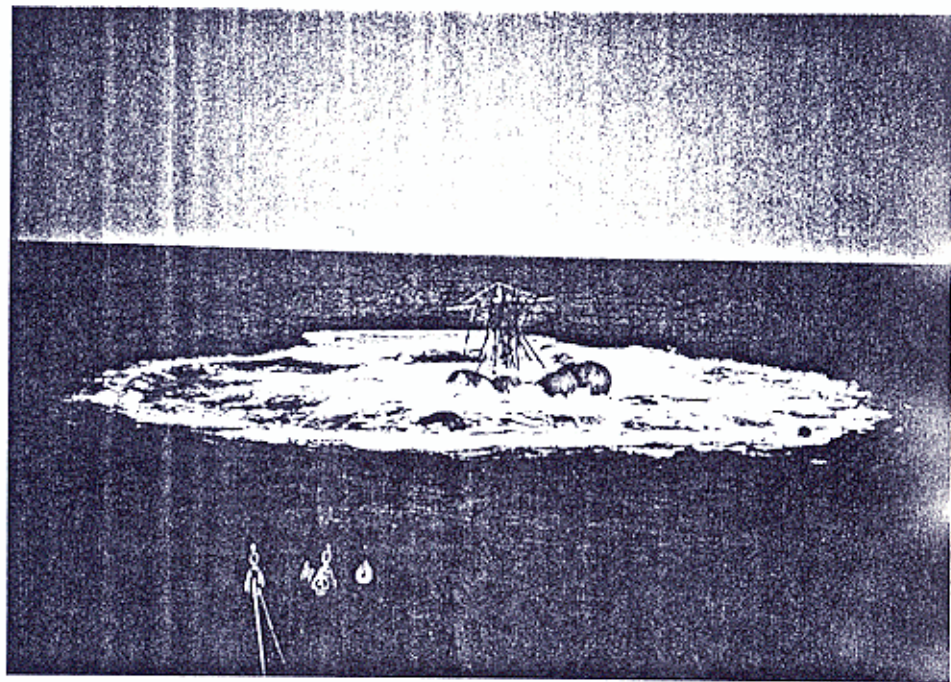
(11 & 12) Vessel breaking surface

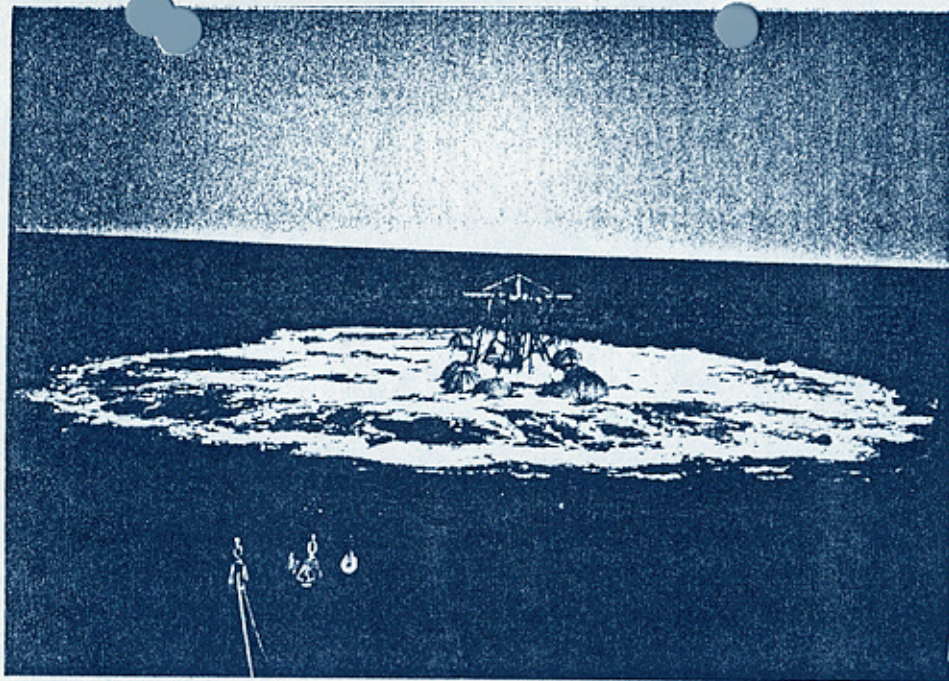
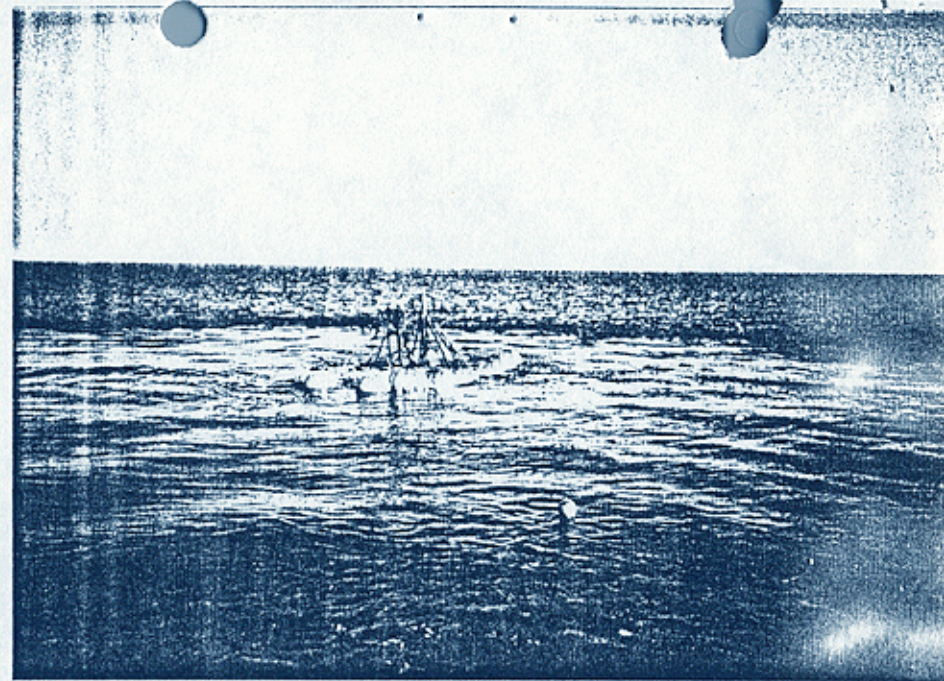
(13 & 14) MISS JENNIFER afloat

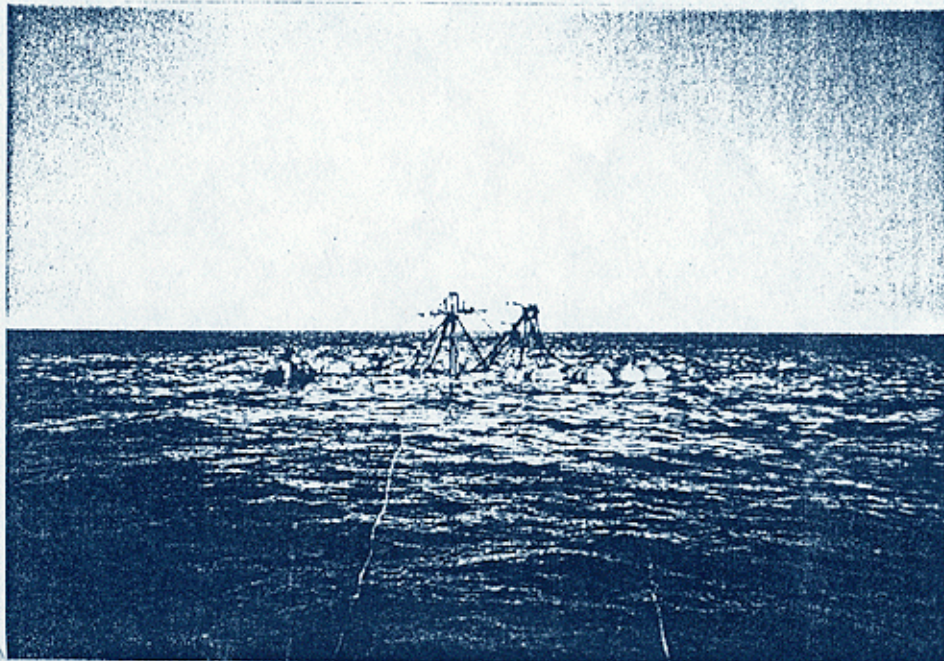
Top of fish hold forward bulkhead fractured and distorted approximately 1½" wide opening. Bow collapsed in the portside and indented inwards approximately 15" area measures approx. 6' x 8'.
Port and starboard side of the stern/lazarette area distorted. ~~207 736 97 50~~
~~700 526 64 24~~

(15) Inspection of F/V by lead diver
