**DESCRIPTIVE REPORT**

*Type of Survey:* **ENC Validation and  
Hydrographic Surveys**  
*Registry Number:* **F00513**

*State:* California  
*General Locality:* San Diego  
*Sub-locality:* San Diego Harbor and Mission Bay

HYDROGRAPHIC SURVEY F-00513

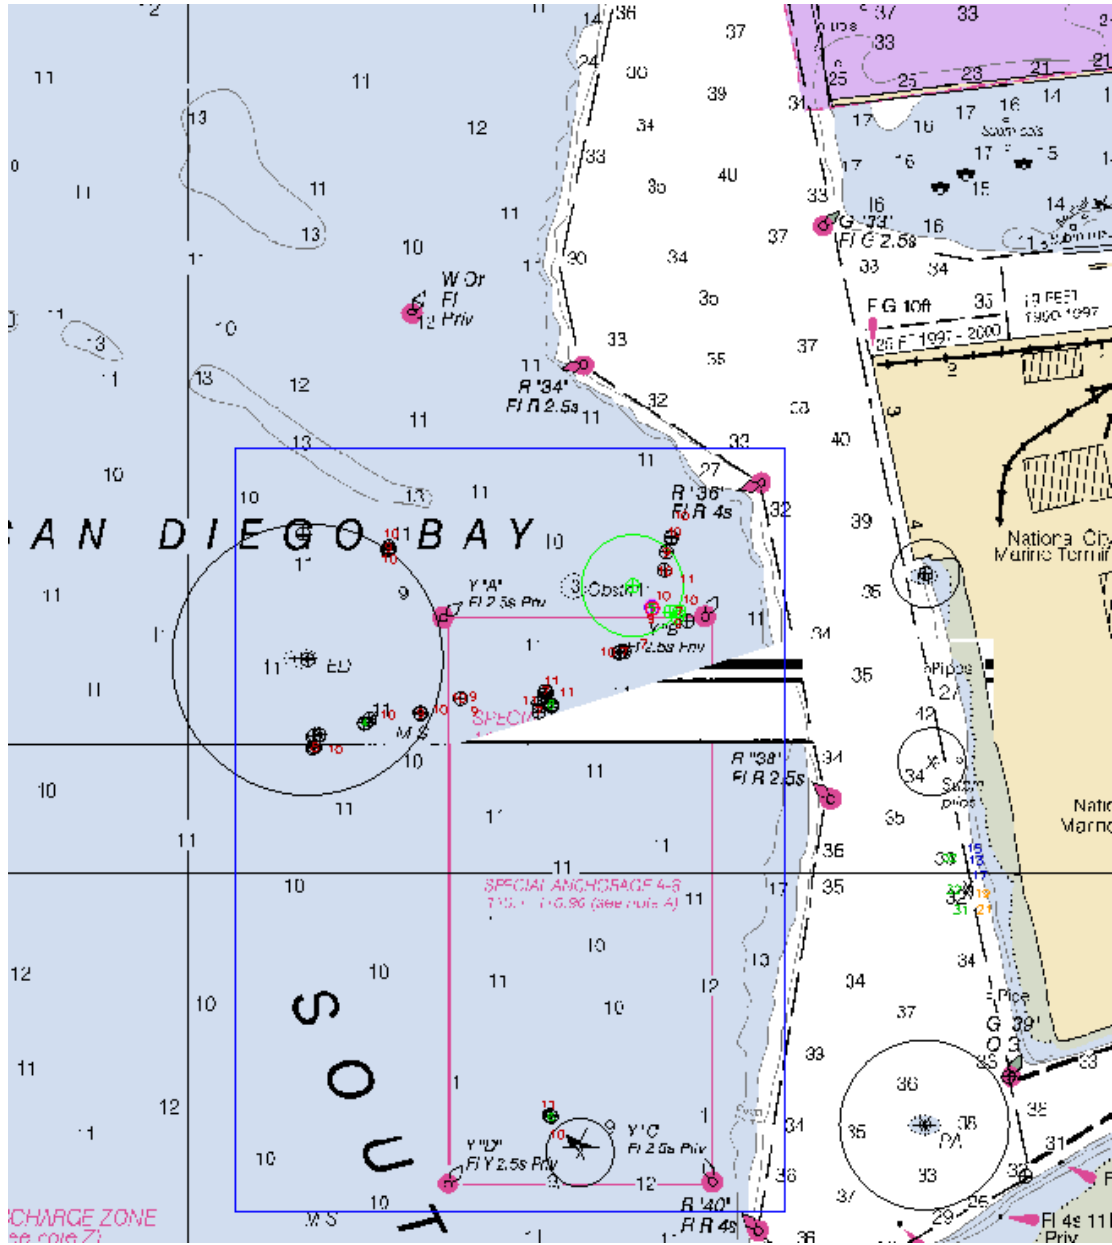
Anchorage A-8, located in the southern area of San Diego Bay, is littered with numerous sunken wrecks and obstructions. Many derelict sailing and motor vessels are anchored in this area, and often sink in or near the charted anchorage. NRT6 was assigned two AWOIS item investigations in or near the anchorage, and located several wrecks and obstructions within the AWOIS search radii. These items were developed with SWMB. Most items warrant charting updates, as either wrecks or obstructions; this is noted in the Pydro PSS. In the PSS each item developed in or near the anchorage is noted with the Keyword "Anchorage A-8", and these items are also found in a separate template page. *Concur.*

Rather than charting each obstruction, it may create less "chart clutter" to denote an area on the chart in which numerous wrecks and obstructions are found. In the figure below, the area in which all of the wrecks and obstructions found during this survey is outlined in blue. *Concur.*

Figure 2: Numerous wrecks and obstructions are located in the area outlined in blue.

The Coast Pilot advises the mariner that numerous wrecks and obstructions exist in southeastern San Diego bay. The Hydrographer will recommend that this entry specifically mention Anchorage A-8. Steps have been taken, after completion of the survey, to clean the Anchorage by the local Port Authority. The Hydrographer will also recommend a complete survey of the anchorage once these efforts are completed.

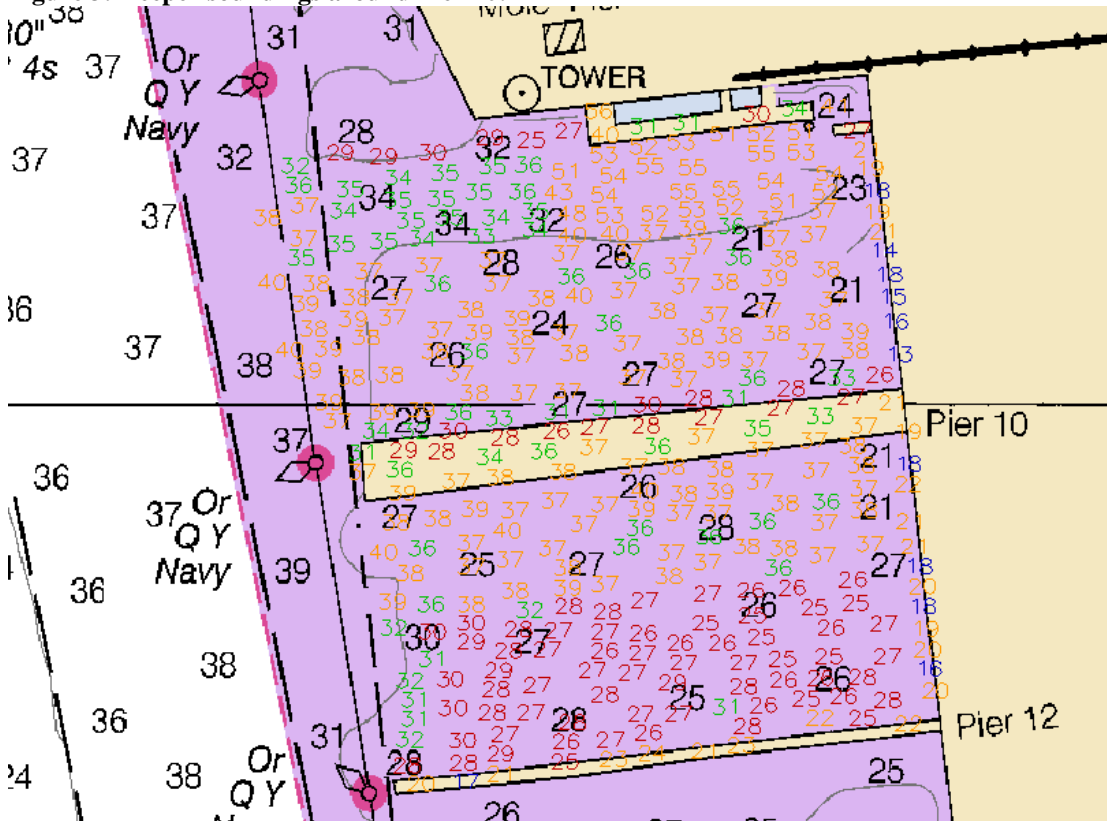
Bathymetry collected for survey F00513 in other areas generally agreed with charted soundings. Survey results show bathymetry north and south of Navy Pier 10 to be deeper than charted. Recent dredging may be seen in the DTM of the area. **Concur.**

Figure 3: Deeper soundings around Pier 10:

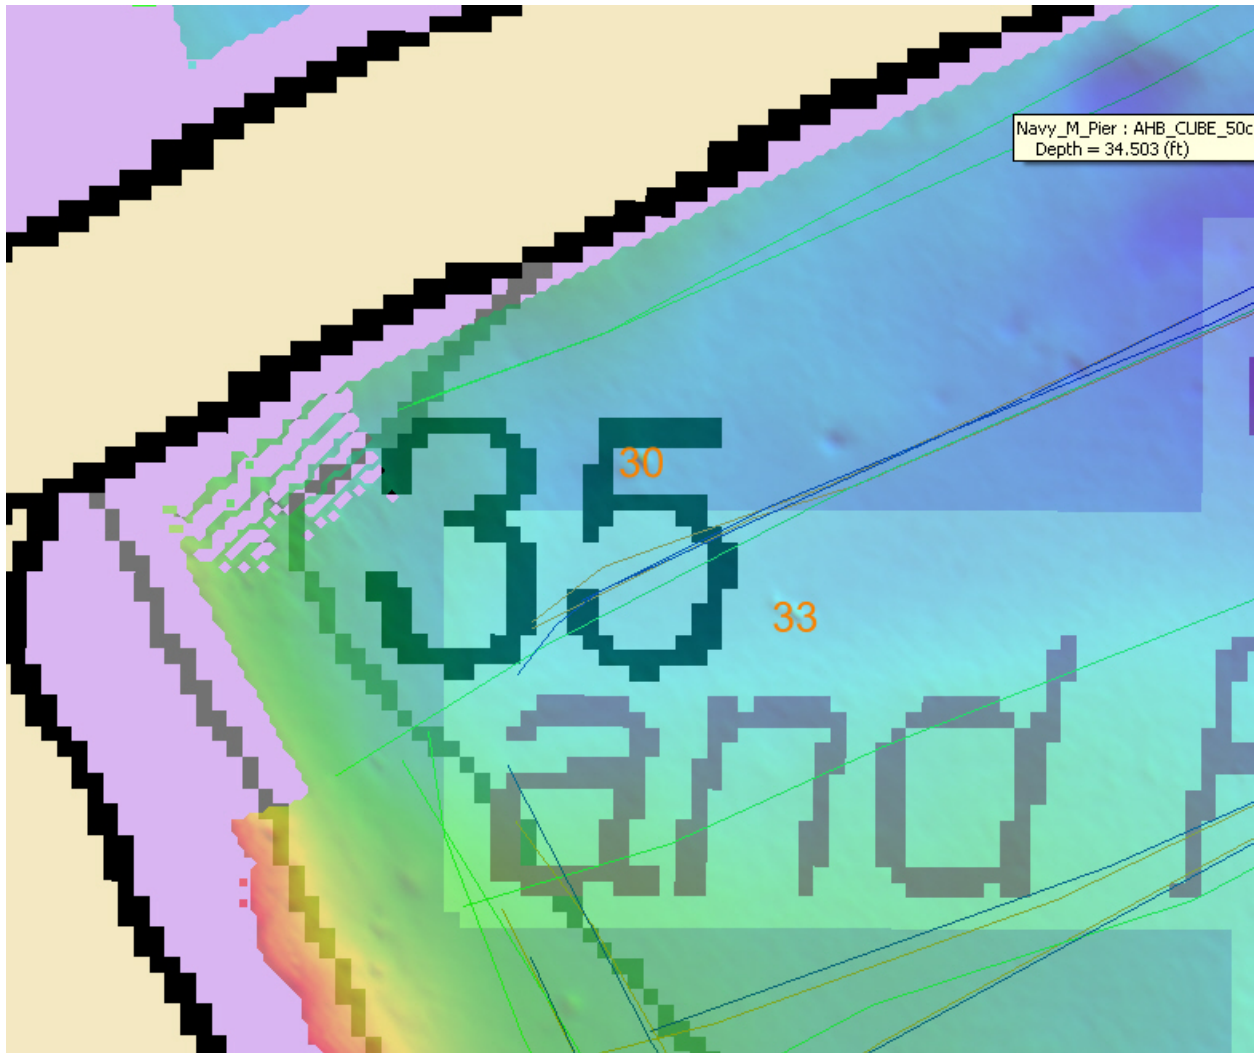
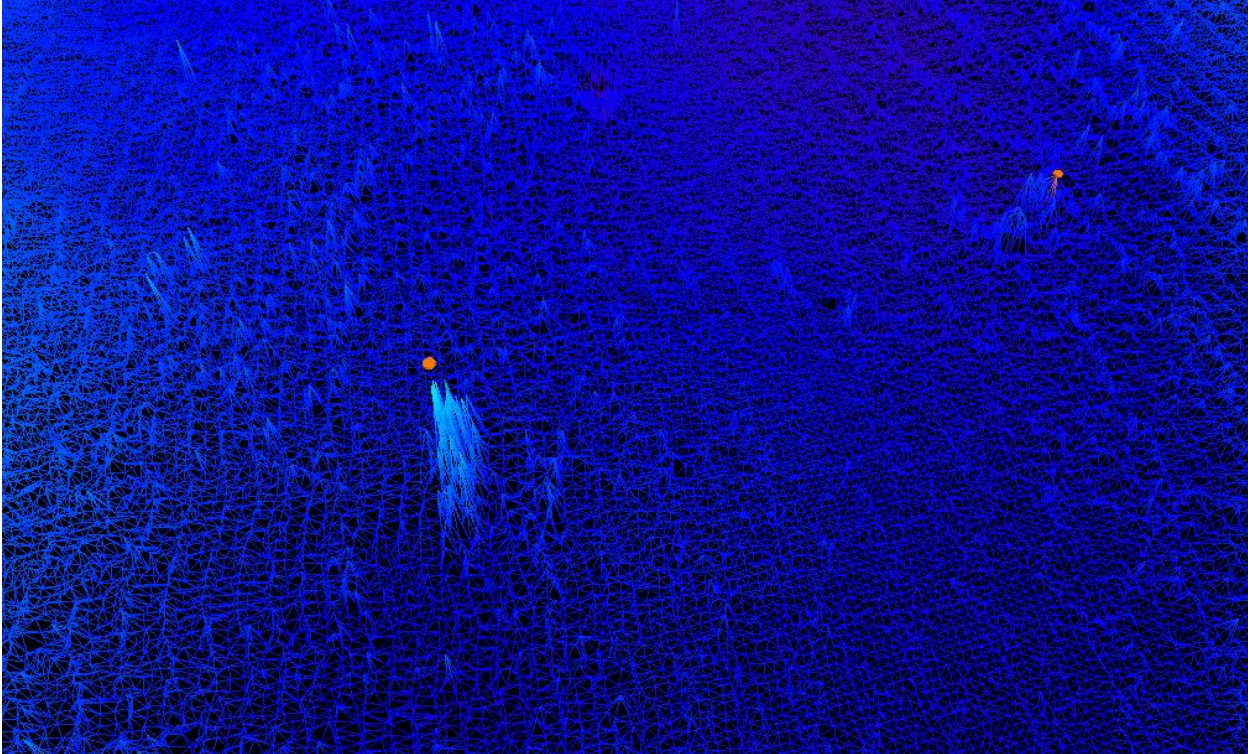
Hydrographer recommends charting 30 ft obstruction at this position. Frequent vessel traffic and the object's proximity to a pier warrant its characterization as an obstruction.

Concur. Chart 30 foot obstruction.

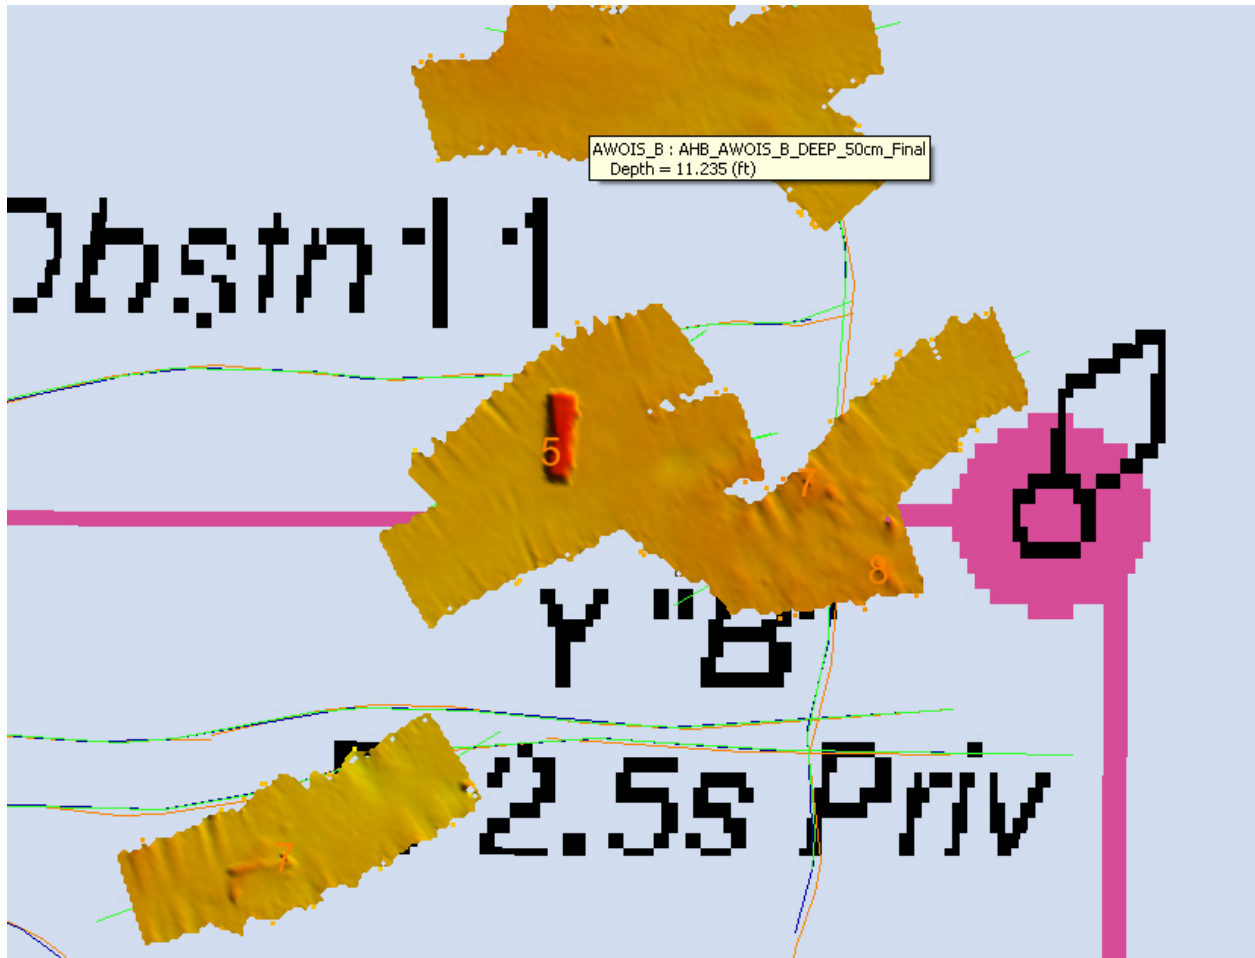
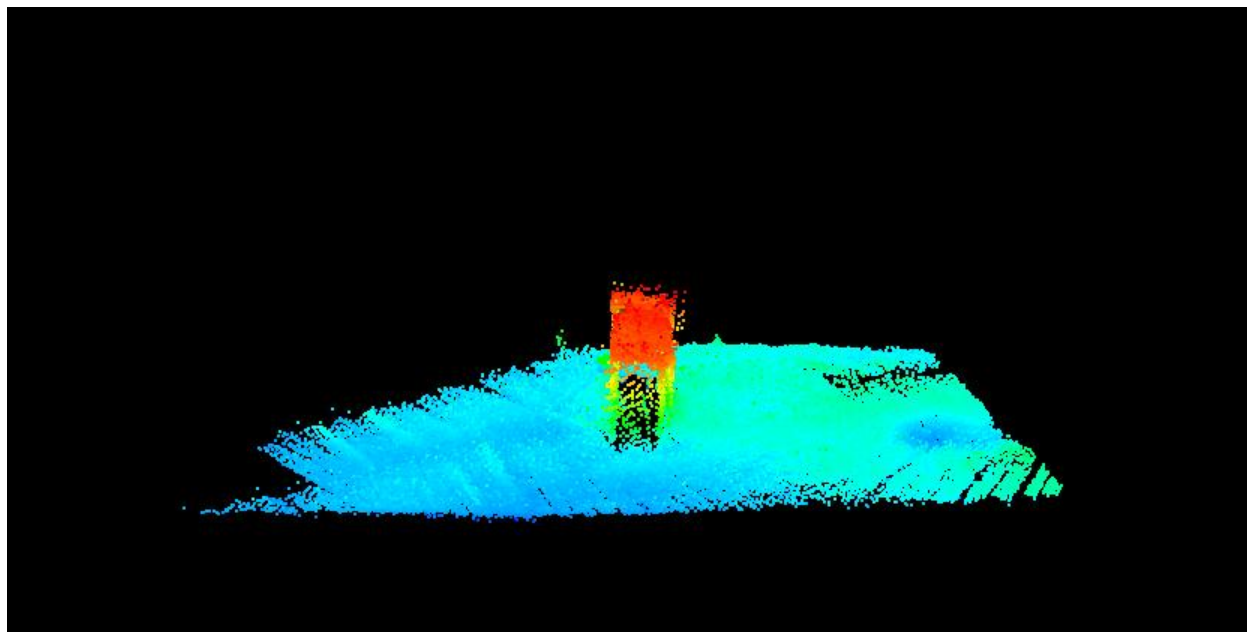
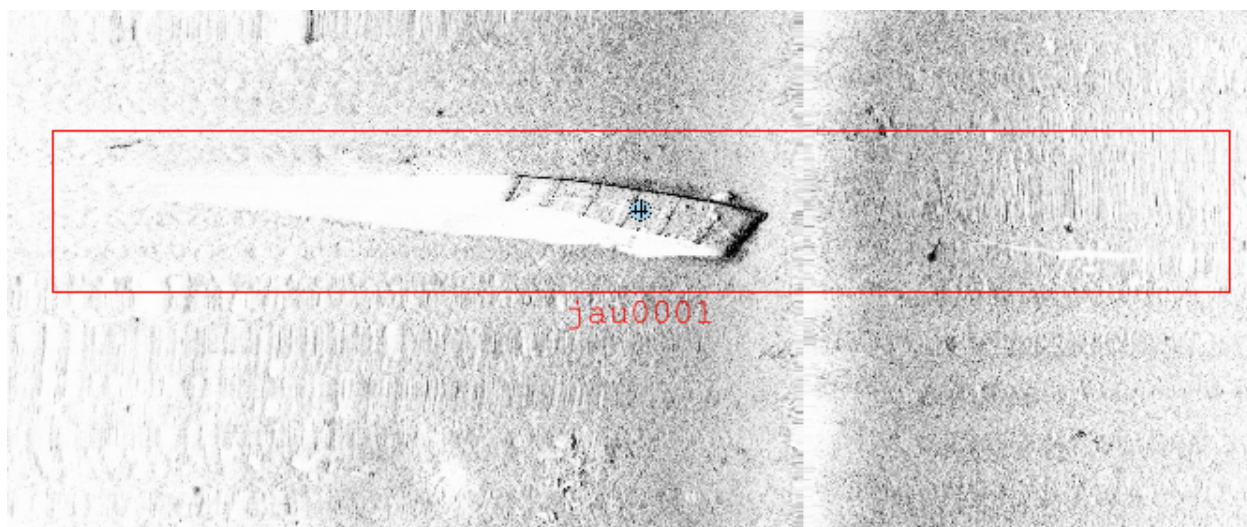
## 1.4) 5ft Obstruction

This obstruction is one of many that lie within or near the boundary of Anchorage A-8. The Hydrographer recommends adding a note to the chart to the effect: "Numerous wrecks and obstructions exist in and around Anchorage A-8". Charting each obstruction separately may result in a cluttered and unreadable chart. Please see the Chart comparison section of the Descriptive Report for a thorough discussion of Anchorage A-8.

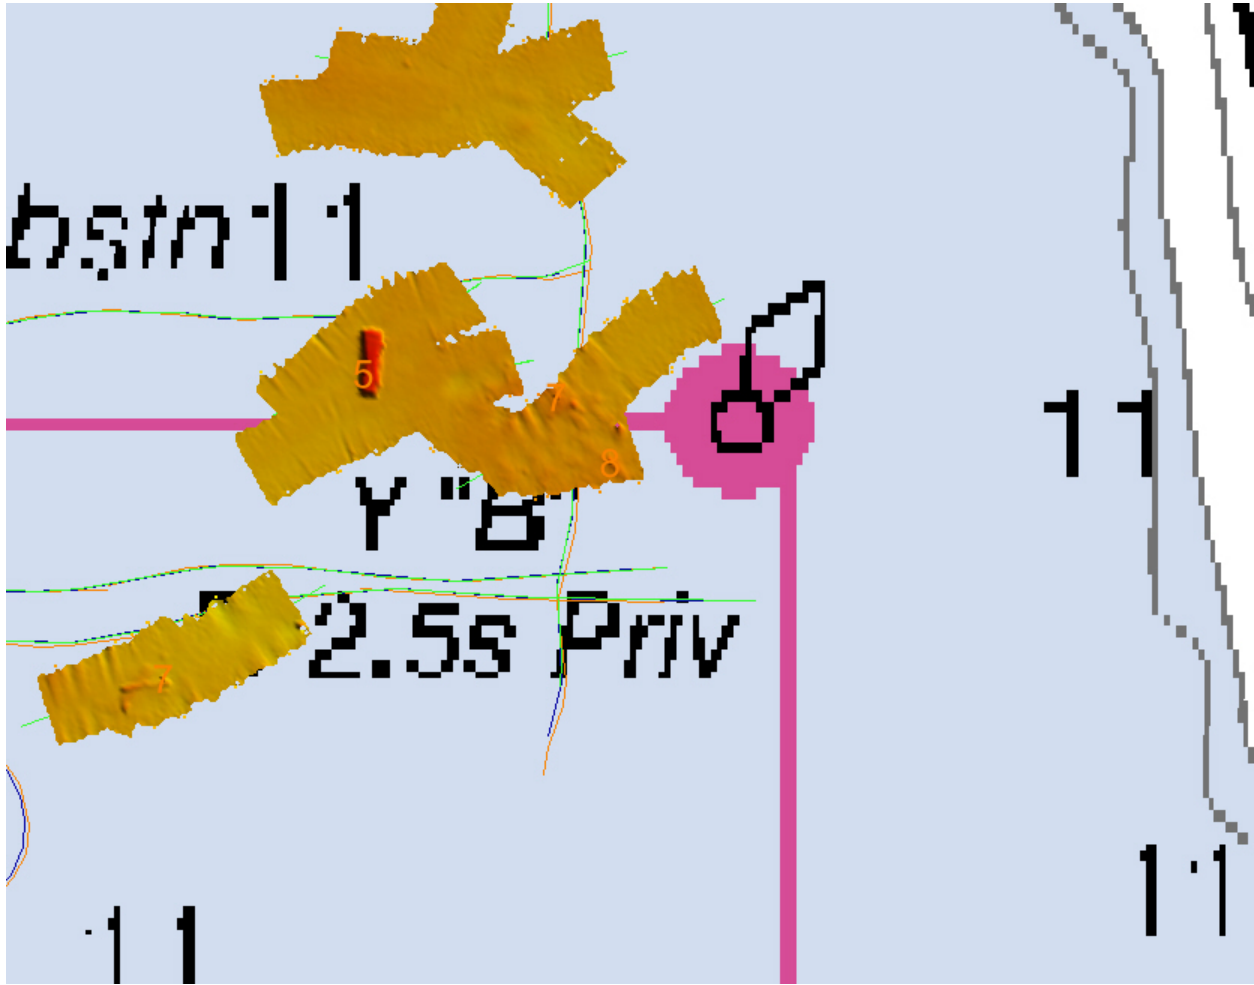
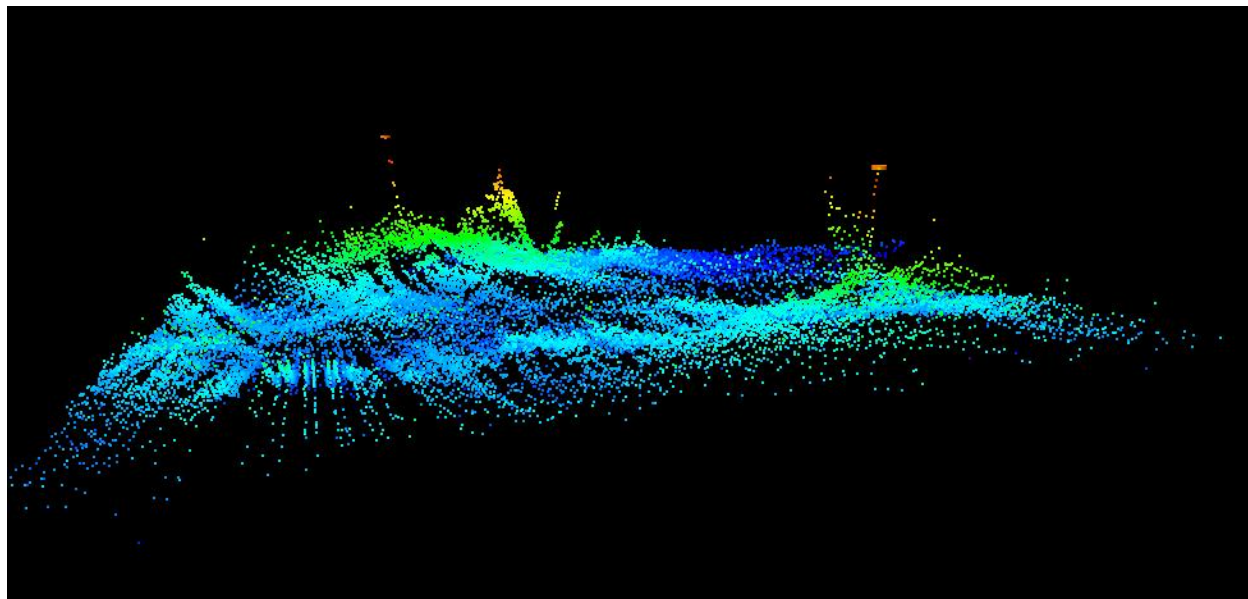
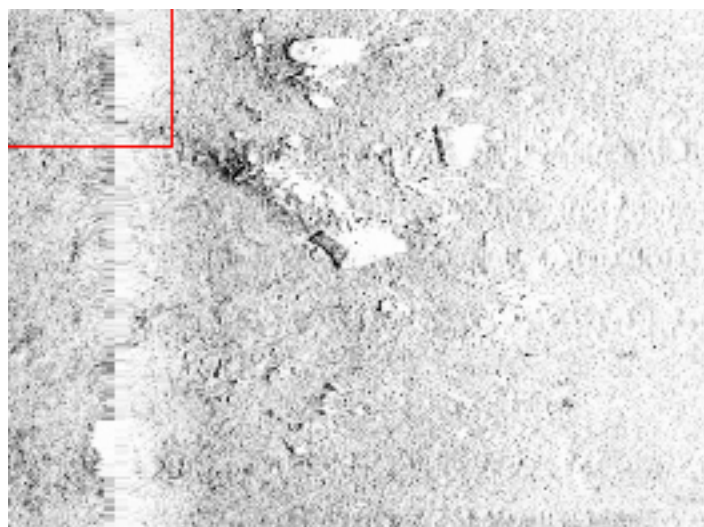
## 1.8) 8ft Obstruction

This obstruction is one of many that lie within or near the boundary of Anchorage A-8. The Hydrographer recommends adding a note to the chart to the effect: "Numerous wrecks and obstructions exist in and around Anchorage A-8". Charting each obstruction separately may result in a cluttered and unreadable chart. Please see the Chart comparison section of the Descriptive Report for a thorough discussion of Anchorage A-8.

Do not concur. Shoaler obstruction in close proximity.

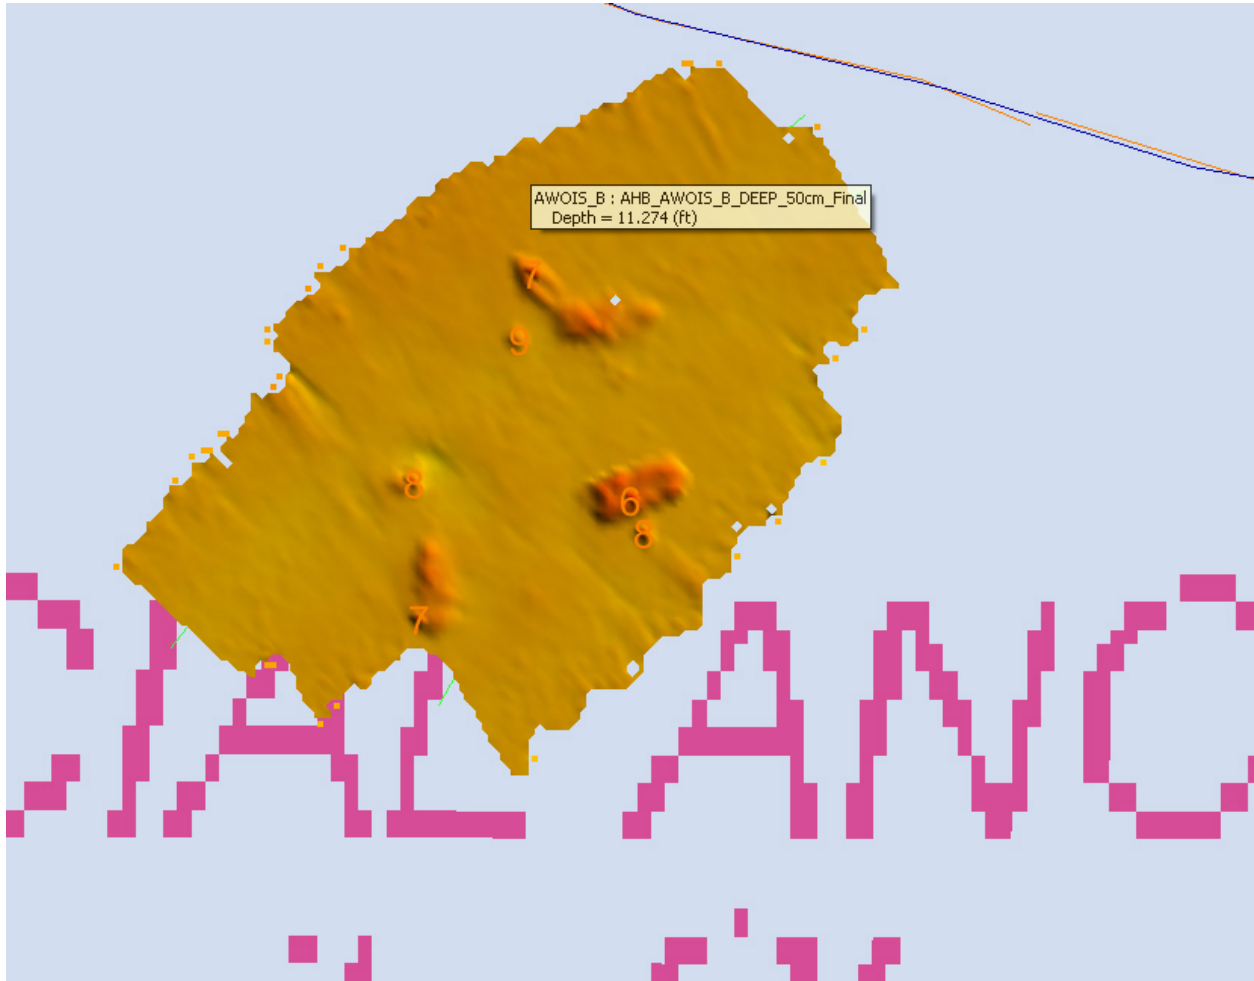
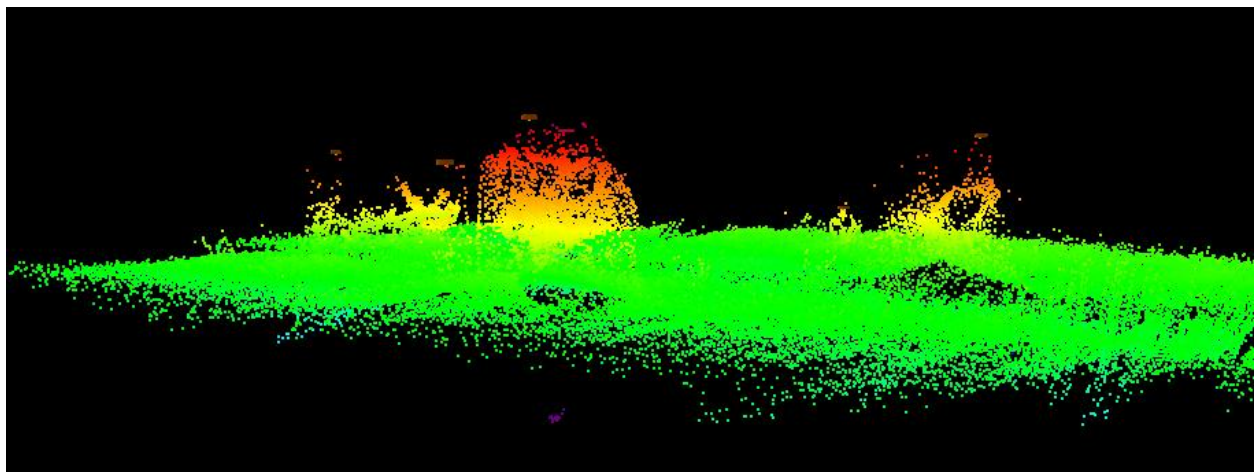
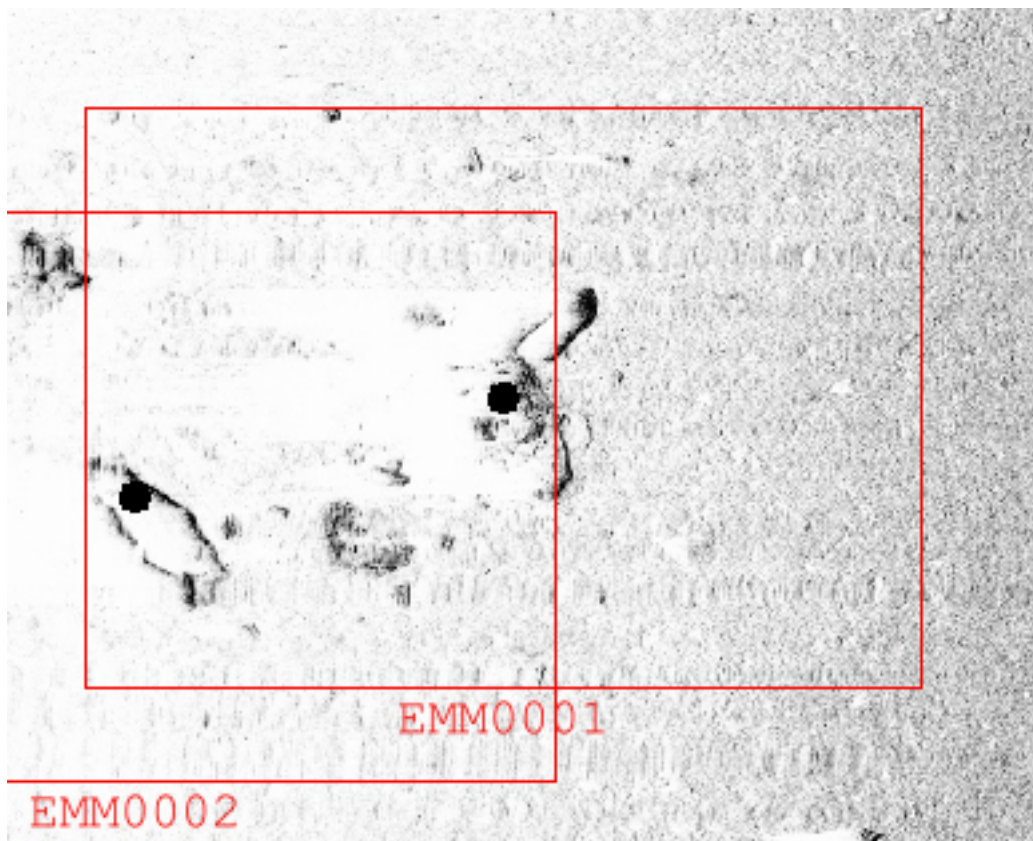
## 1.12) 6ft Wreck

This obstruction is one of many that lie within or near the boundary of Anchorage A-8. The Hydrographer recommends adding a note to the chart to the effect: "Numerous wrecks and obstructions exist in and around Anchorage A-8". Charting each obstruction separately may result in a cluttered and unreadable chart. Please see the Chart comparison section of the Descriptive Report for a thorough discussion of Anchorage A-8.

Concur with clarification. SSS indicates wreck. Chart as 6 foot wreck.

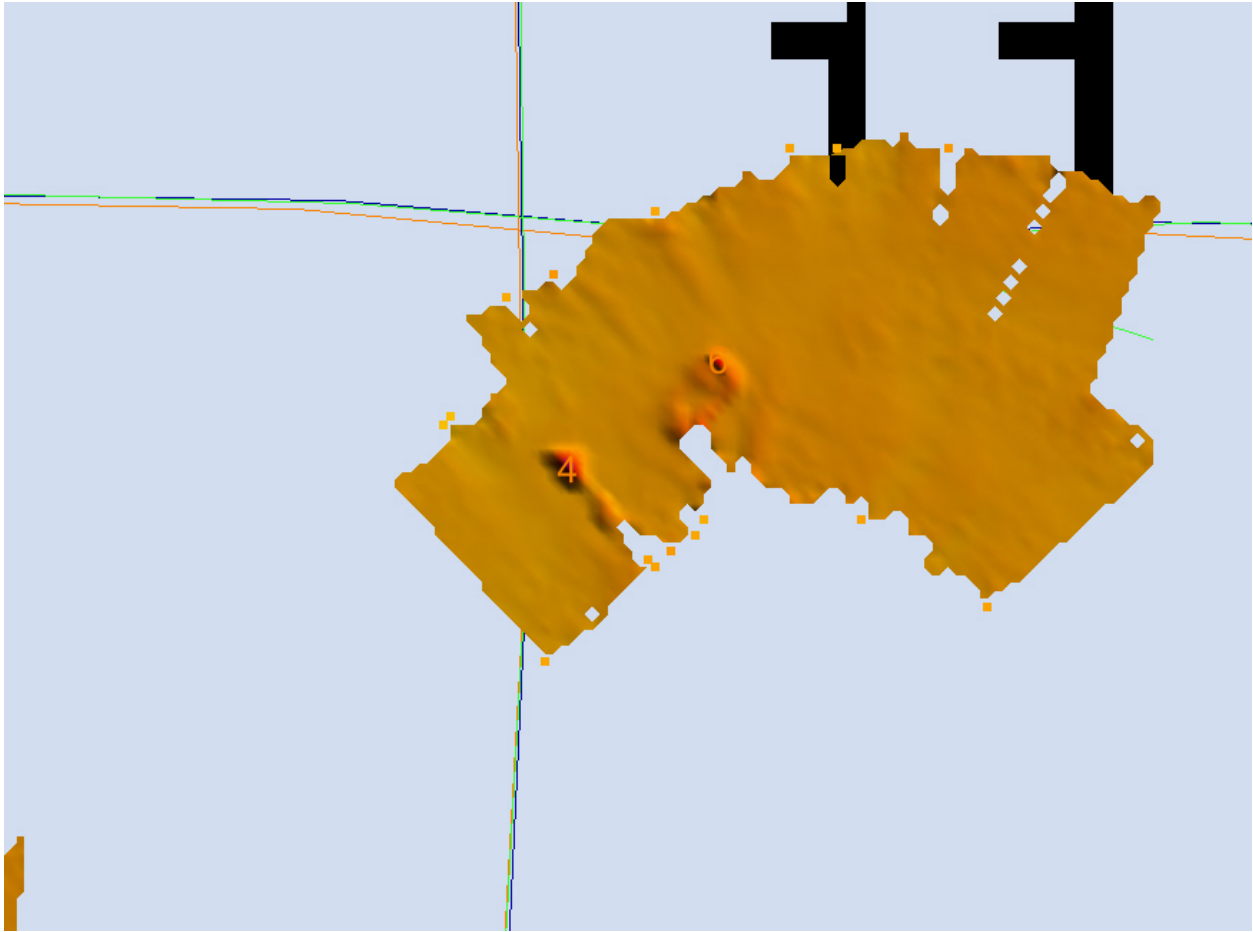
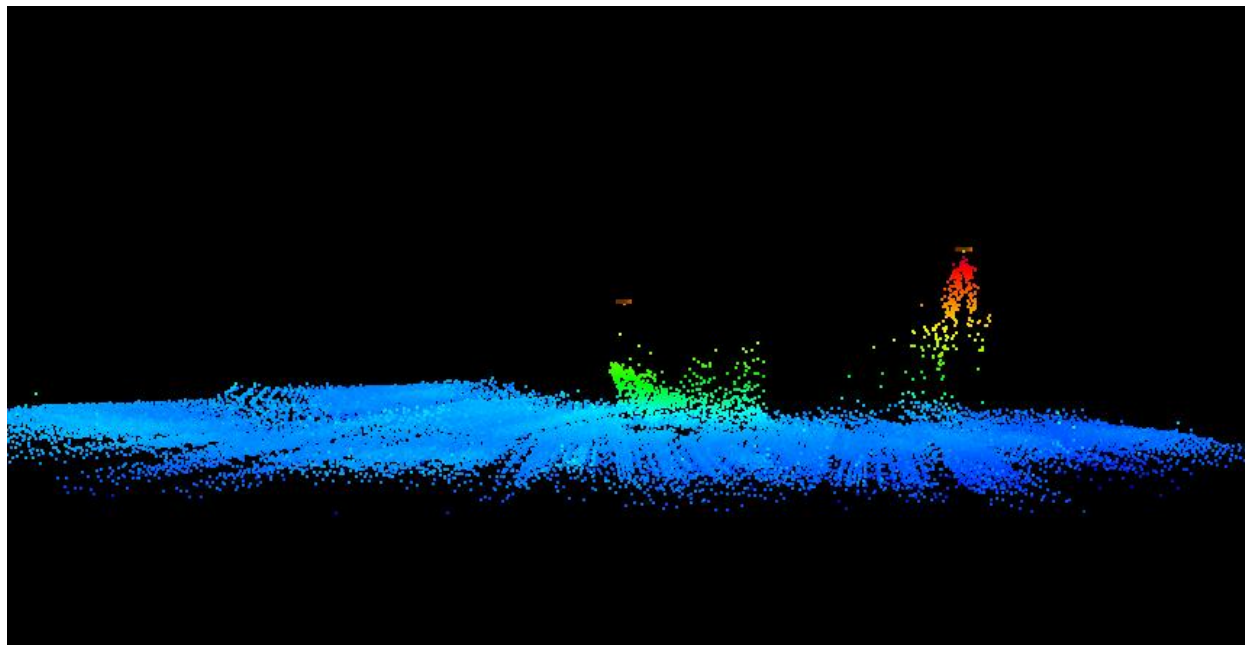
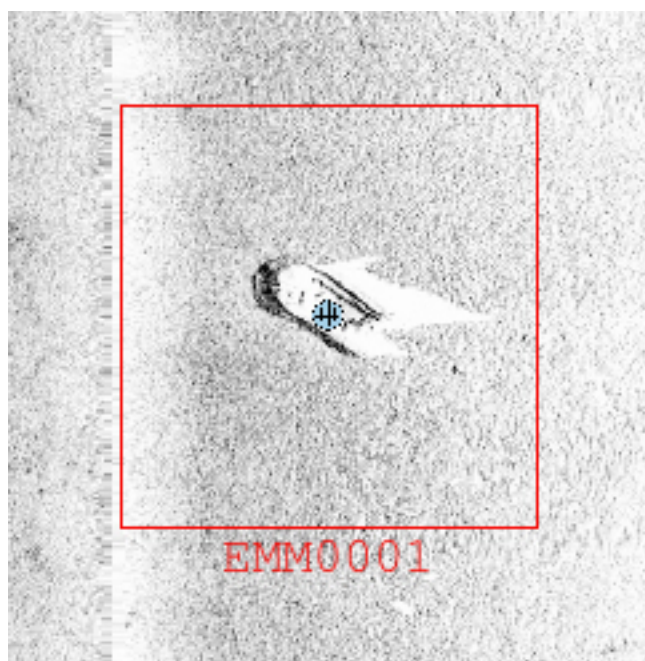
This obstruction is one of many that lie within or near the boundary of Anchorage A-8. The Hydrographer recommends adding a note to the chart to the effect: "Numerous wrecks and obstructions exist in and around Anchorage A-8". Charting each obstruction separately may result in a cluttered and unreadable chart. Please see the Chart comparison section of the Descriptive Report for a thorough discussion of Anchorage A-8.

Do not concur. 4 foot sounding is part of the wreck. Chart 4 foot wreck in this position.
