Form 504	
DEPARTMENT OF COMMERCE	
U. S. COAST AND GEODETIC SURVEY	
....., Director	
State: Maine	
DESCRIPTIVE REPORT	
Topographic Hydrographic	Sheet No. 1245 a+b
LOCALITY	
Mt. Desert Narrows	
Eastern and Western Bays	
Bartlett Narrows	
1874, 1903	
CHIEF OF PARTY	
J.W. Donn, J.B. Boutelle

EXAMINATION

Reported 4-1/2 fathom Spot

(Notice to Mariners No. 296, March, 1903)

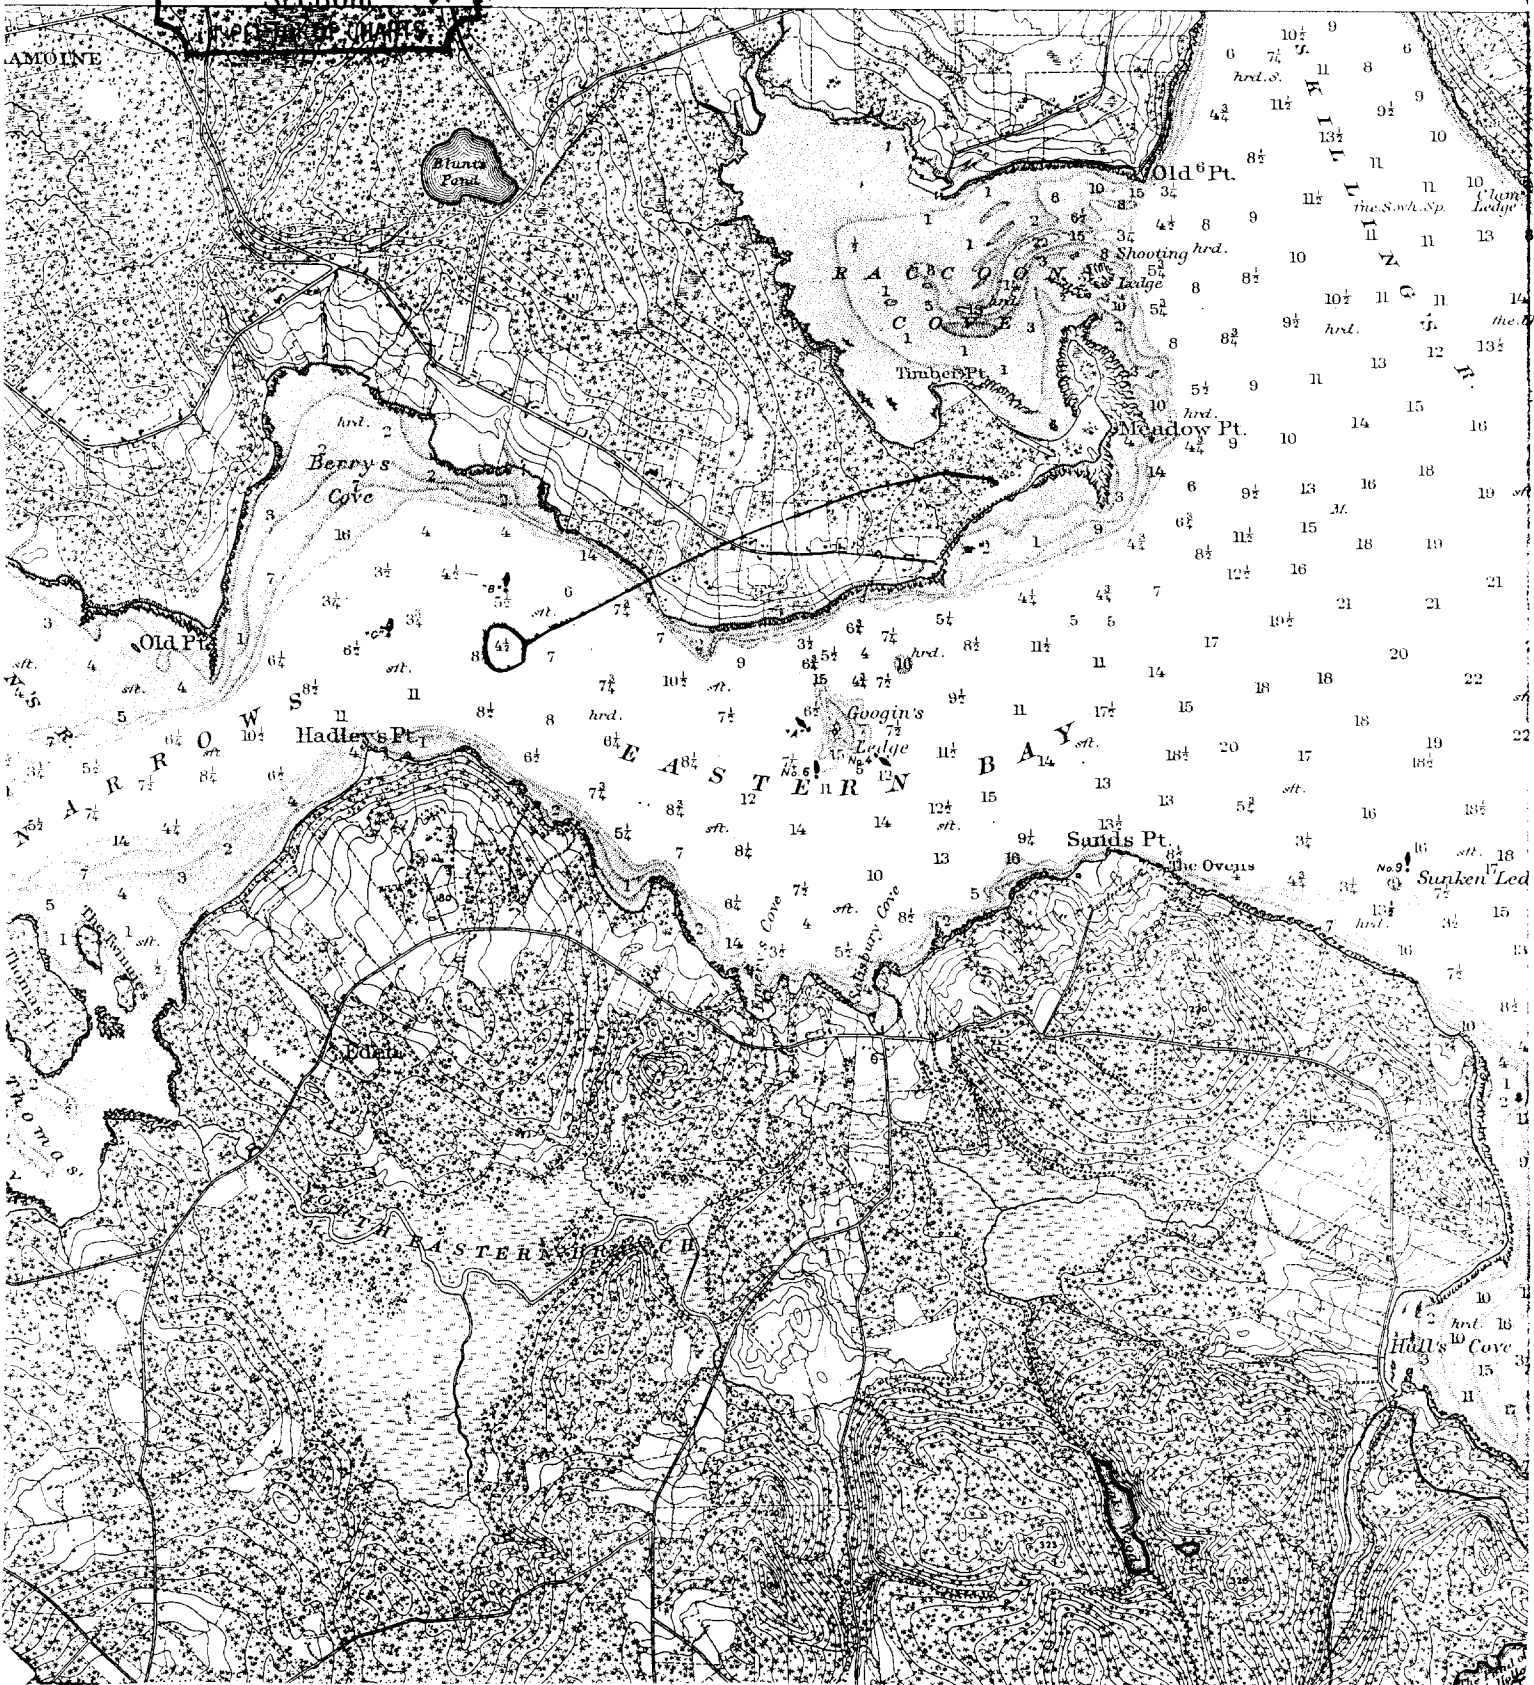
PLATE No. 2551

*28 ft sounding on #12452 was not
charted on 292 until the edition, a
section of which is attached. No
edition was found in file which shows
the 28 ft. sounding. I believe the
omission was discovered, resulting
in the note to mariners. Thus,
only one 4 1/2 fm sounding exists,
an apparently erroneous one on the survey
G.F.H. 4/7/104*
