DESCRIPTIVE REPORT

State *California*  
General locality *San Diego*  
Locality *Bar*

SAN DIEGO BAY BAR - CAL.

Descriptive Report to accompany Hydro-  
graphic Sheet San Diego Bar, 1902.

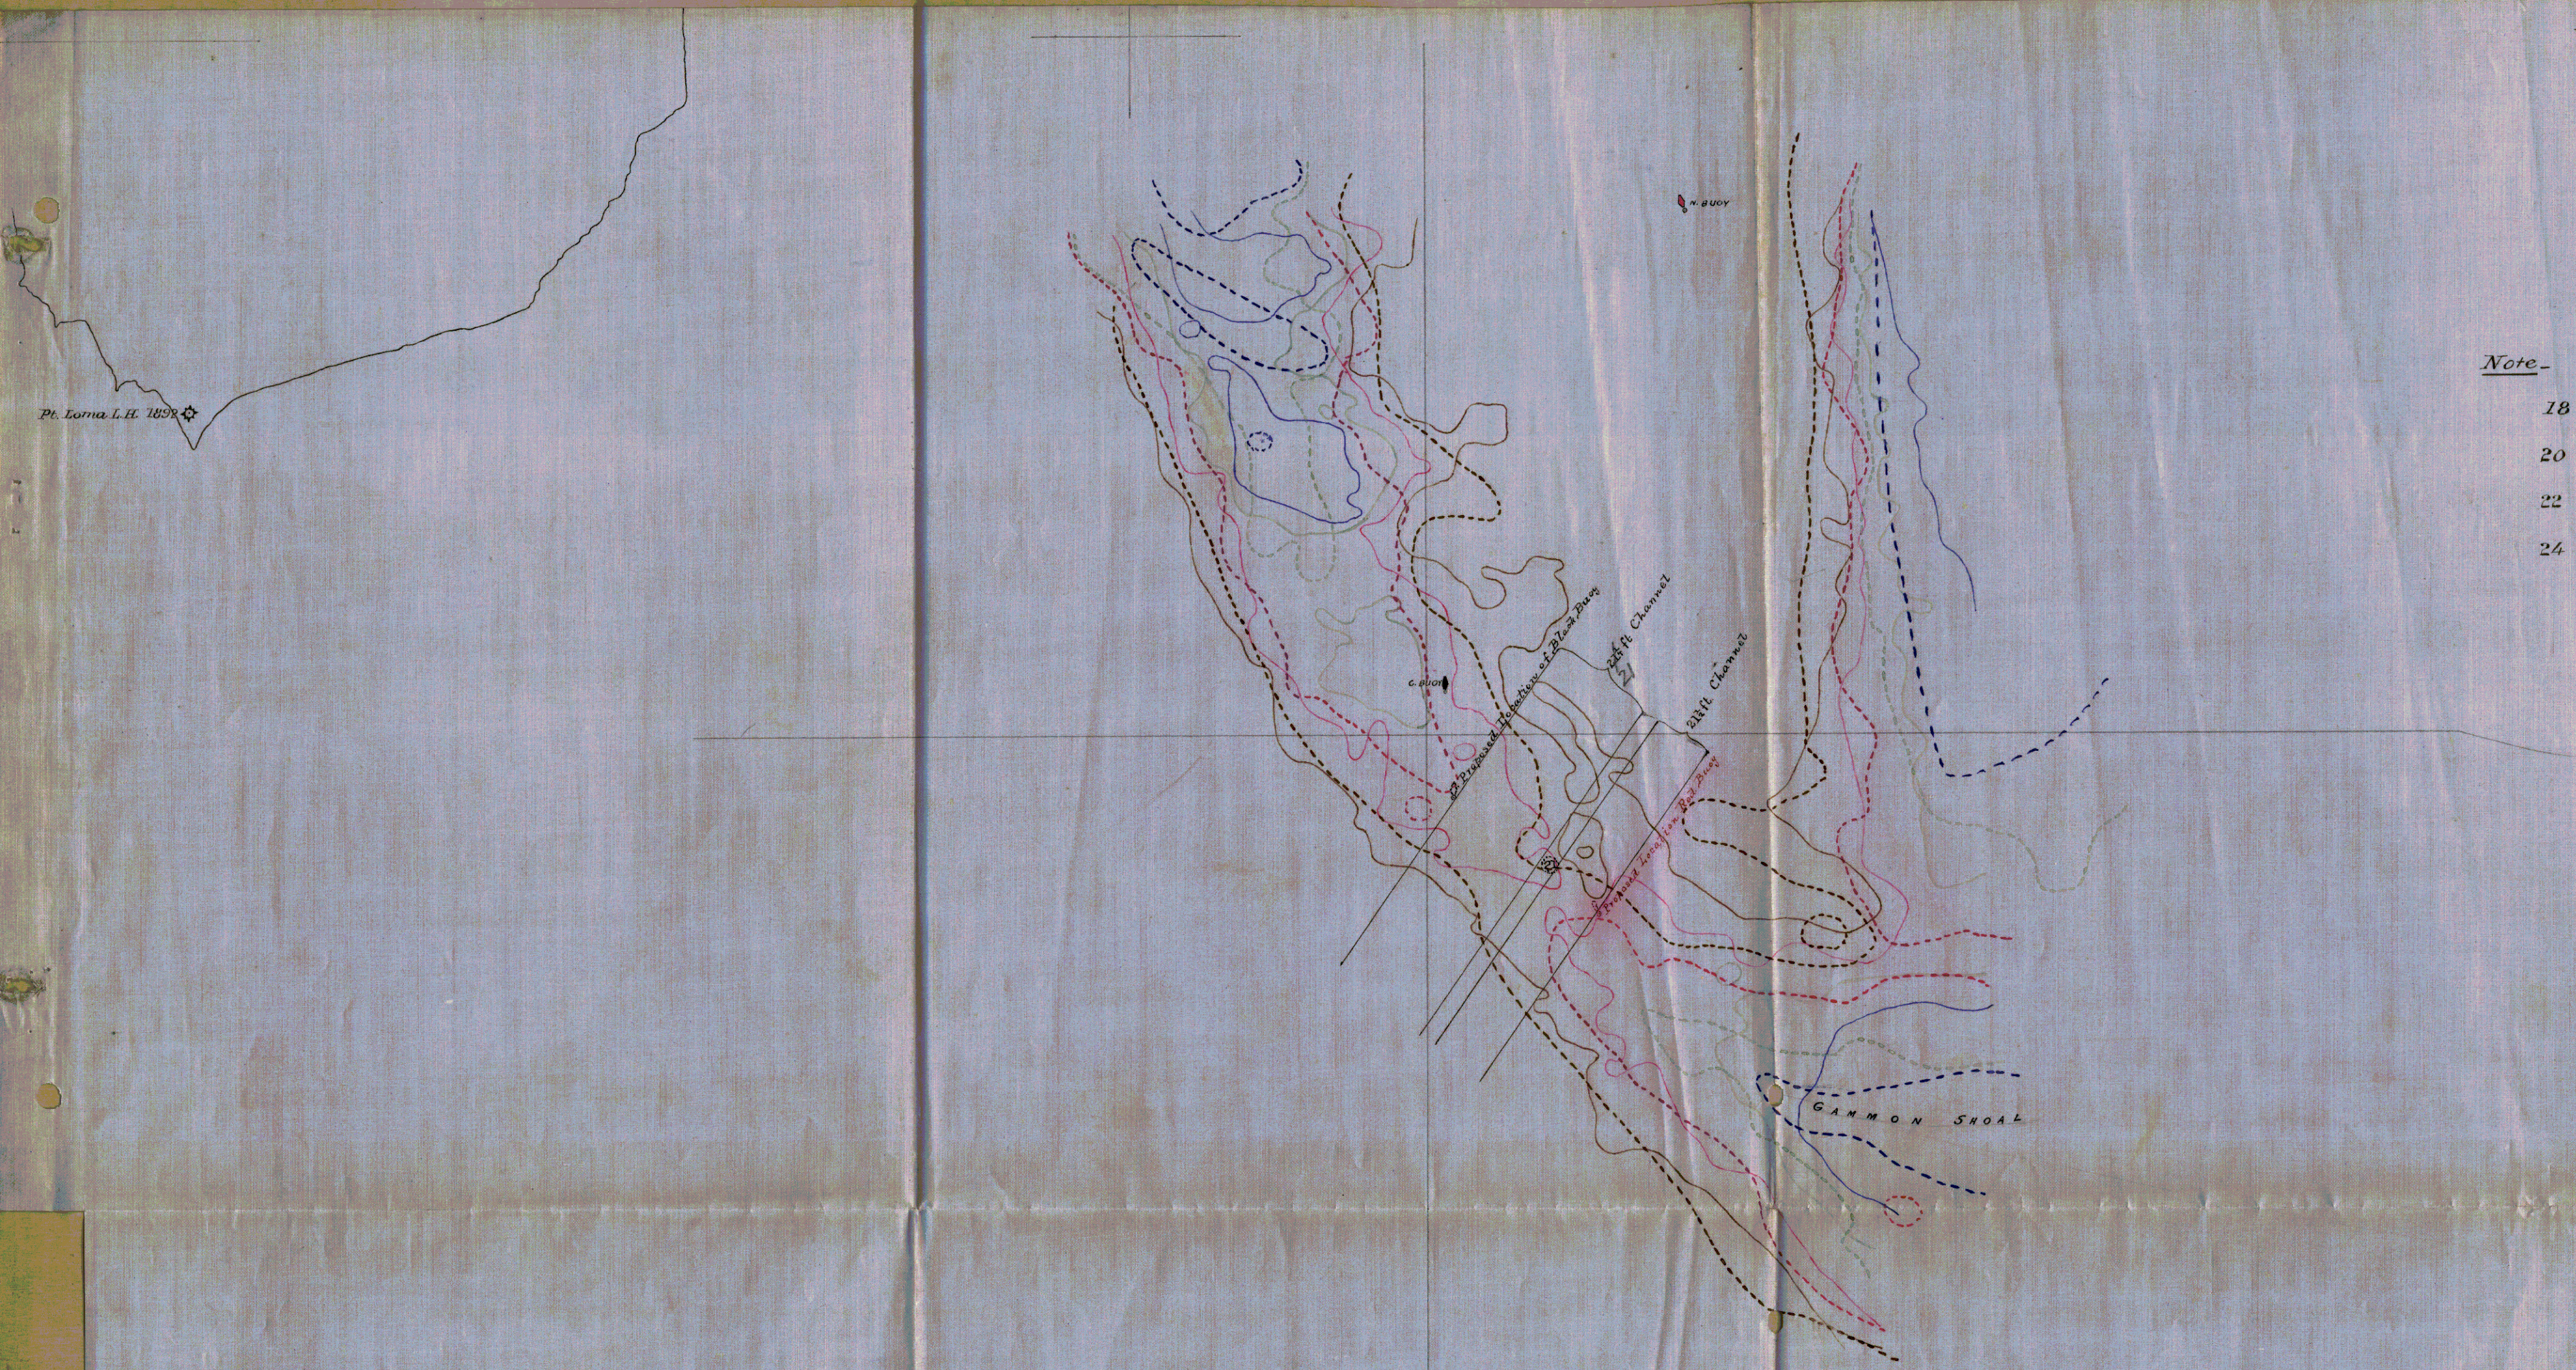
In order to make a comparison of the general outline of the outer bar in 1898-9 and 1902, a tracing was made of the 18, 20, 22 and 24 ft. curves as shown in each survey; those for 1902 in full lines and for 1898-9 in dashed lines.

The 24-ft. curve along the outer edge of the bar is practically the same in both surveys. On the inner slope of the bar, however, there is a decided difference - the width of the bar between the two 24-ft. curves, outer and inner, being very decidedly greater at the present time. At the point where in 1898-9 the bar was narrowest between these curves, it is now more than three times as wide. On the East side of the main channel inside the bar the 24-ft. curve is now farther to the Eastward than it was in 1898-9. In other words the East bank of this channel seems to be eroding, and the material depositing on the inner slope of the bar, increasing its width.

Taking next the 22-ft. curve we find similarly that along the greater part of the outer slope of the bar it is practically the same in both surveys, except that on the West side of the bar channel the point of the <sup>new</sup> curve, extends about 125 meters farther S.E. and almost meets the same curve on the East side of the channel.

The same position of the East bank of the channel inside the bar shown by the 24-ft curve, and the depositing of material on the inner edge of the bar is apparent from the position of the 22-ft curve. In like manner the 20-ft. and 18-ft curves show the same tendency.

This shoal as indicated by the 18-ft. curve has increased in size North and South, while the West point of it has been slightly eroded. The depth of water on it is now less than in 1898-9, 15 feet being the least depth obtained as against 16 feet in the

The least depth found in the channel over the bar was 21 ft. in one spot at the S.E. extremity of the loop of the 22 ft. curve. To the South and East of this spot there is a channel over the bar about 65 metres wide in which the least depth found was  $21\frac{1}{2}$  feet. To the North and West of the same spot there is a channel about 115 metres wide in which the least depth found was  $21\frac{1}{4}$  feet. These two channels are indicated on the accompanying tracing showing the curves of the two surveys. In a very narrow passage between the two loops of the 22 ft. curve  $22\frac{1}{2}$  ft. can be carried over the bar; but it would be practically impossible to keep a ship in so narrow a passage.

6  
shows a like depth. So far as the depth of water on the bar is concerned the jetty thus far appears to have been without effect.

The present black buoy on the bar seems to be situated too far north, and should, in my opinion, be moved south about 100 metres. To define the Eastern edge of the bar channel and the point of Gannan Shoal a red buoy might be placed at the spot indicated on the tracing. Then in entering if the black buoy is kept close aboard nothing less than  $2\frac{1}{4}$  ft will be crossed; or by hugging the red buoy the  $2\frac{1}{2}$  ft spot will be avoided and nothing less than  $2\frac{1}{2}$  ft. crossed.
