DESCRIPTIVE REPORT.

Hyd Sheet No. *3932-3932a*

Inshore Hydrography, Cape Mazon to Port Bazan.

DALL ISLAND, ALASKA.

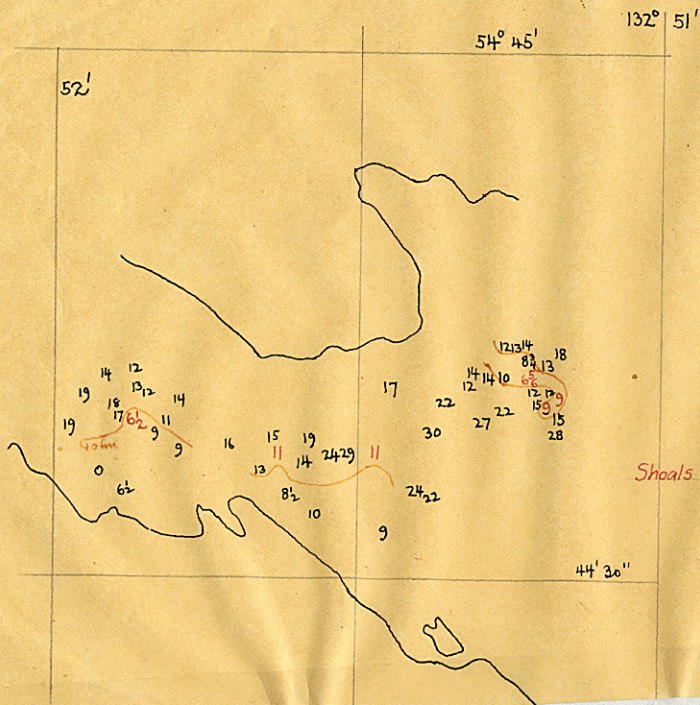
Hyd. Sheet 3932 ~~1~~

9 ft sdg. should be developed

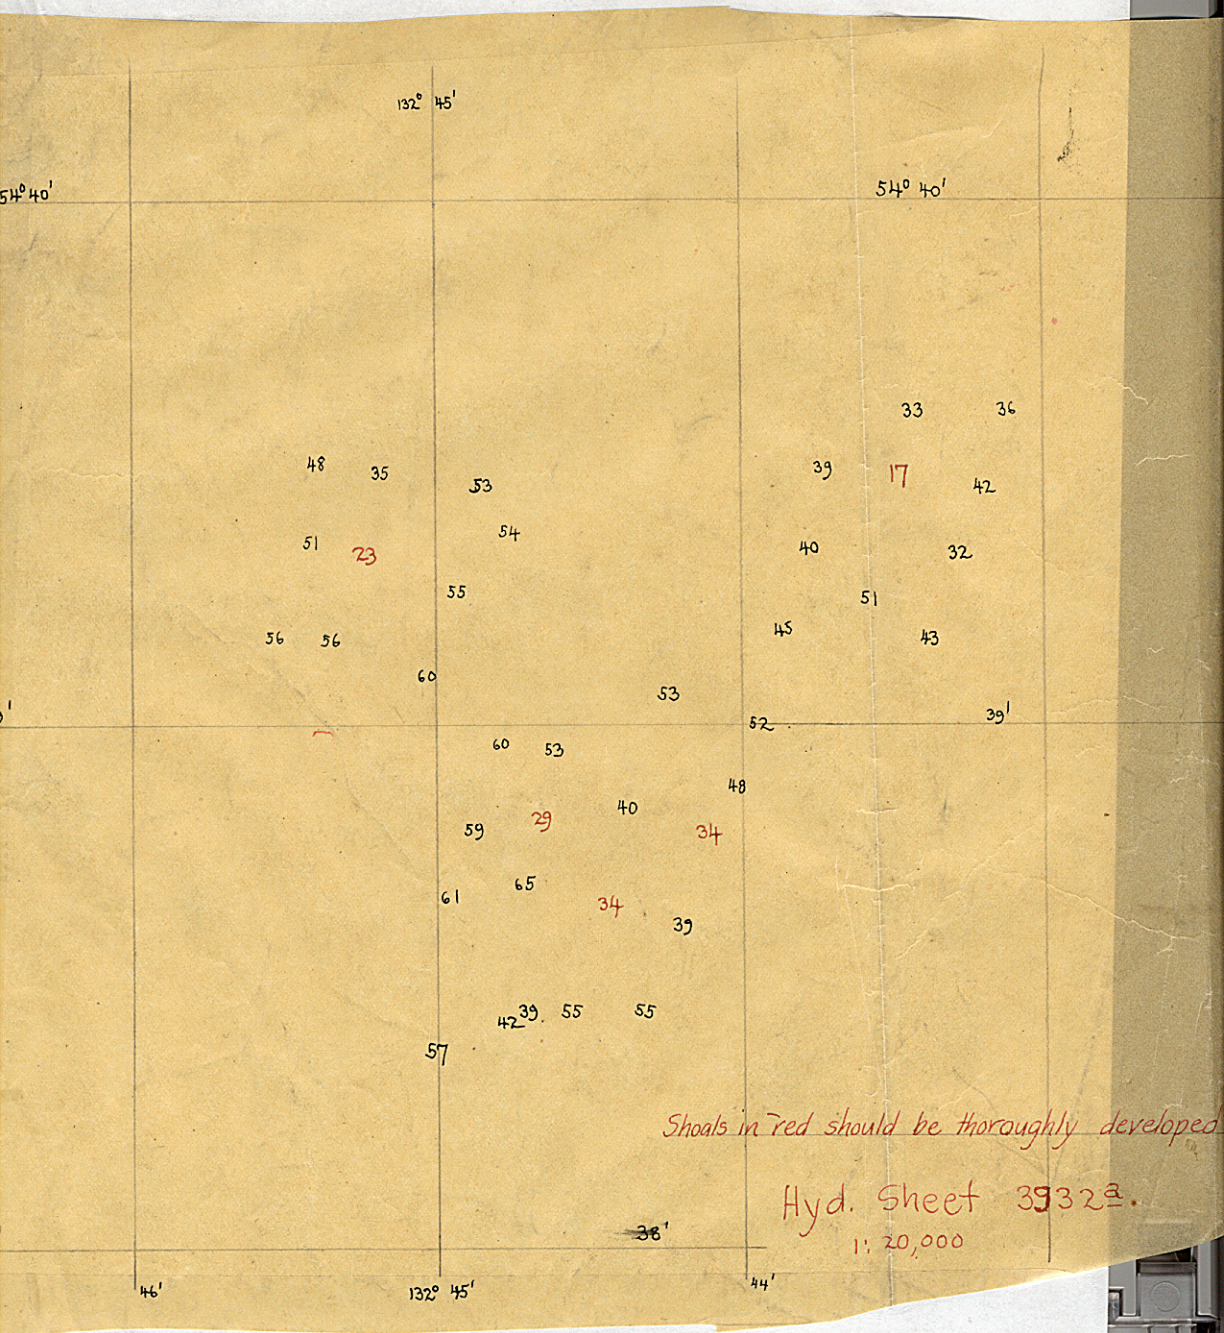
Security Cove
1:10,000
Hyd. Sheet 3932 ~~2~~

In addition, there are several shoals in Security Cove shown on Hyd. Sheet 3922, which was surveyed in 1916, which are in need of further development. The draftsman who verified and inked the sheet last year neglected to call attention to them, but they are of great importance because they lie in the path of vessels using this cove as a harbor. These shoals may be indications of serious menaces to navigation and a close and thorough development is necessary.

These shoals are shown in red on the accompanying tracings and it is recommended that soundings be made of these areas and sent to the Party working in this vicinity for development.

Shoals in red should be thoroughly developed
