DESCRIPTIVE REPORT

5314

Nantucket Sound

Entrance to Edgartown Harbor

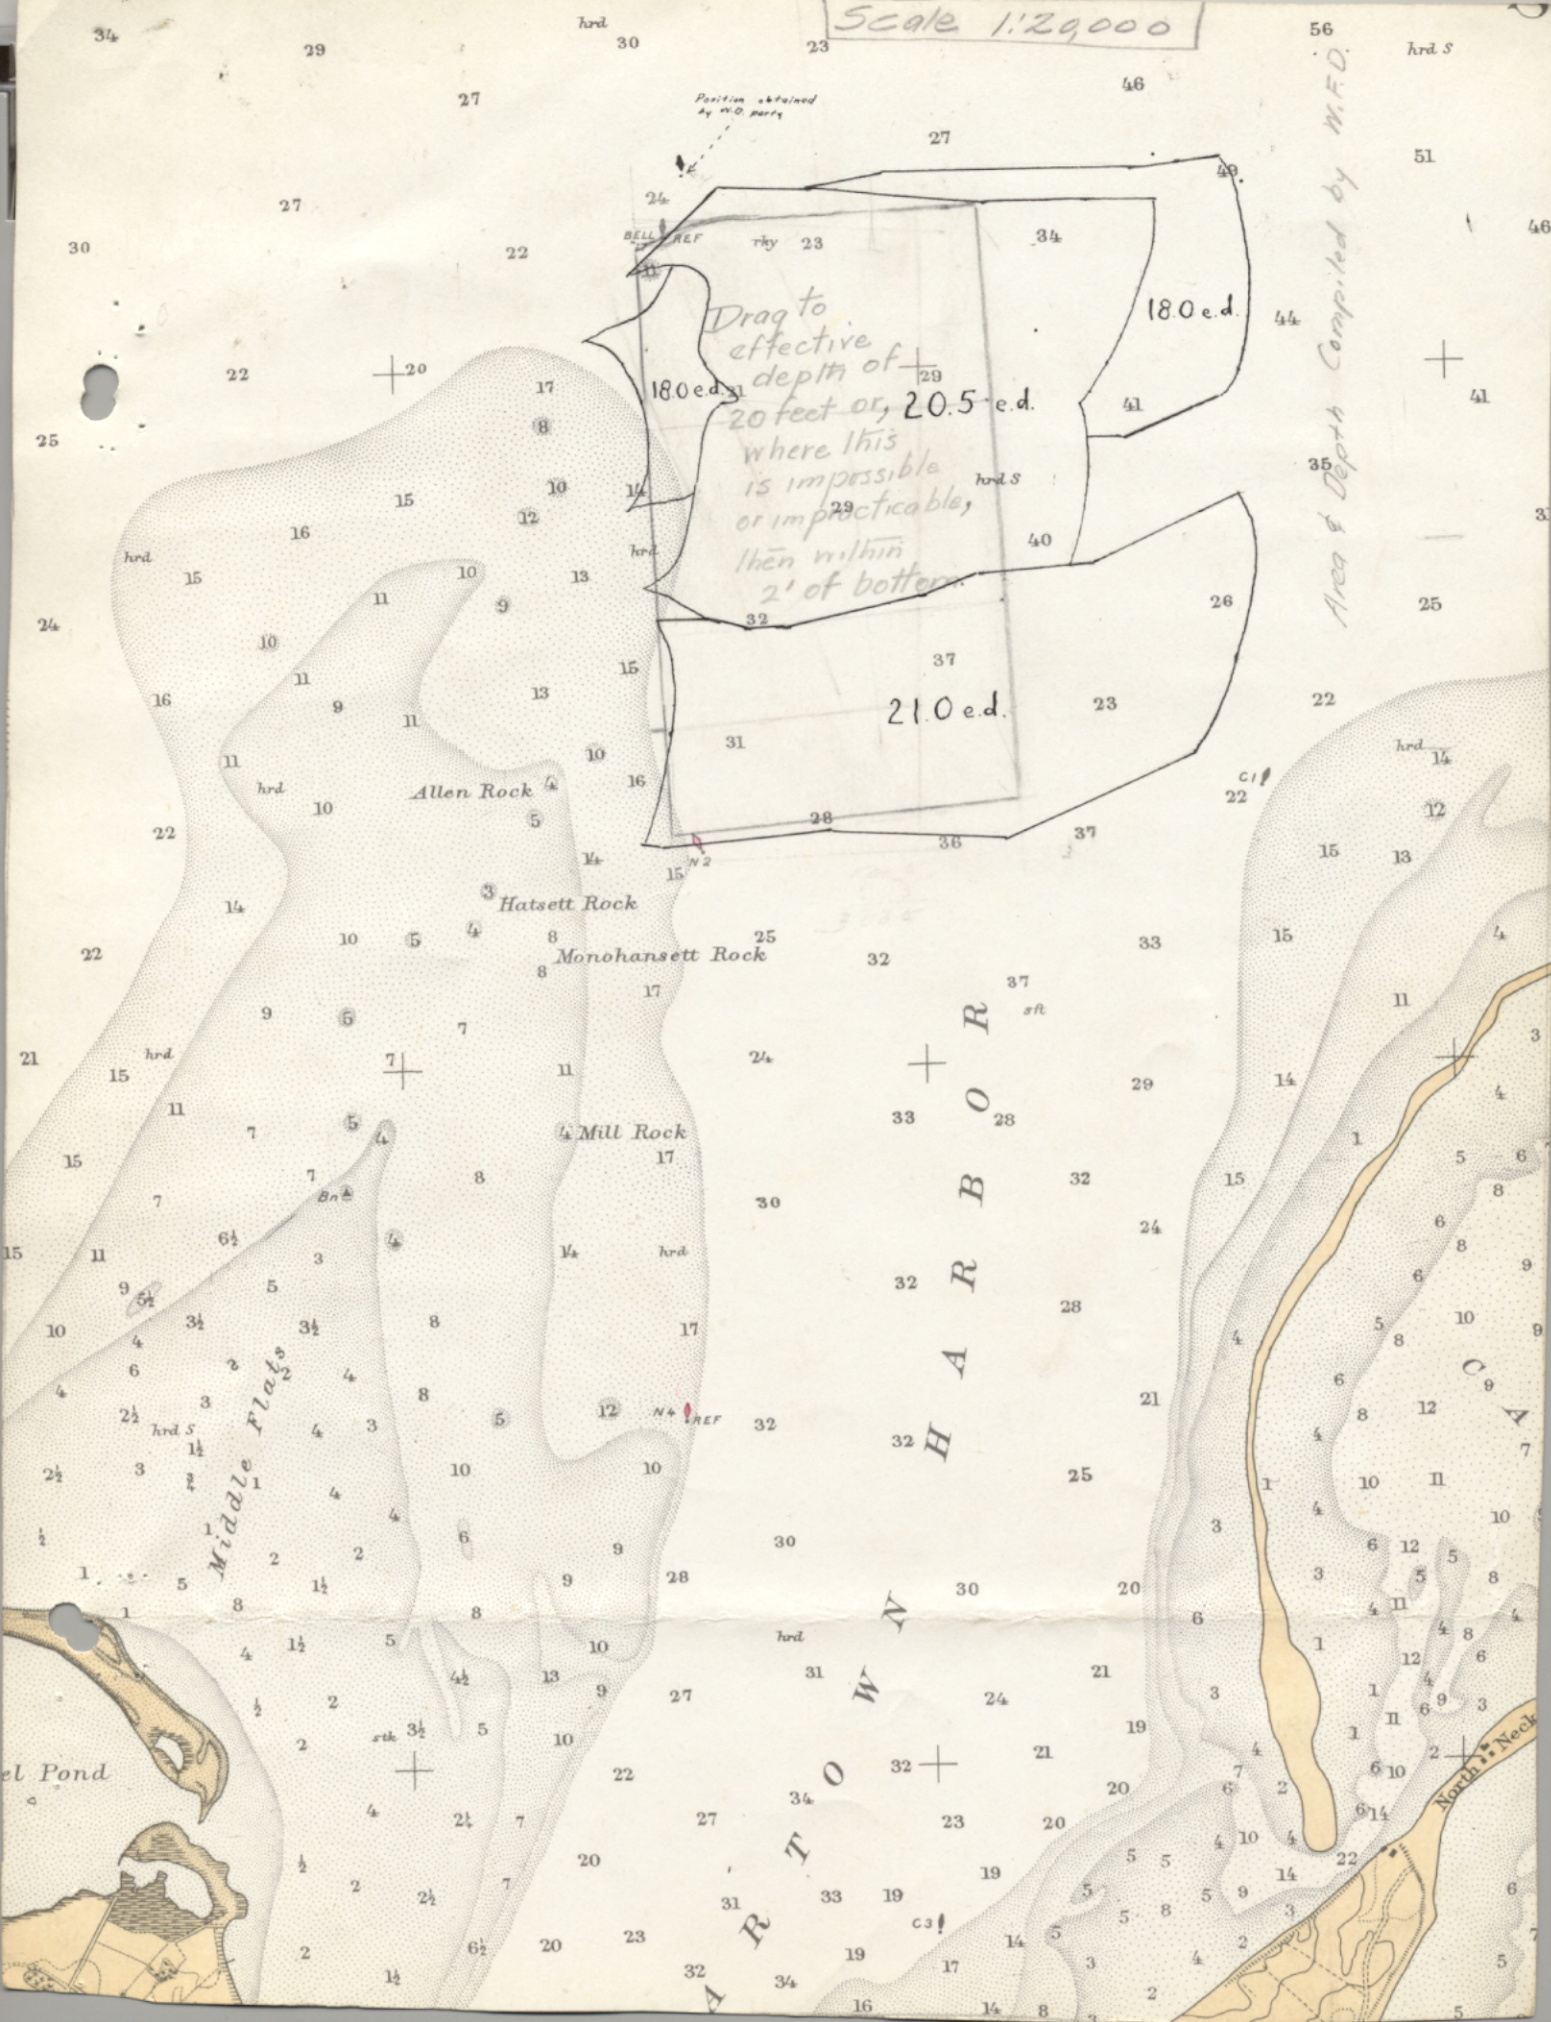
The position obtained by the party of reflector bell buoy "17" plots 184 meters N 17° E True from the charted position. This latter discrepancy could account for the NOURMAHAL hitting the charted 11 feet sounding while attempting to pass the buoy to port enough to clear the spot.

Position obtained by W.D. party

Drag to effective depth of 20 feet or 20.5 e.d. where this is impossible or impracticable, then within 2' of bottom.

180 e.d.

21.0 e.d.
