DESCRIPTIVE REPORT

Field No. 13 Office No. H-5462

General locality Galveston Bay

DESCRIPTIVE REPORT TO ACCOMPANY
HYDRO. SHEET #13
GALVESTON TO TEXAS CITY.

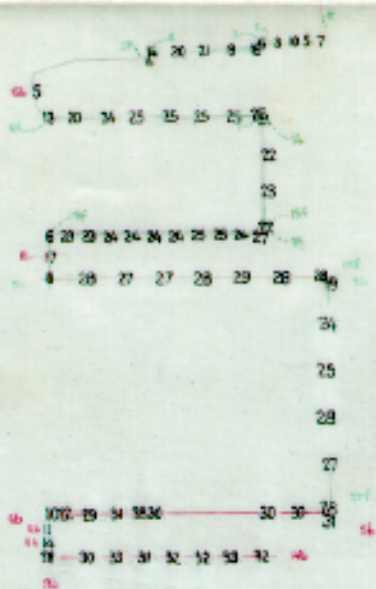
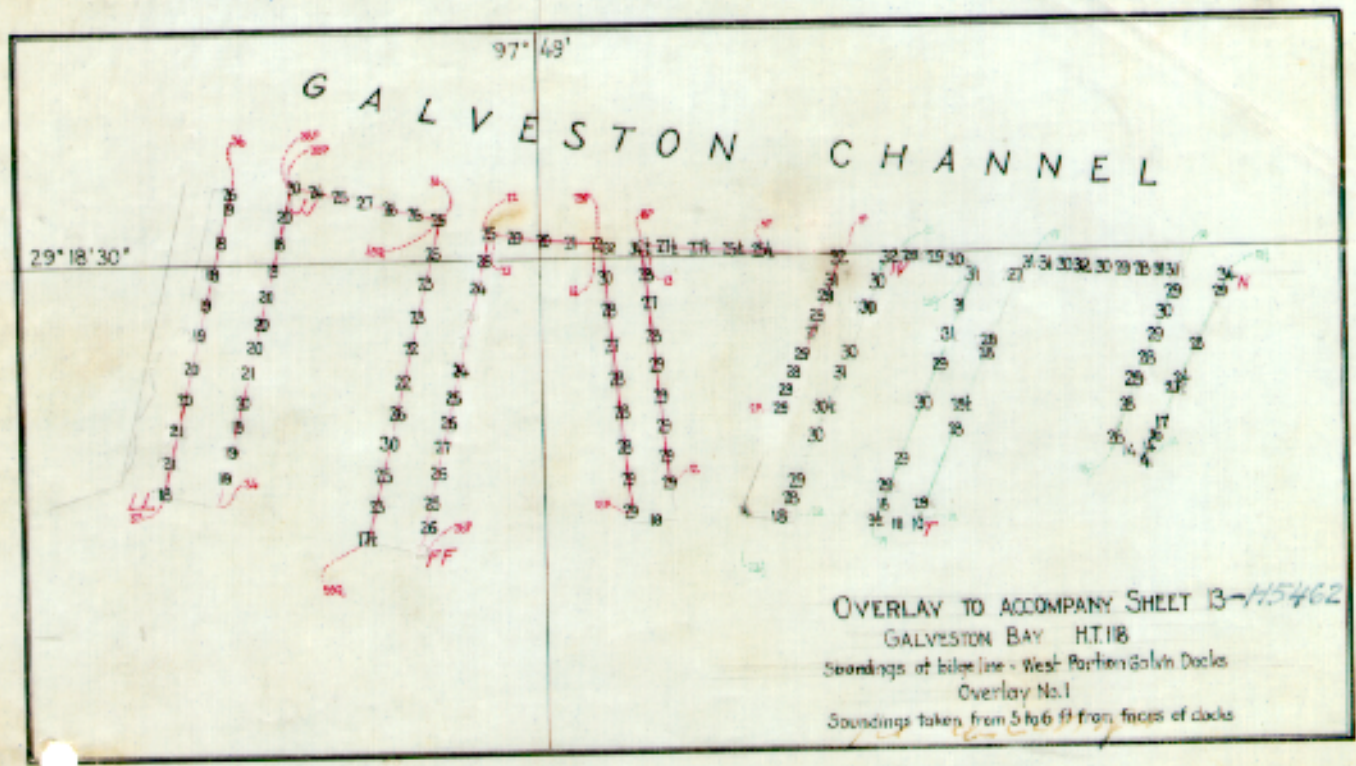
OVERLAY TO ACCOMPANY SHEET 13 - H-5462

2. All soundings along docks on the smooth sheet are at a distance of twenty feet from the faces of the docks. Additional soundings varying from three to six feet from the faces of the docks may be found on tracings filed with this descriptive report. This inner line of soundings at the Texas City docks averages about four or five feet shoaler than the line shown on the smooth sheet. In the Galveston
