DESCRIPTIVE REPORT

Type of Survey Hydrographic

General locality Galveston Bay

Locality Morgan Pt. to Red Fish Bar

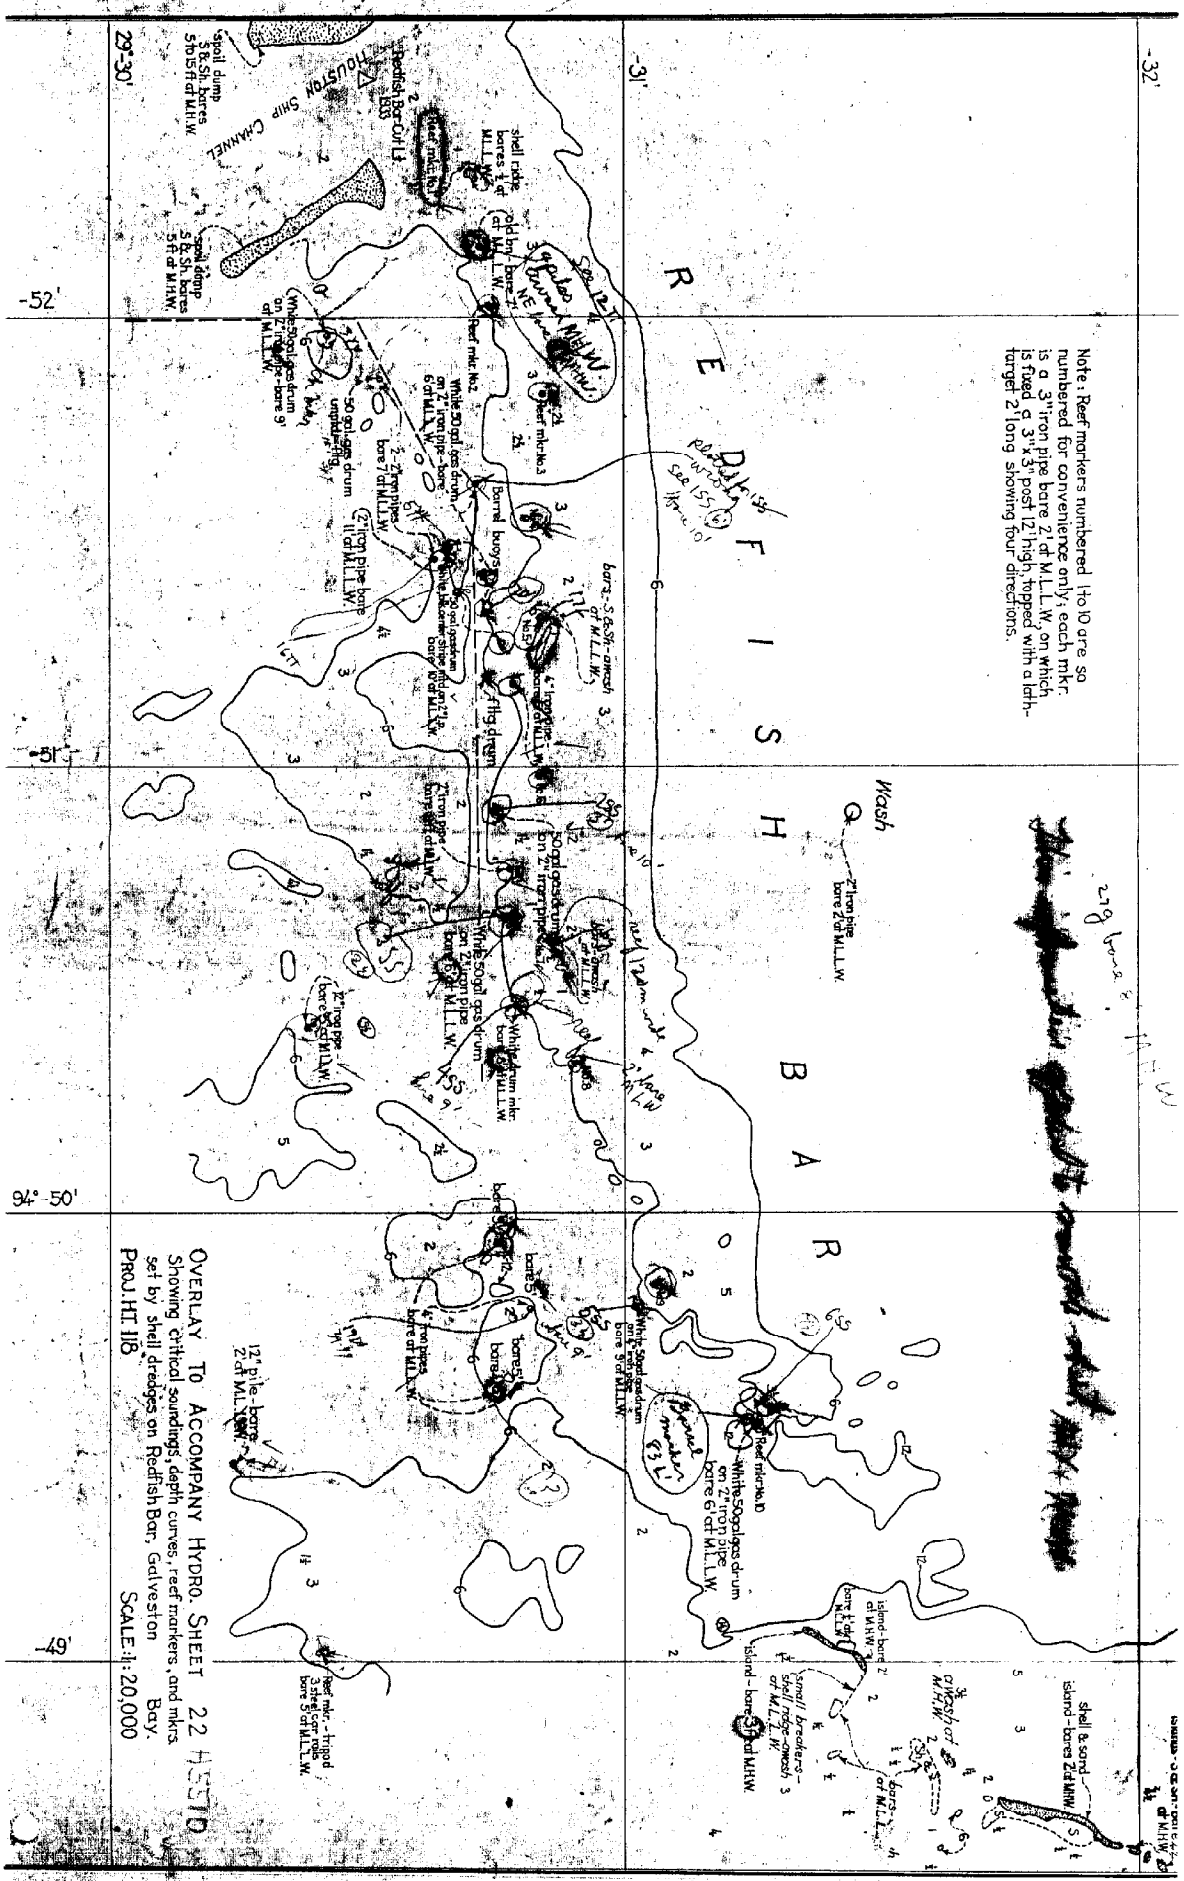
OVERLAY TO ACCOMPANY HYDRO. SHEET 22 45510
Showing critical soundings, depth curves, reef markers, and mkr.
set by shell dredges on Redfish Bar, Galveston Bay,
PROJ. H. 118 SCALE: 1:20,000

Note: Reef markers numbered 1 to 10 are so numbered for convenience only; each mkr. is a 3" iron pipe bare 2' of M.L.L.W. on which is fixed a 3" x 3" post 12" high, topped with a 1-ft-4" target 2' long showing four directions.

REEF MARKERS
See 155
See 156
