DESCRIPTIVE REPORT

Long Island Sound

Project. H.I.T. -150

HYDROGRAPHIC SHEET #1 - 1:10,000 (SAUGATUCK RIVER TO BLACK ROCK HARBOR)

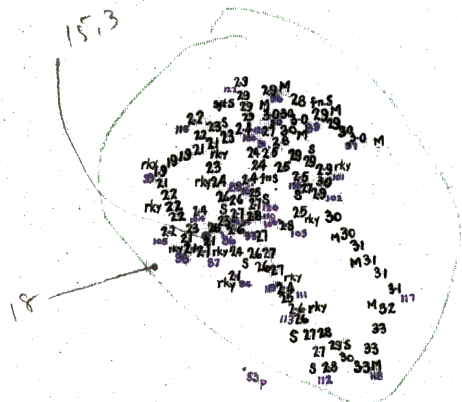
OVERLAY No 2
 SHEET No. 1
 Vol. No. 3
 'P' DAY

POSITIONS 86-122

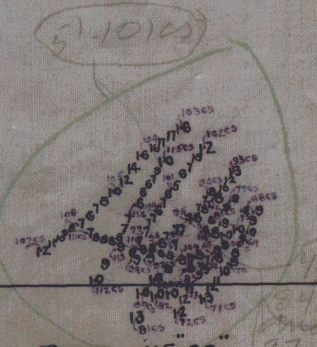
OVERLAY - No. 6
SHEET - No. 1 VOL. No
"CS" DAY

Two 5' depth locations west of George Rock, positions 101 "CS" day overlay #6 and 28 "K" day overlay #2 check with positions shown on chart. *"K" #6*
