DESCRIPTIVE REPORT

ST. JOHNS, RIVER

JACKSONVILLE TO JULINGTON CREEK

SHEET NO. 20 H 6296 (1934-35)

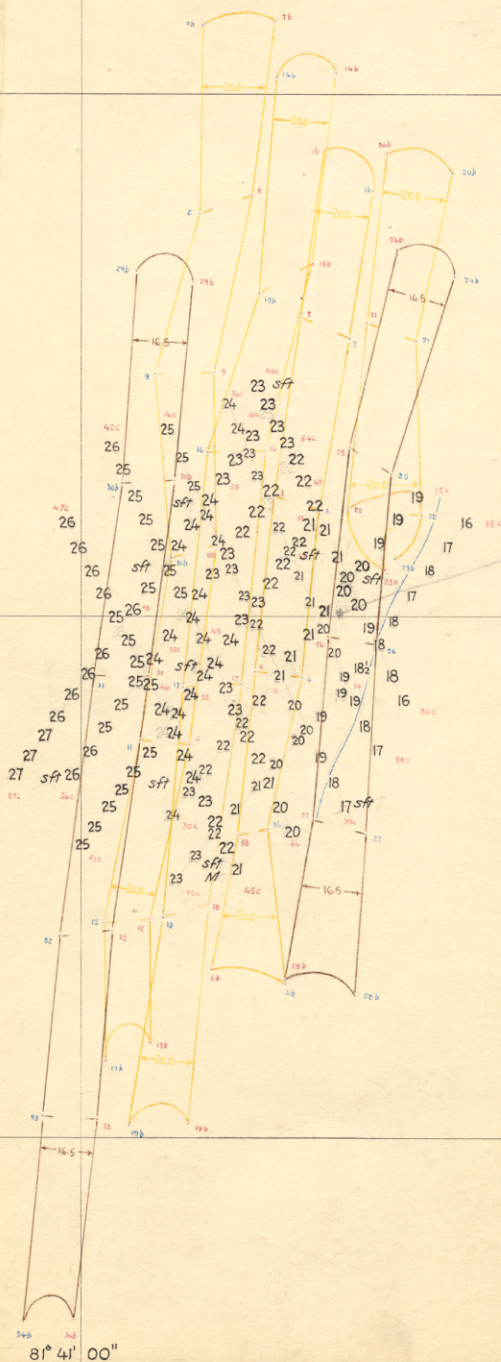
The charted shoal in Lat. 30 09.5, Long. 81 40.9 was dragged with an effective depth of seventeen and twenty feet for three hours and twenty minutes. The drag hung up twice but investigation with hand lead and later redragging indicated the drag was grounded. No evidence of the shoal as charted was found. Area "B"

2 3/4' short from
H-13642 (1876-77)

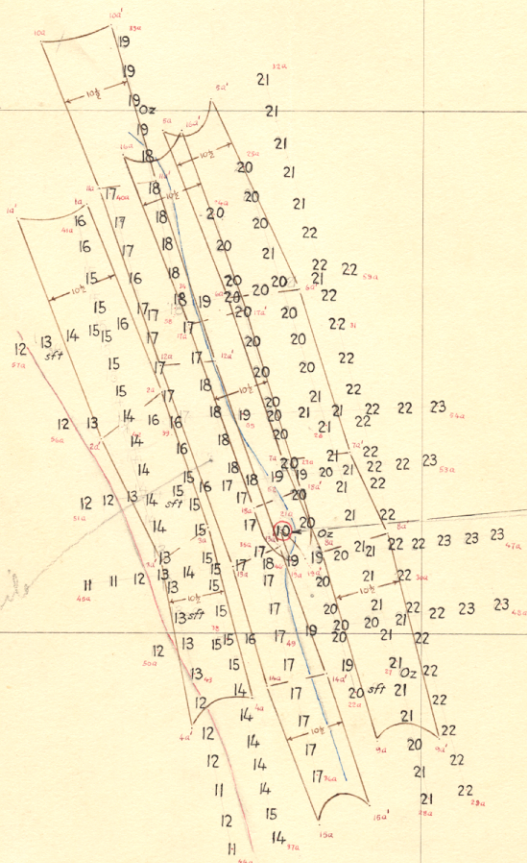
Top of submerged
tree stump

An obstruction was found with the rope drag at fix 21c (about 100 meters southeast of the obstruction found in 1935). This obstruction is apparently a stump about $2\frac{1}{2}$ feet in diameter narrowing to about 8 inches at the top and is standing in an upright position. It is covered by $10\frac{1}{2}$ feet of water at mean low water and is in surrounding depths of $16\frac{1}{2}$ feet.
not plotted
