DESCRIPTIVE REPORT

Sheet No. 1-6350

Southern coast of Cape Cod.

Nantucket Sound

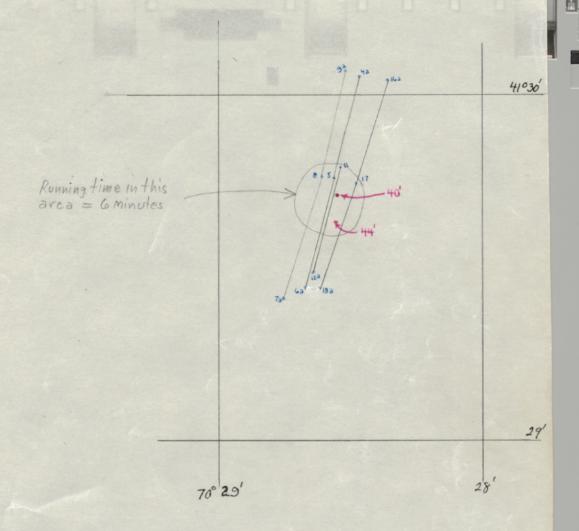
Overlay tracing showing sounding lines in immediate vicinity of 40 and 44 foot depths

The 40 and 44 foot soundings (line 62-64J) in latitude 41°29.7', Rev., for longitude 70°28.5' falling in depths of 62 to 70 feet are possibly erroneous since the original soundings were 7 fathoms plus and may have been mistaken for 11 fathoms. They were not specifically investigated and have been retained.

1. A close system of lines failed to verify the 40 and 44 foot spots at Lat. 41° 29'.7, Long. 70° 28'.55 and Lat. 41° 29'.6, Long. 70° 28'.55, respectively. A 54 foot sounding was obtained 55 meters north of the 40 and a 64 foot sounding 45 meters NW of the 44. It is recommended that the 40 and 44 be deleted and the soundings as shown on the current development substituted.
