DESCRIPTIVE REPORT

Field No. **Gi-1255** ..... Office No. **H-8207**

Locality ..... FALL RIVER HARBOR

DESCRIPTIVE REPORT TO ACCOMPANY  
HYDROGRAPHIC SURVEY

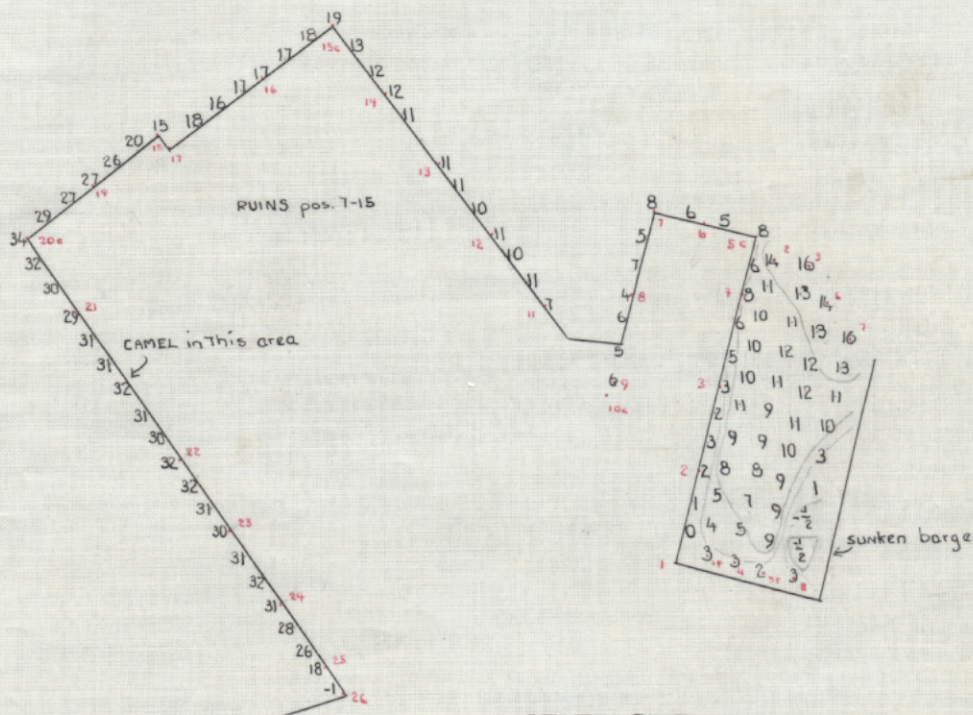
OVERLAY FOR  
G1 25/155

STATE PIER  
# 20

soundings from Vol. 5  
around pier - pgs. 36-37  
in slip - pgs. 50-51

*cht. 353 - no correction*
