DESCRIPTIVE REPORT
(HYDROGRAPHIC)

Type of Survey Hydrographic
Field No. ECFP-1456
Office No. H-8313

Hydrographic Survey H-8313 - Field No. ECFP-1456
Greenwich Bay, Rhode Island

PROJECT: 13870 1956 SCALE 1:10,000

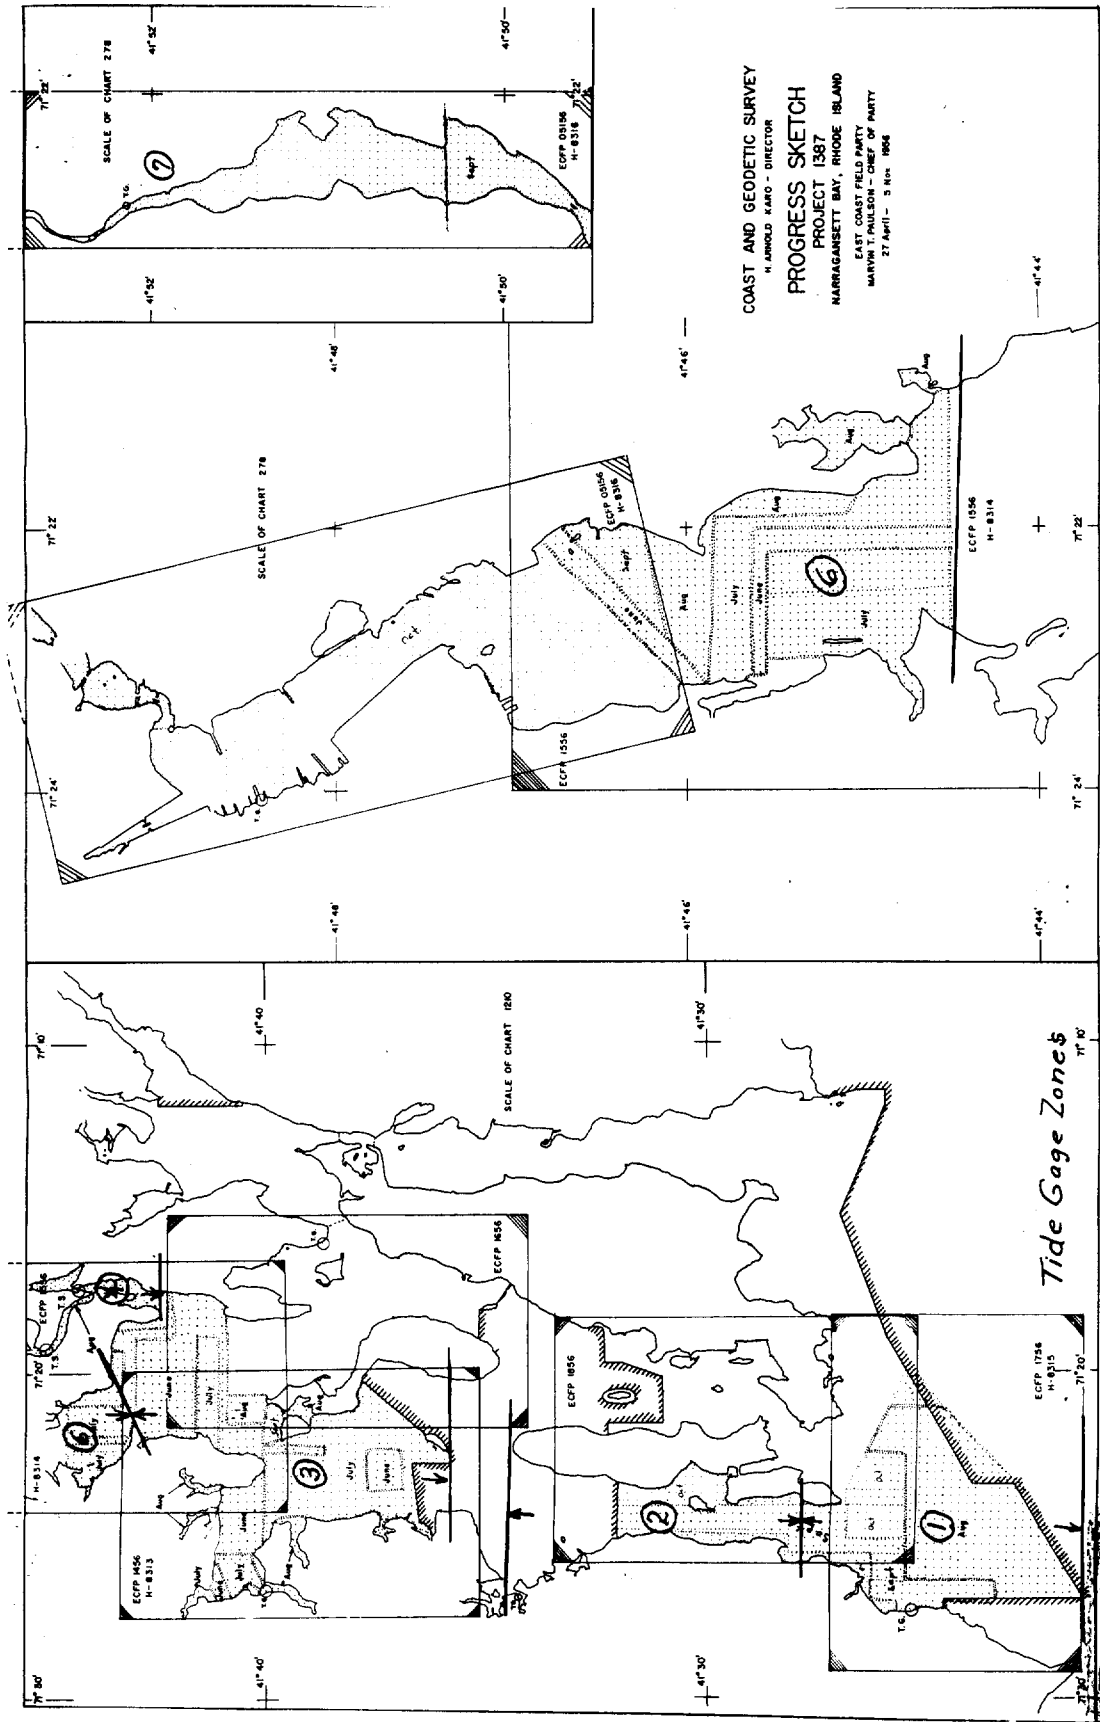
Tide Gage Zones

H-8313 (1956) falls in Tidal zone #3
