DESCRIPTIVE REPORT

Field No. ECFP-2258 Office No. H-8412

HYDROGRAPHIC SURVEY H-8412 FIEID NO. ECFP-2258 St. Johns River, Florida

Subject: Report to Accompany Hydrographic Survey H-8412 (Field No. ECFP 2258)

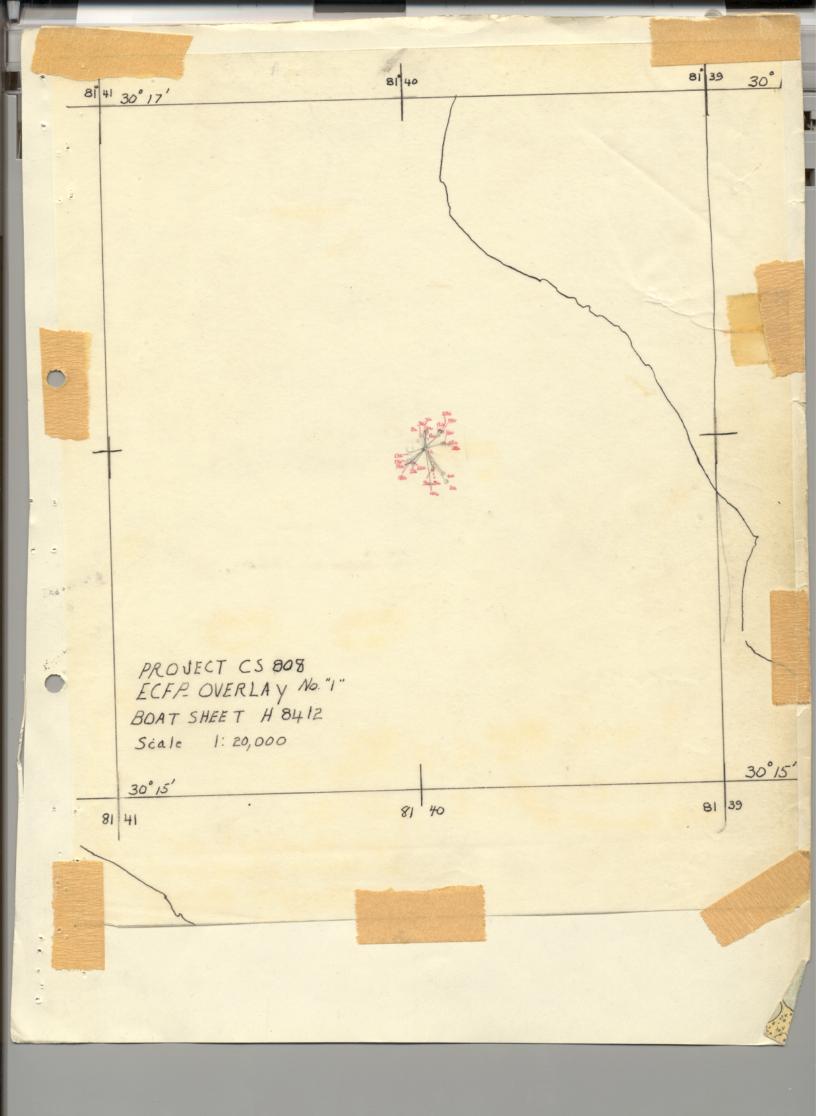
The submerged miling "remains of a former light structure" charted in lat. 30°16'.0", long. 81°39'.5" was not located by using a marlin sweep as described in Special Publication No. 118 and by other means which are described in the sounding records.

It was estimated that the area shown on Overlay Ho. 2 was cleared to a depth of 13.0 feet, and and grass from the bottom within evidence when the drag was brought aboard. The drags were done on Overlays numbered 1 and 2 which will accompany boat sheet H-8412.

41	00"	81° 40'00"	39 00"
	\$	17'00"		
		16'00"	Scharted location of subm. piling	16'00"
	9	Project: 808 ECFP Overlay No. "2" Boat Sheet H 8412 Scale 1: 20,000	ESTIMA	39'00" 3015'00"
0,000			81 40 00"
