DESCRIPTIVE REPORT

Type of Survey Hydrographic

Field No. EX-20-1-63 Office No. H-8808

Locality Diamond Shoals

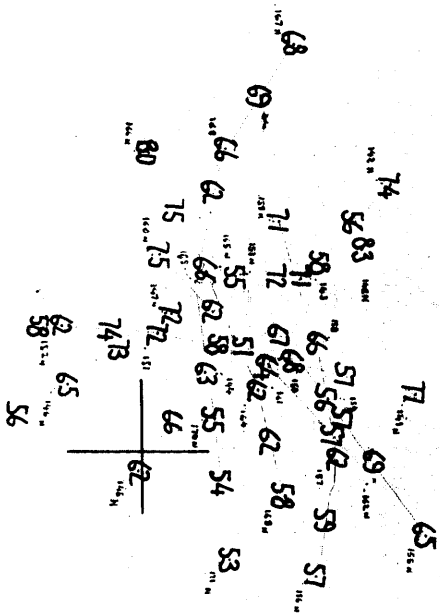
OVERLAY No. 1
 EX 20-1-63 H-8808
 EXPLORER
 "N" DAY
 Pos. 142-171

Development lines 142 through 171N (bl), which fall slightly South of the wreck charted at Lat. 35-09.4' & Long. 75-18.2', are being submitted on a smooth overlay. No trace of the wreck was found.
