## DESCRIPTIVE REPORT

Field No. EX-5-3-65 Office No. H-8862

Locality Ensenada Honda

DESCRIPTIVE REPORT ✓  
To Accompany Hydrographic Survey  
EX 5-3-65, Roosevelt Roads  
1965 Scale 1:5000  
USC&GS Ship EXPLORER  
Marvin T. Paulson, Comdg.

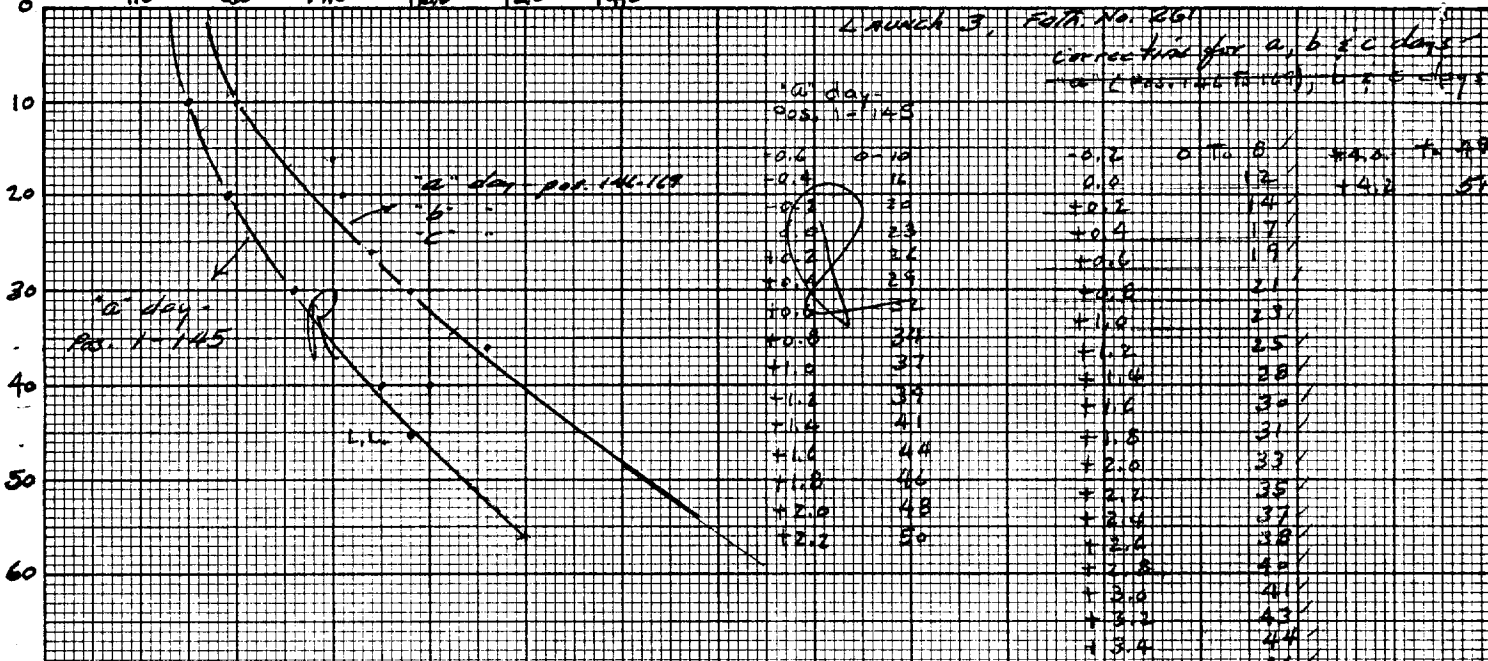
Launch 3, Path No. 261

The first bar check on "a" day, Lch. 3, was rejected. A mean of the remaining bar checks was used for corrections on all of a, b and c days. (See attached abstract)

Correction for a, b & c days

Note: Reject first bar check on 'a' day  
mean other bar checks for all work of launch 3 -  
H.H.P.
