DESCRIPTIVE REPORT

Field No. MI-5-2-70 ..... Office No. H-9120

Locality ..... GUANICA HARBOR

DESCRIPTIVE REPORT  
TO ACCOMPANY  
HYDROGRAPHIC SURVEY SHEET  
MI-5-2-70 (H-9120)  
1970 FIELD SEASON

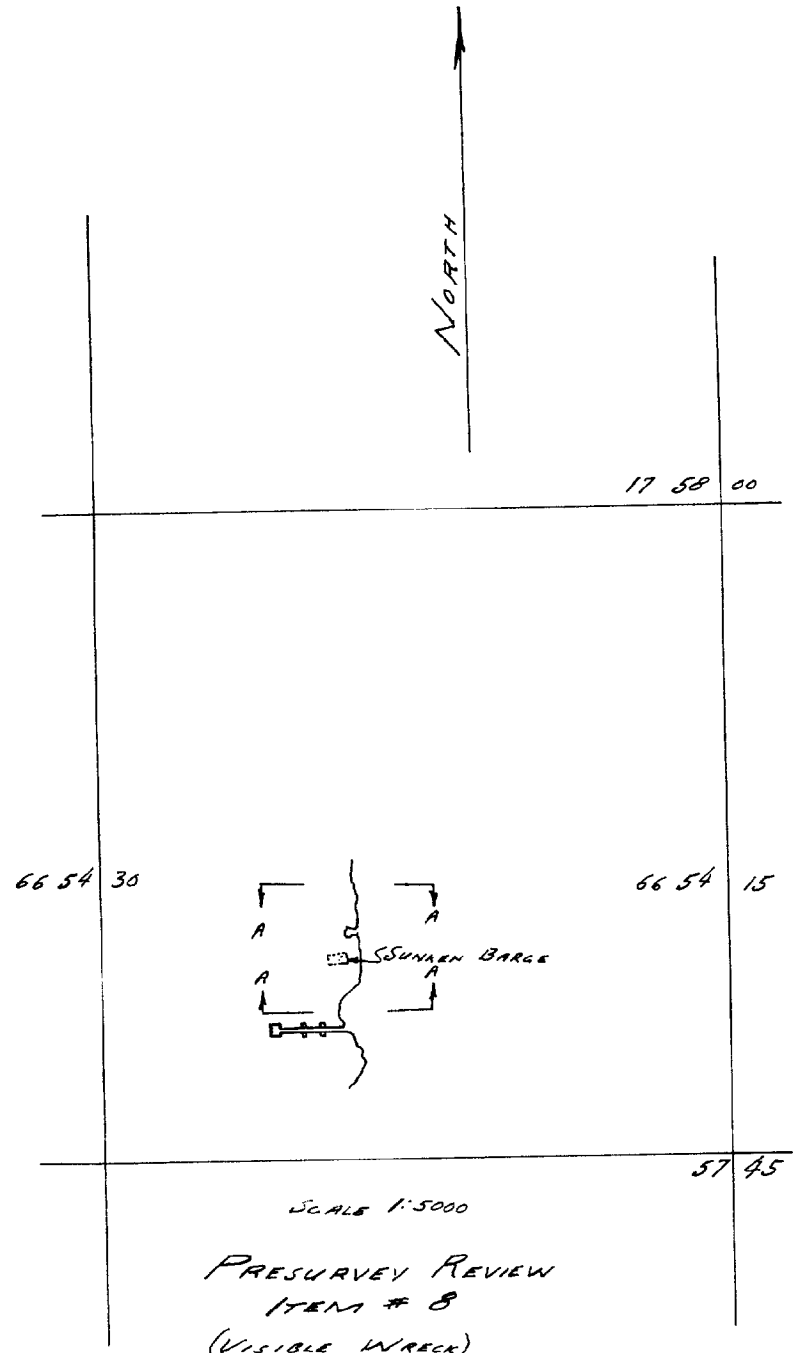
PRESURVEY REVIEW  
ITEM # 8  
(VISIBLE WRECK)

Item 8: The visible wreck charted at latitude  $17^{\circ} 57' 48.4''$ , longitude  $66^{\circ} 54' 24.5''$  is located at  $17^{\circ} 57' 49.5''$  N and  $66^{\circ} 54' 24.5''$  W. The wreck is outlined on the page following this section.
