## DESCRIPTIVE REPORT (HYDROGRAPHIC)

Type of Survey ..... HYDROGRAPHIC  
Field No. .... DA-5-2-74  
Office No. .... H-9411

State ..... WASHINGTON  
General Locality .. PUGET SOUND  
Locality ..... N.E. PORTION OF COMMENCEMENT BAY

OPR-412-DA-74  
 TACOMA HARBOR,  
 WASHINGTON

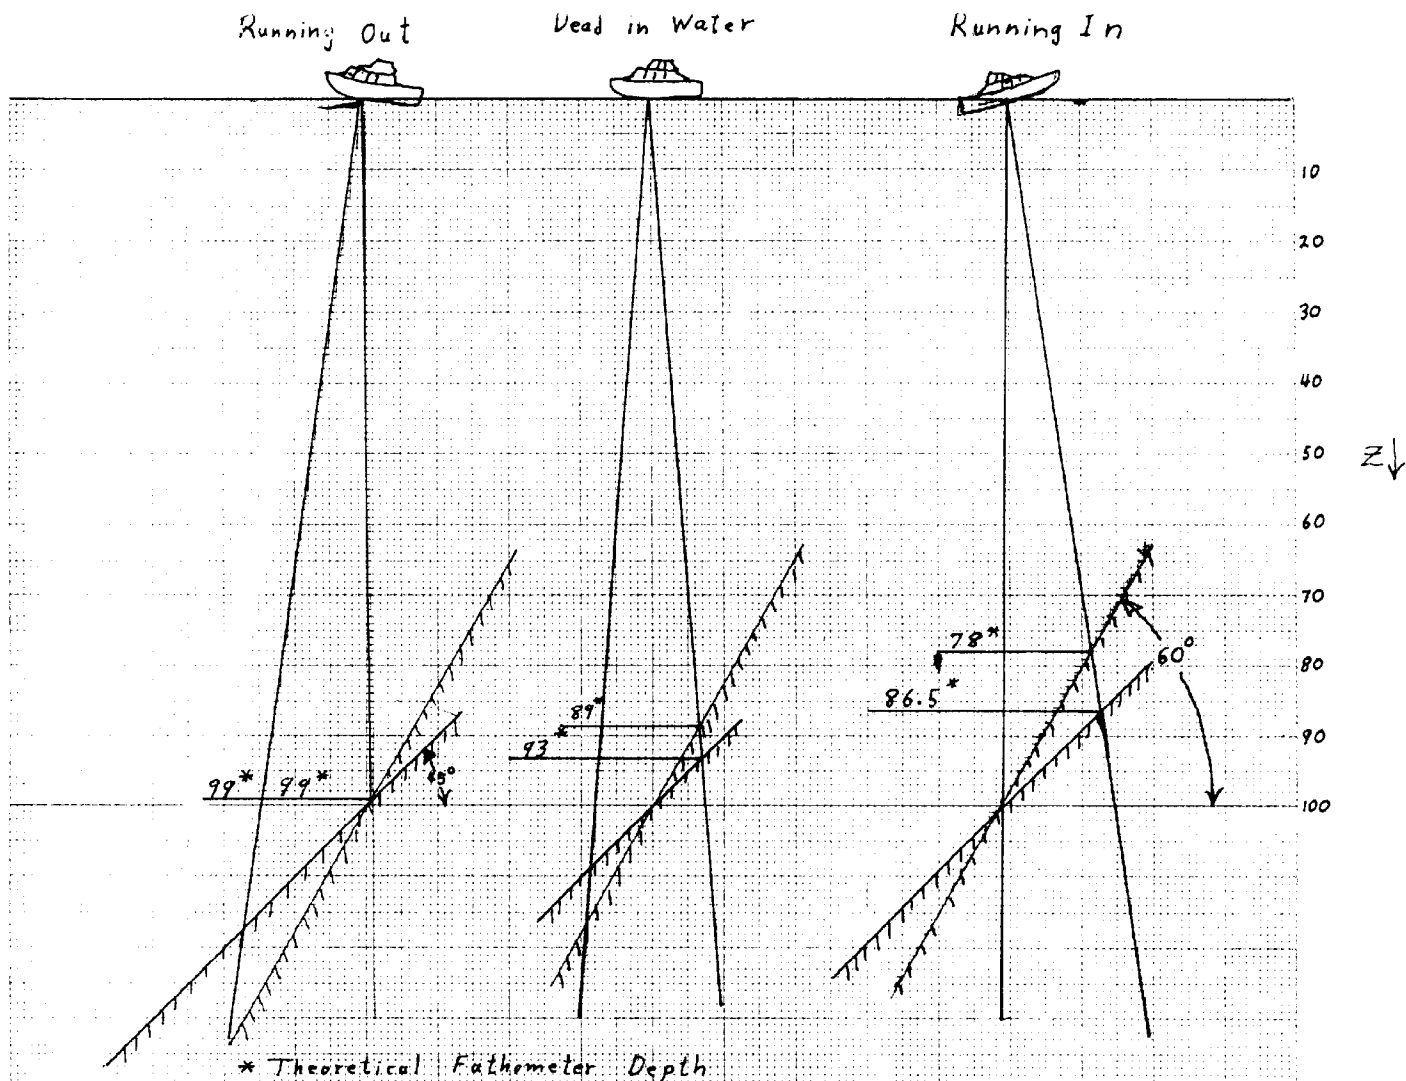
The Ross 5000 system uses a narrow beam-type transducer which appears to be on the whole, an improvement over the wide beam transducers which were subject to deceptive side echoes. However, the narrow beam width sounding depends greatly on which direction the transducer is pointed. For example, it was calculated that with a 5° nose up running attitude, a launch running normal to a 45° bottom slope would experience a 14% difference between depths obtained while running up-slope and those obtained while running down-slope. This theory was substantiated by comparing soundings from adjacent lines running in towards the shore and away from the shore. (See Appended Diagram)

No corrections for this type of error were practical; but, with the steep bottom slopes in Commencement Bay, it is not unrealistic to expect significant sounding errors due to beam width-bottom slope effect.

Some sounding error is probably due to the actual "pointing" of the transducer, which is a function of how it is mounted on the hull and what the attitude of the launch is at any given sounding. DA-1 was found to change pitch attitude by 4° when running as compared to its

This diagram assumes: 9° beam width fore and aft

That launch has 4° nose up attitude while running

That transducer is pointed normal to surface when launch isn't running
