DESCRIPTIVE REPORT
(HYDROGRAPHIC)

Type of Survey ... HYDROGRAPHIC
Field No. FA 10-1-74
Office No. H-9467
.....

State California
General Locality ... Southern California
Locality ... Dana Point and Vicinity
.....

SURVEY H-9467 (FA 10-1-74)

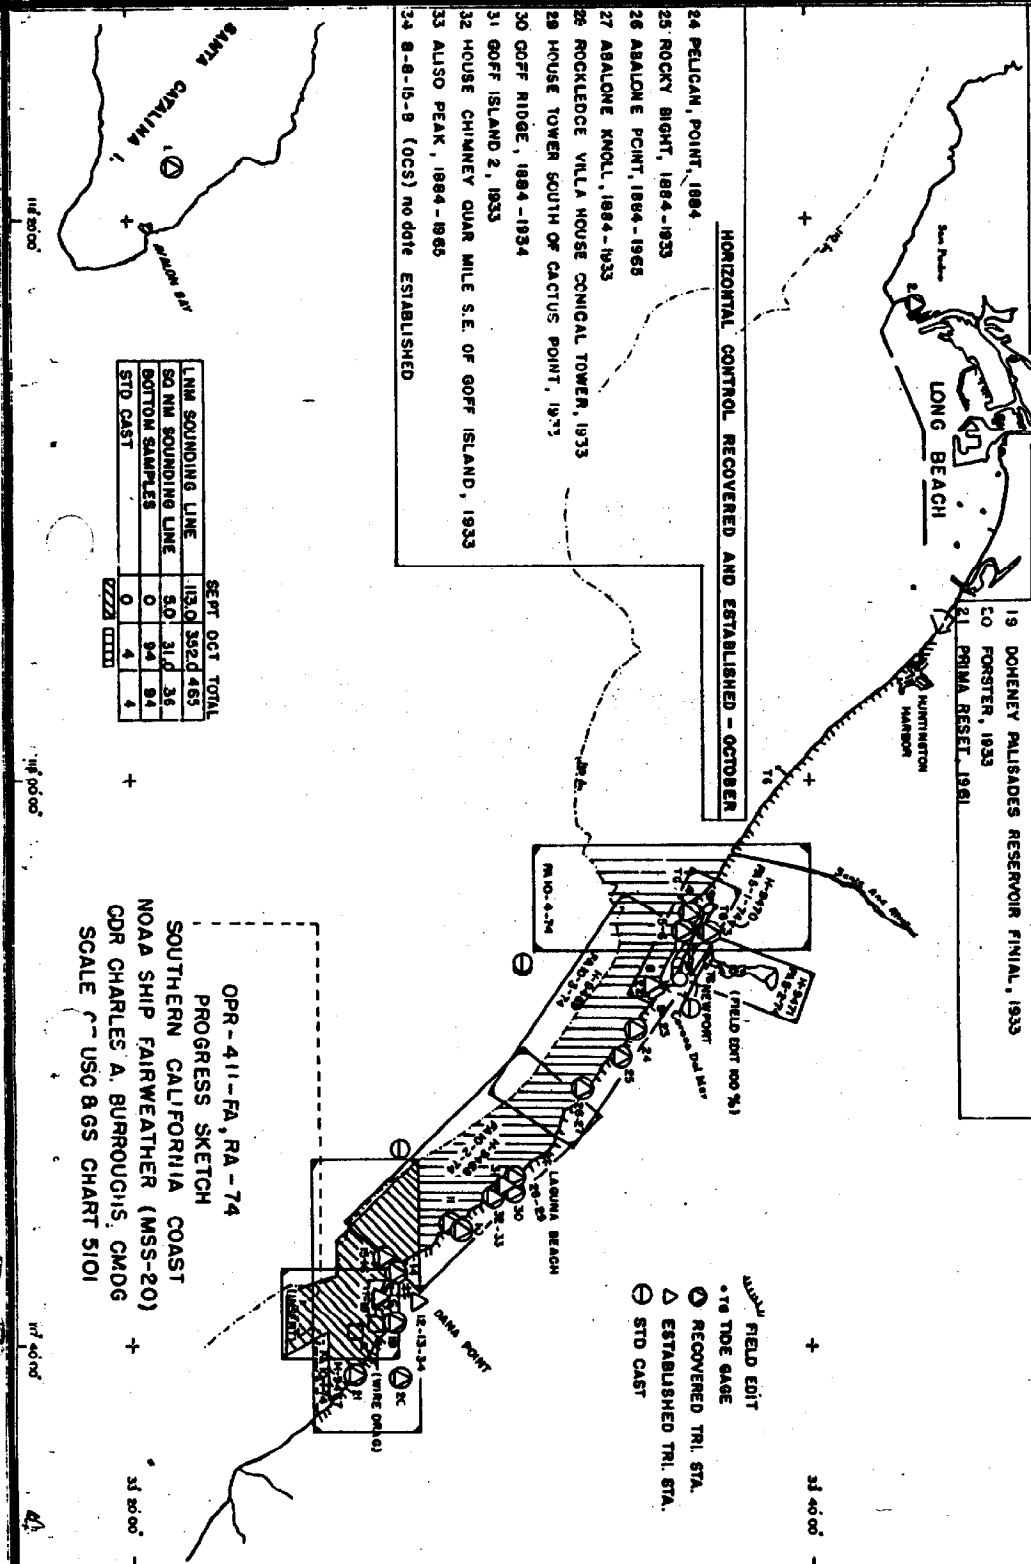
OPR-411-FA, RA-74
 PROGRESS SKETCH
 SOUTHERN CALIFORNIA COAST
 NOAA SHIP FAIRWEATHER (MSS-20)
 CDR CHARLES A. BURROUGHS, CMDG
 SCALE 1" = 500' BGS CHART 5101
