DESCRIPTIVE REPORT (HYDROGRAPHIC)

Type of Survey **HYDROGRAPHIC**
Field No. **AHP-20-4-75**
Office No. **H-9533**

State **NEW JERSEY**
General Locality **DELAWARE BAY**
Locality **CAPE MAY POINT TO EAST POINT**

DESCRIPTIVE REPORT
TO ACCOMPANY
HYDROGRAPHIC SURVEY H-9533 (AHP-20-4-75)

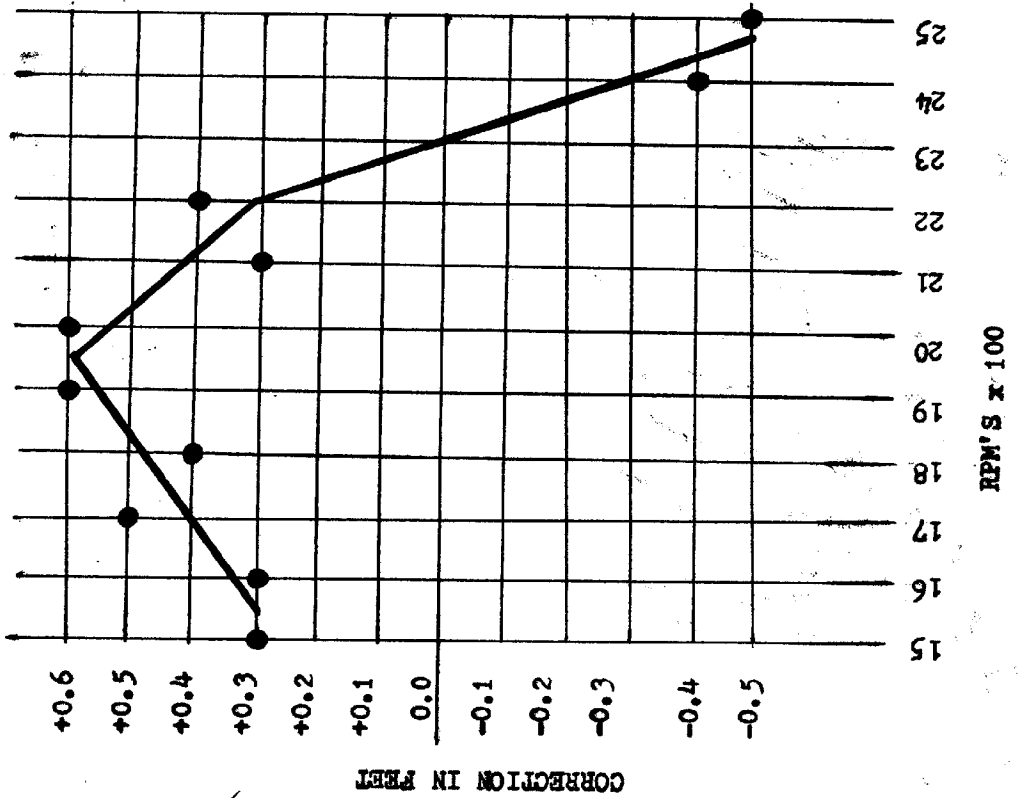
SETTLEMENT AND SQUAT TEST

22 OCT., 1975
