DESCRIPTIVE REPORT
(HYDROGRAPHIC)

Type of Survey HYDROGRAPHIC
Field No. RA-5-3-75
Office No. H-9570

State CALIFORNIA
General Locality SANTA CATALINA ISLAND
Locality CATALINA HARBOR AND APPROACHES

Locality CATALINA HARBOR and Approaches

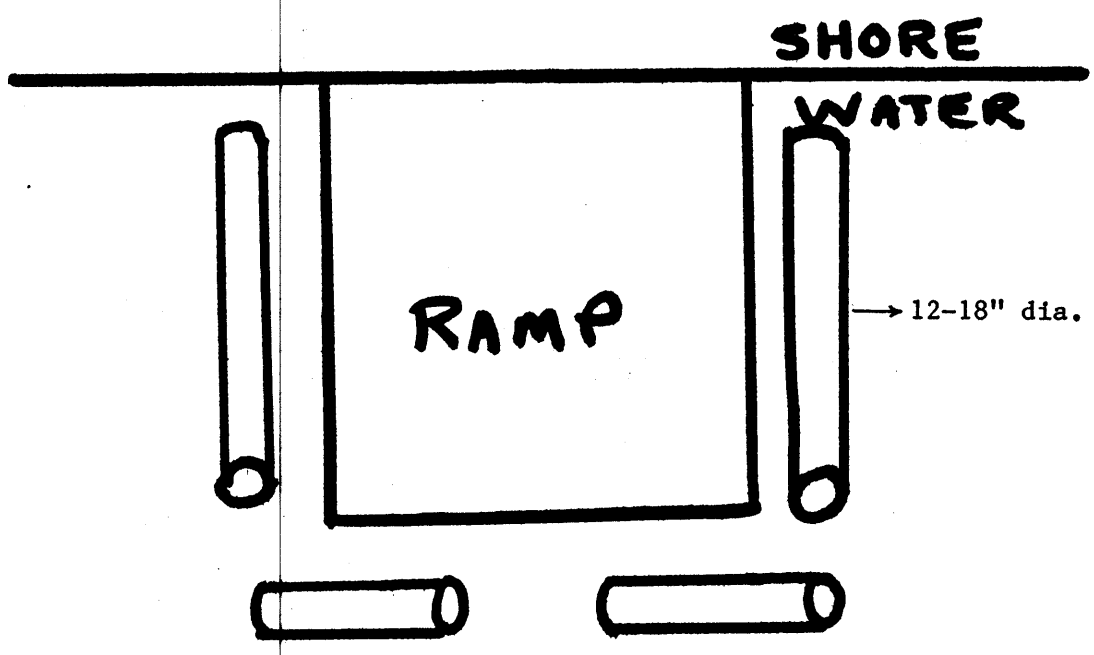
A pier ruin, which was shown on the T-sheet manuscript due west of the tide gage pier, was discovered to be an extension of a seaplane landing ramp. The ramp continued underwater for approximately 12-15 feet, and was surrounded by a square shaped pattern of concrete cylinders 12-18 inches in diameter and laying flat. It appears the cylinders were used to prevent sand and silt from

depositing on the ramp. The arrangement appeared as indicated in the following sketch:

This arrangement is out of the navigation channel, and is not a hazard to navigation. However, it is recommended that it be charted for completeness.
