DESCRIPTIVE REPORT
(HYDROGRAPHIC)

Type of Survey Hydrographic
Field No. FA-5-1-78
Office No..... H-9737

LOCALITY
State California
General Locality Estero Bay
Locality Morro Bay

DESCRIPTIVE REPORT
NOAA SHIP FAIRWEATHER S220
OPR-L100-(411)-FA-78
SURVEY H-9737 (FA-S-I-78)

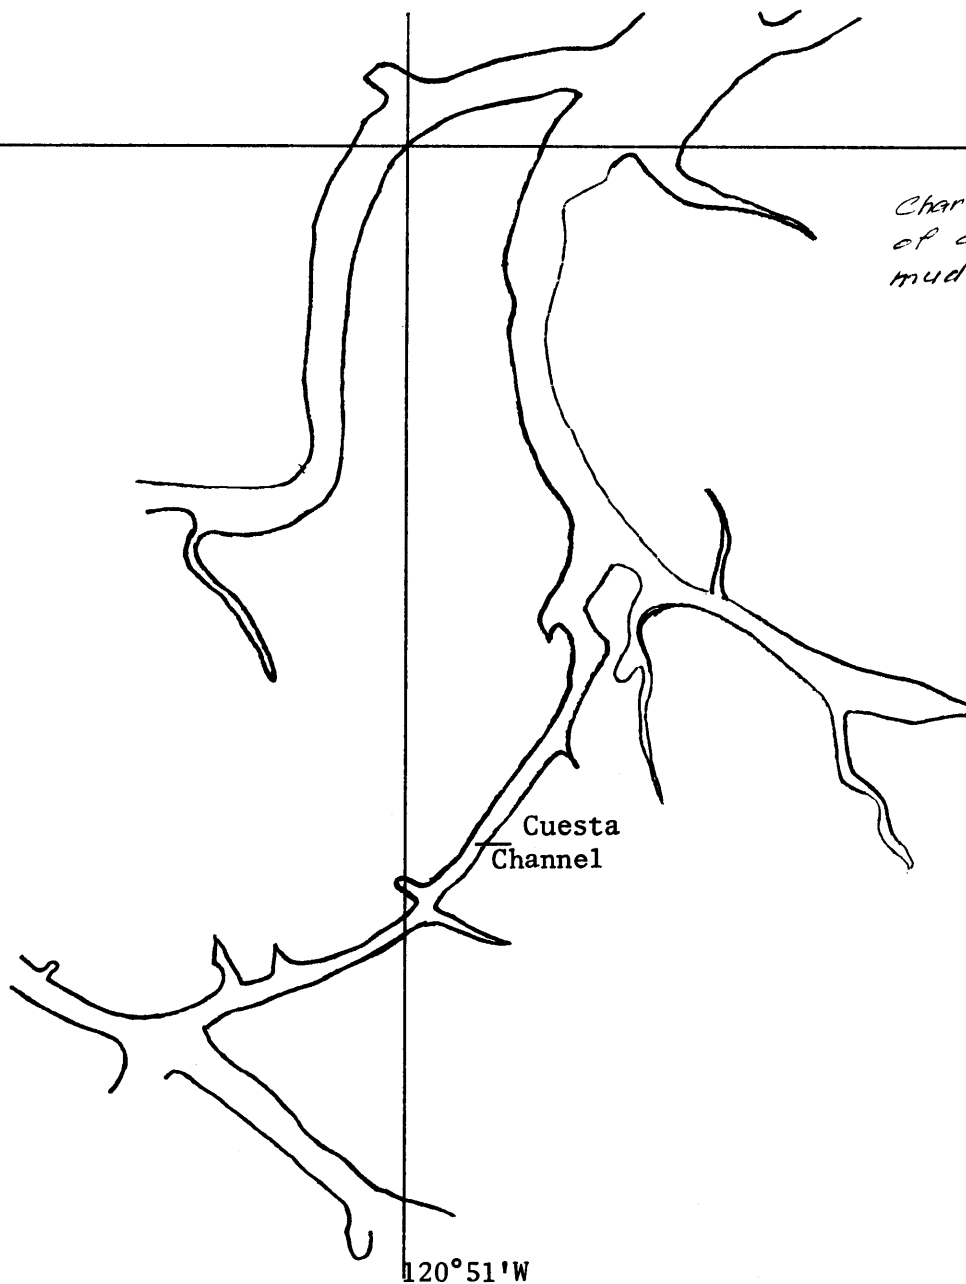
*Charted delineation
of channels thru
mud flats*

The main channel at Lat. 35°21'54"N Long. 120°52'00"W was found slightly shoaler than the charted depths with the minimum depth in the area of ~~14~~ ¹¹ feet, compared to the charted 3 1/2 fathoms. The ^{main} channel leading to White Point Marina was found to have a least depth of 12³ to 12⁷ feet compared to the charted depth of 2 1/2 fathoms. A deep point off Fairbank Point exists at a comparable depth to the charted depth. The channel listed as abandoned in the southern portion of Morro Bay, Cuesta Channel, was actually found to be the main channel to use to reach the south end of the bay. ✓

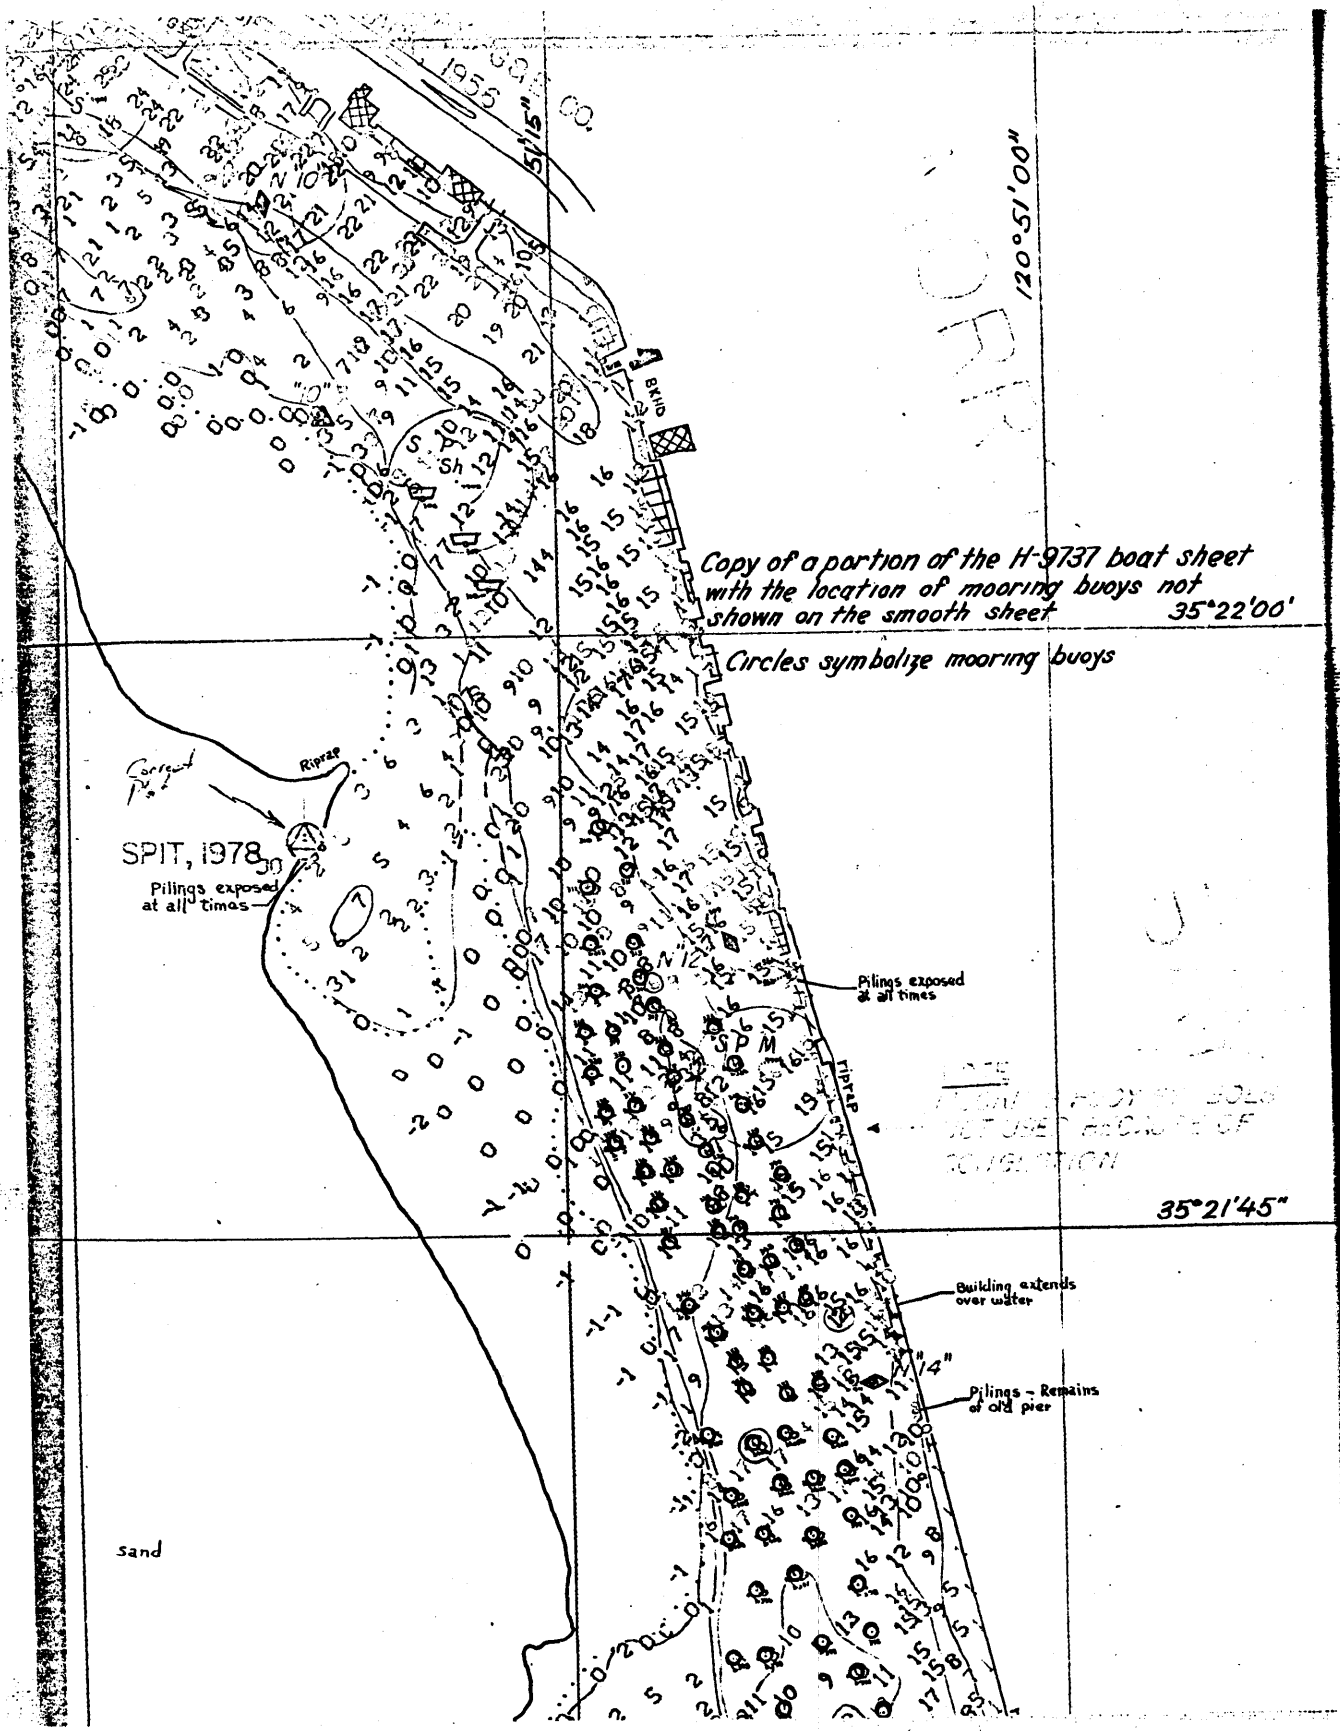
Copy of a portion of the H-9737 boat sheet
with the location of mooring buoys not
shown on the smooth sheet 35°22'00"

Circles symbolize mooring buoys

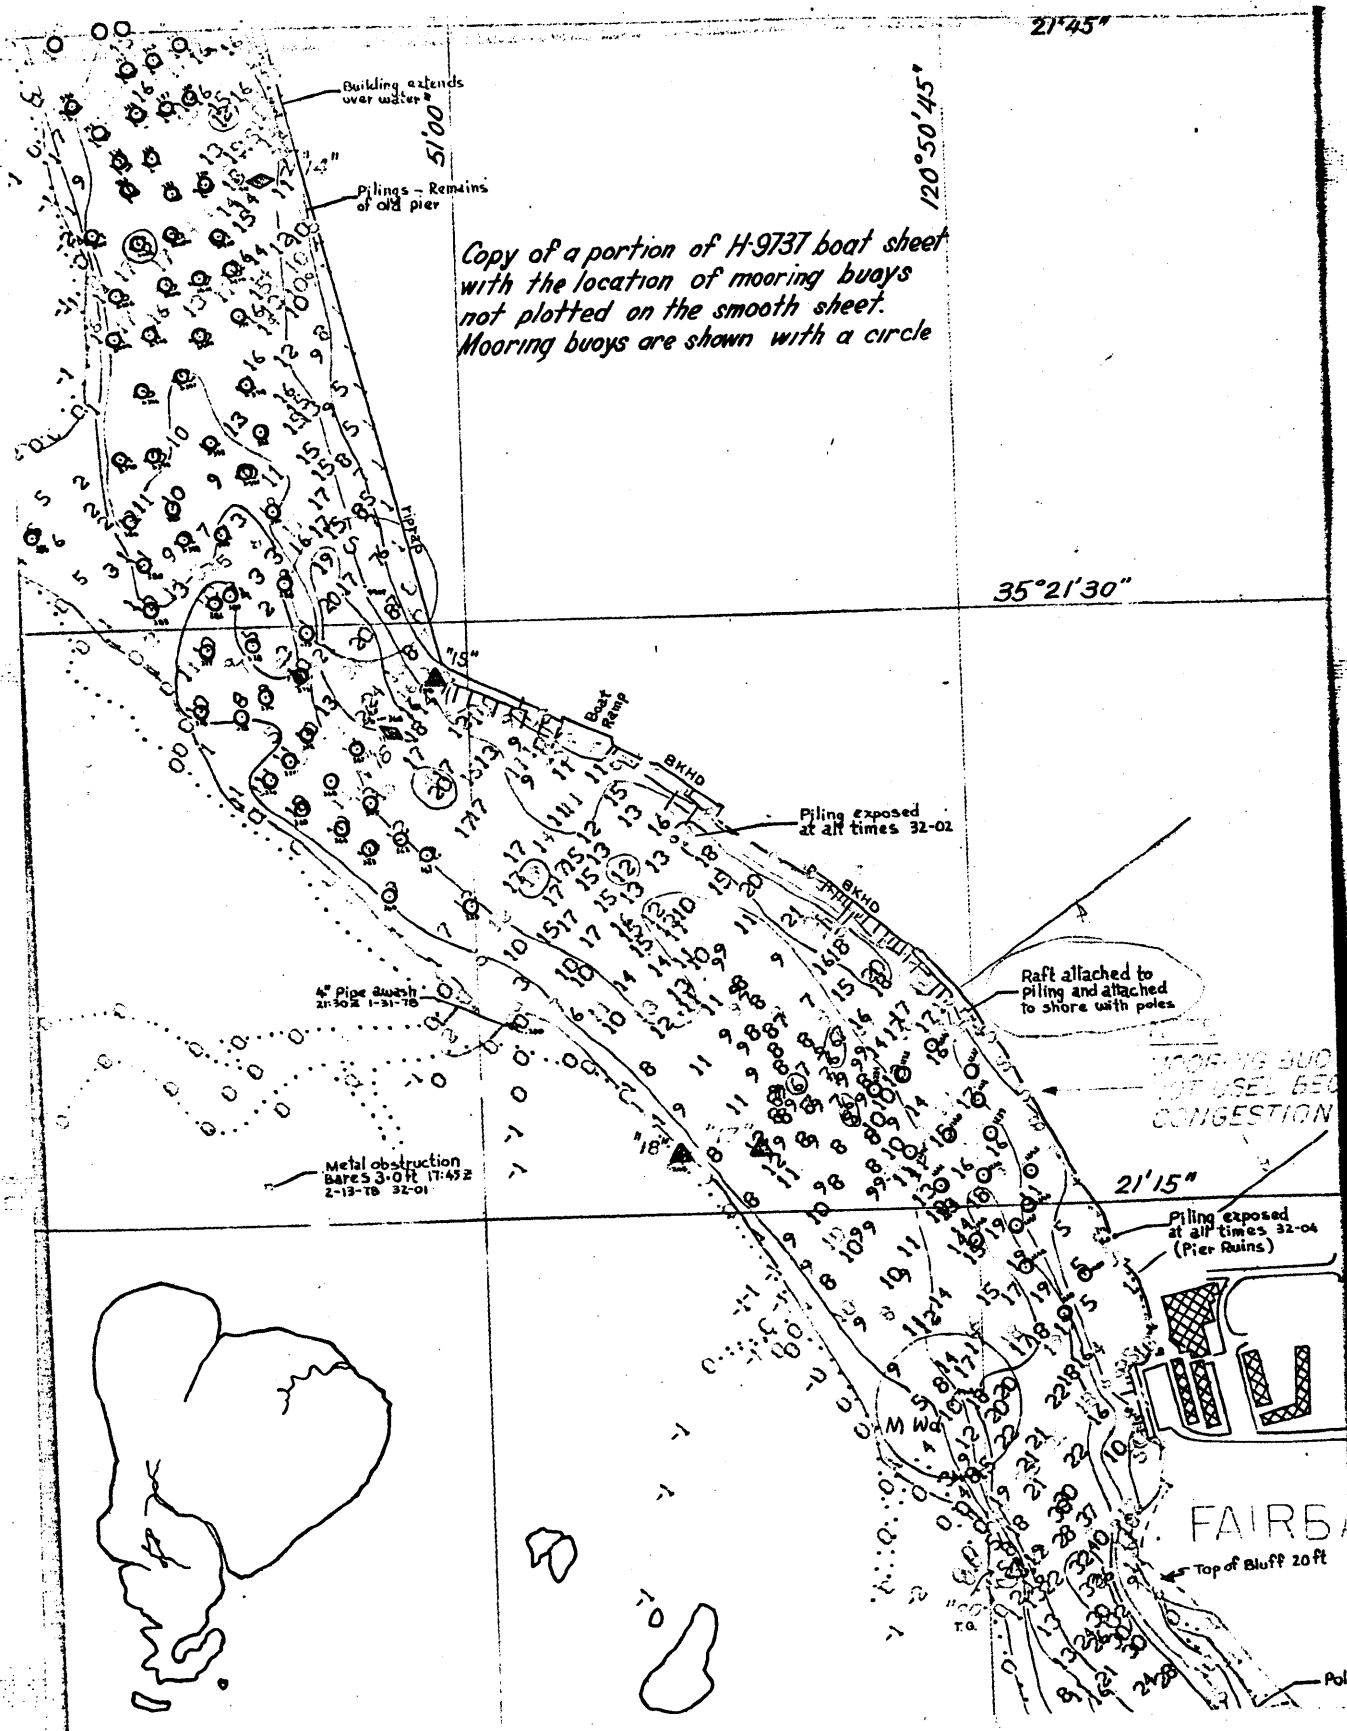
Copy of a portion of H-9737 boat sheet
with the location of mooring buoys
not plotted on the smooth sheet.
Mooring buoys are shown with a circle
