DESCRIPTIVE REPORT (HYDROGRAPHIC)

Type of Survey WIRE DRAG
Field No. RU/HE-20-2-76
Office No. H-9758 W.D.

State Delaware
General Locality Delaware Bay Entrance
Locality Vicinity of Cape Henlopen

Project No. OPR-515 - RU/HE - 76

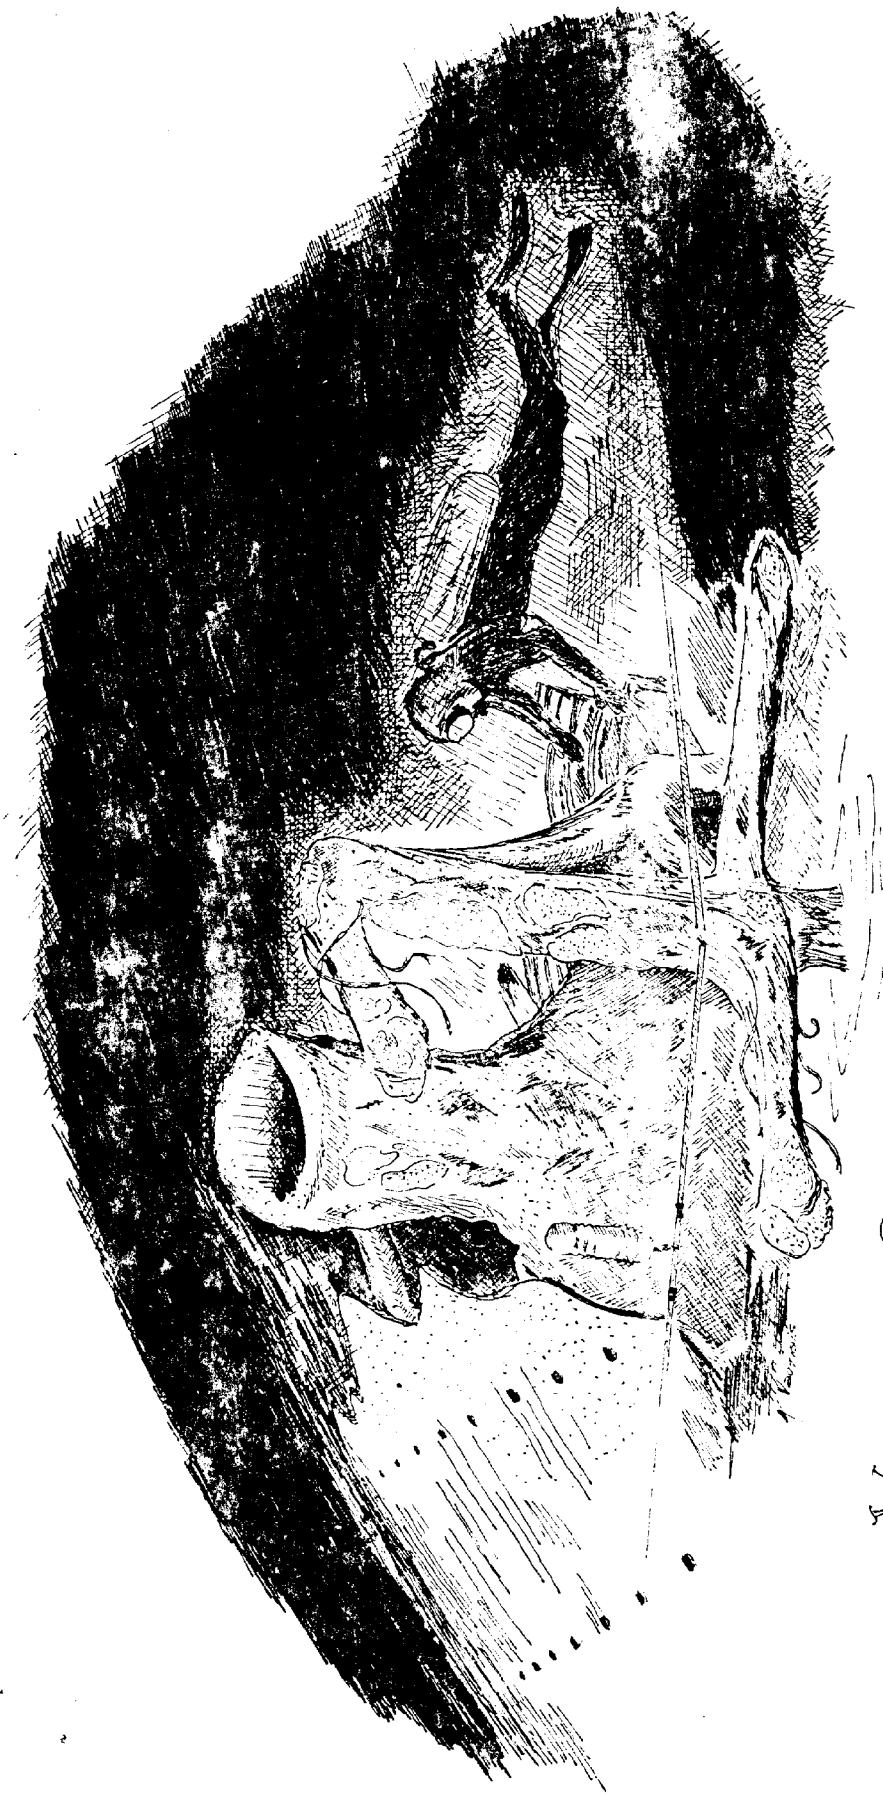
Recently a sailing vessel SAINT MARGARET II (approximately 90' length) went aground on Cape Henlopen. It presents no threat to navigation as it is well aground, almost on the beach. It is likely the vessel will remain aground until it breaks up. The position of the vessel as of 4 November 1976 is latitude 38°48.22'N, longitude 75°05.56'W, about 3250 feet off Breakwater Harbor Lighthouse @ 043°.

Wreckage Discovered
by RUDÉ, c'ck, in
65 fms. of water off
Harbor of Refuge, Do.
23 September, 1976
