DESCRIPTIVE REPORT

Type of Survey ... Hydrographic
Field No. ... HSB-10-1-82
Registry No. ... H-9995

State ... Florida
General Locality ... Pensacola Bay
Sublocality ... Fort McRee to Bayou Chico

DESCRIPTIVE REPORT
TO ACCOMPANY
HYDROGRAPHIC SURVEY H-9995
HSB-10-1-82

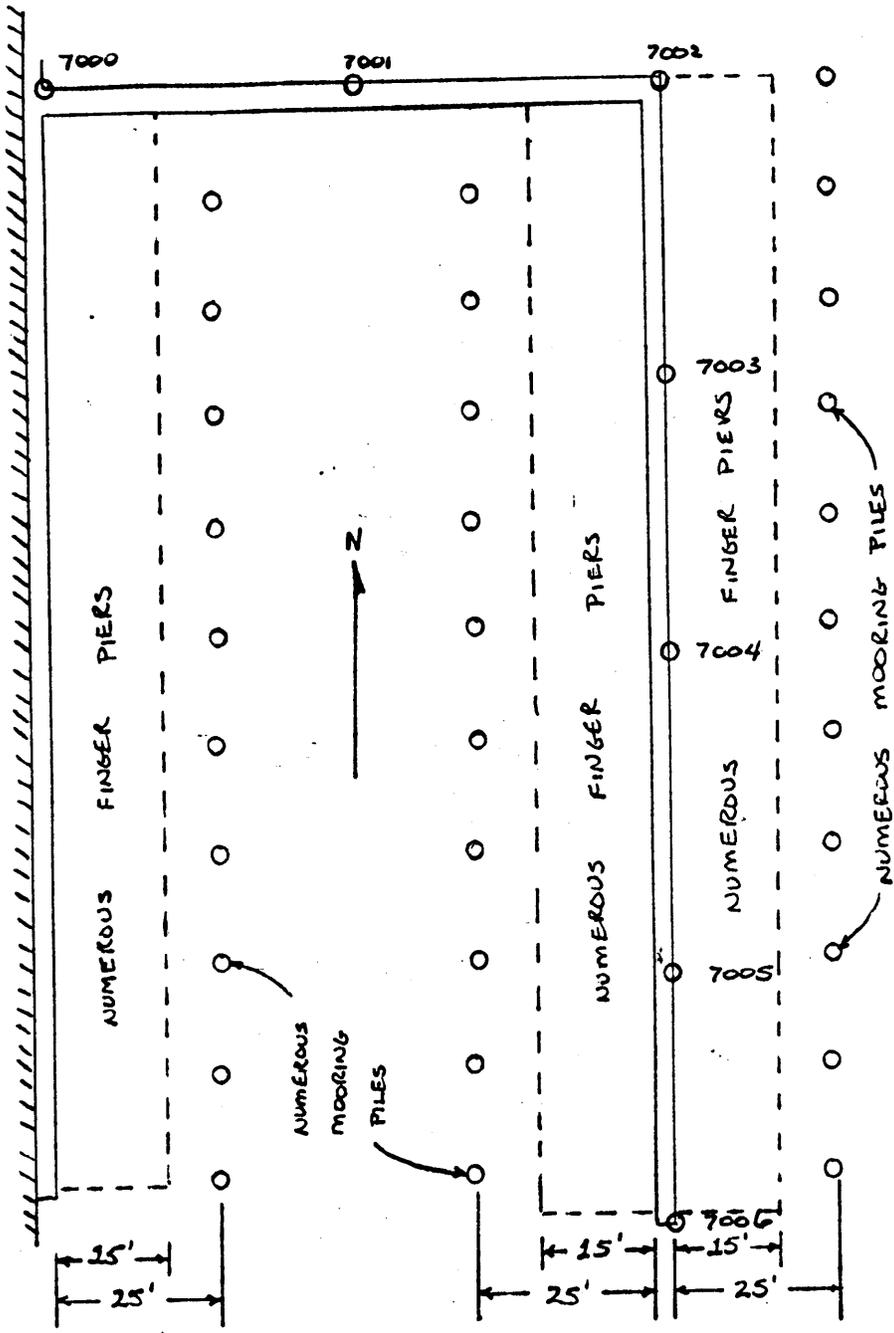
PSR Item # 329

329. Pier and Dols, PA, in the vicinity of 30°22'02"N, 87°16'10"W, originates with a U.S. Corps of Engineers permit (CL-519/1978). During the course of running the Bayou Grande phase of this project, HFP-1 based operations out of this facility. It is known as the "Naval Sailing Facility" on NAS Pensacola. DPs were taken at the points designated on the diagram enclosed. Soundings were taken by leadline at each position (determined with a HP-3810) and were not reduced or smooth plotted. With the exception of numerous finger piers, the pier was found as described by Plan 2-76-92-F from the Navy Public Works Center (enclosed).

SAILING FACILITY PIER, AS FOUND 28 JAN 83

RECOMMENDATION: Chart the pier as denoted in the attached diagrams at the positions determined. *See section 7.a.13) of the Evaluation Report.*

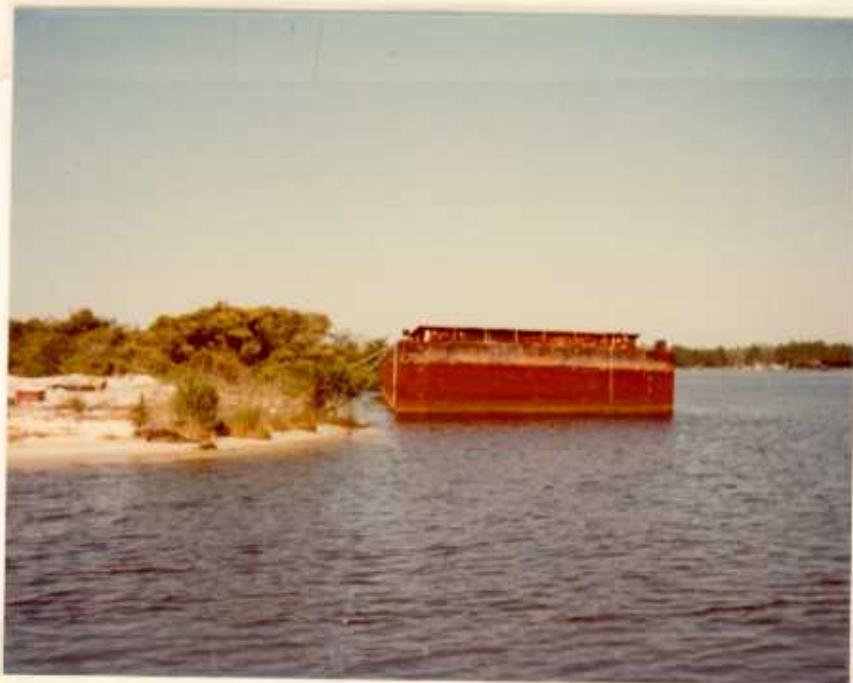
PSR # 329 NAVY SAILING FACILITY IN BAYOU GRANDE

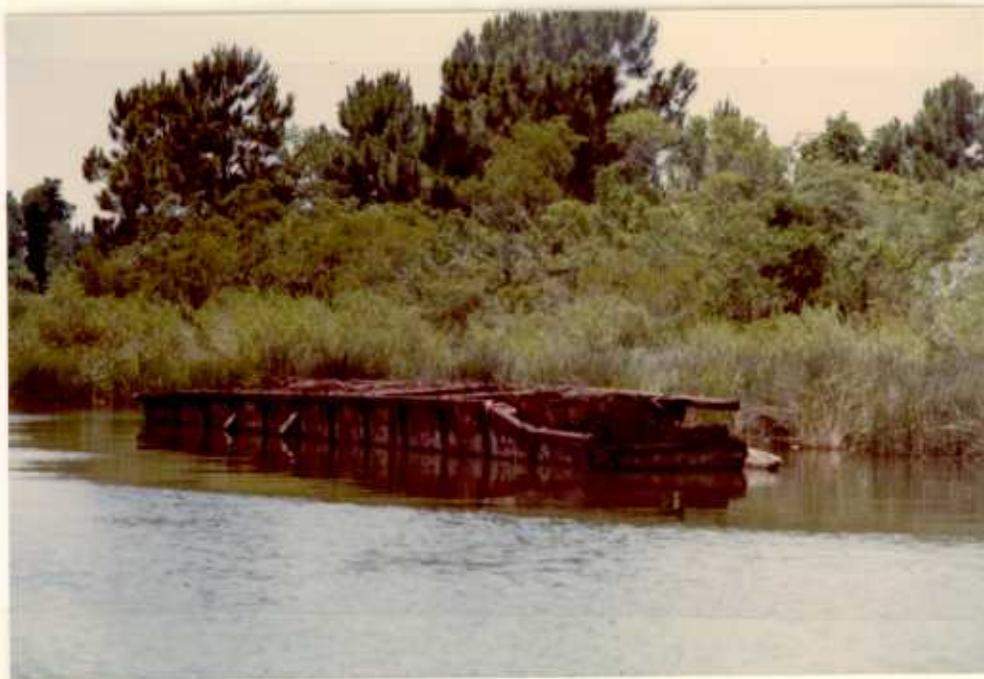
BARGE MOORED ATOP PSR # 325 NEAR ISLAND IN BAYOU CHICO
BARGE NEVER MOVED DURING COURSE OF SURVEY

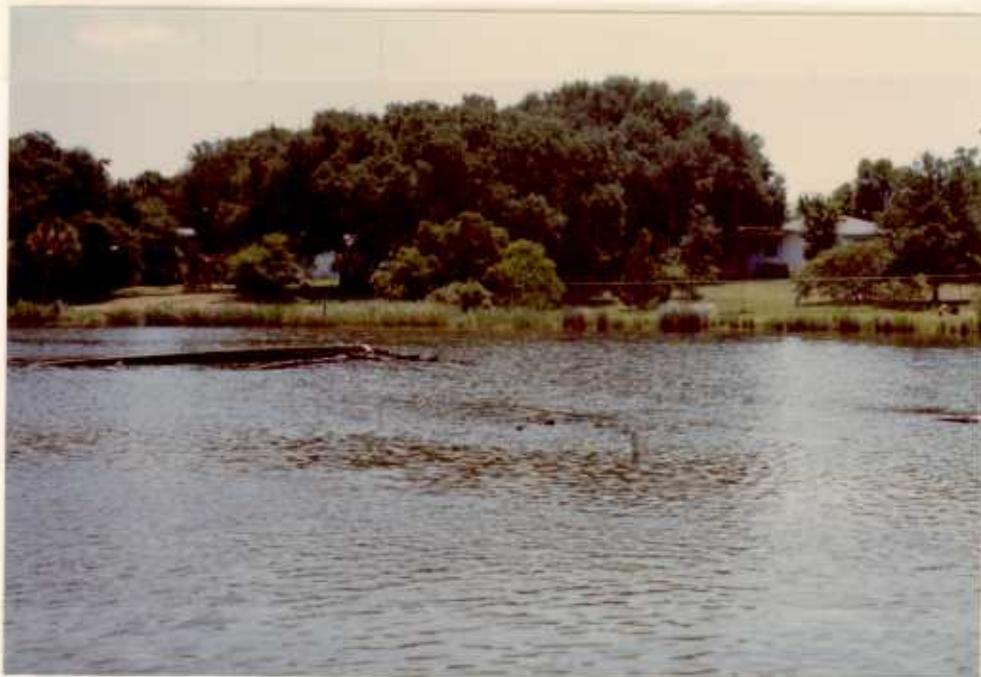
UNASSIGNED ITEM IMMEDIATELY SOUTH OF SAILING FACILITY
IN BAYOU GRANDE

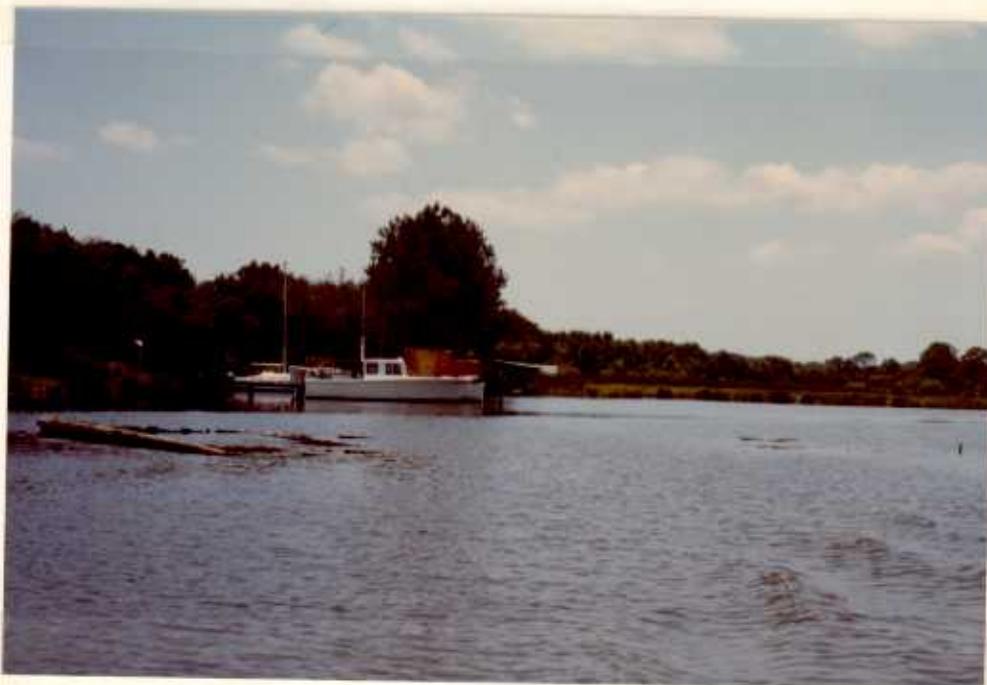
UNASSIGNED BARGE AWASH IN BAYOU CHICO

A stranded wooden barge is shown on Map TP-00544 in Bayou Chico but not on either chart of the area. The wreck was observed at the position shown on the "T" sheet while doing "See field Sheet" on JD 056 (1983). The wreck is a very old wooden barge, about 80 feet long and has a 25 foot beam. Conversation with the captain of the tugboat "TECO 2" who has operated in the Bayou for the past 25 years said the barges were old government "DPC" fuel barges which carried bunker "C" prior to World War II. He also said that the barge was of similar construction as PSR Items 325, 326, and 327. A photo of the wreck is enclosed.

RECOMMENDATION: A stranded wreck symbol should be charted at the position of the wreck ~~on TP-00544.~~
