DESCRIPTIVE REPORT

Type of Survey ... Navigable Area Hydrographic ...
Field No. ... FA-5-1-82 ...
Office No. ... H-10032 ...

State ... Alaska ...
General Locality ... Kodiak Island ...
Locality ... St. Paul Harbor and Approaches ...

1982-83

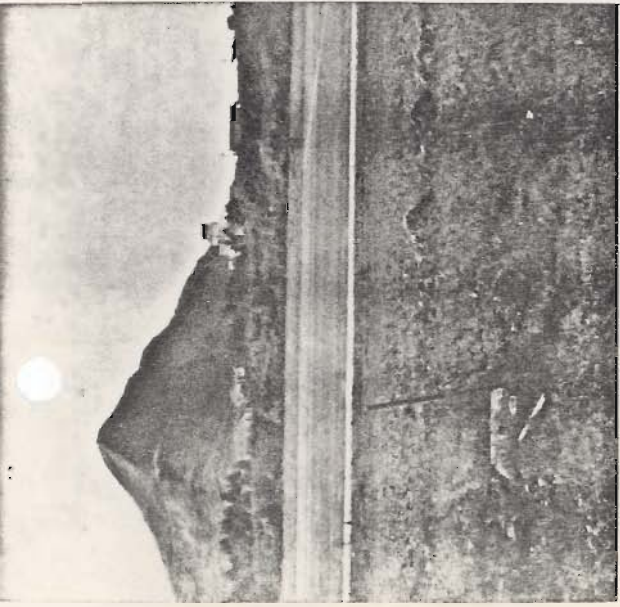
KODIAK TIDE STATION
Bm 21 visible in concrete slab in foreground
note Barometer Mt and control tower in background.

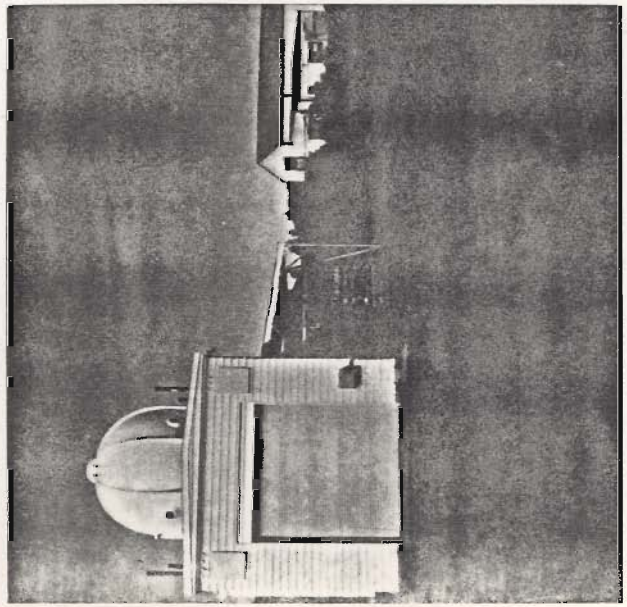
KODIAK TIDE STATION
Bm 14 lower left base of structure foreground
Bm 21 note the weatherhouse in background

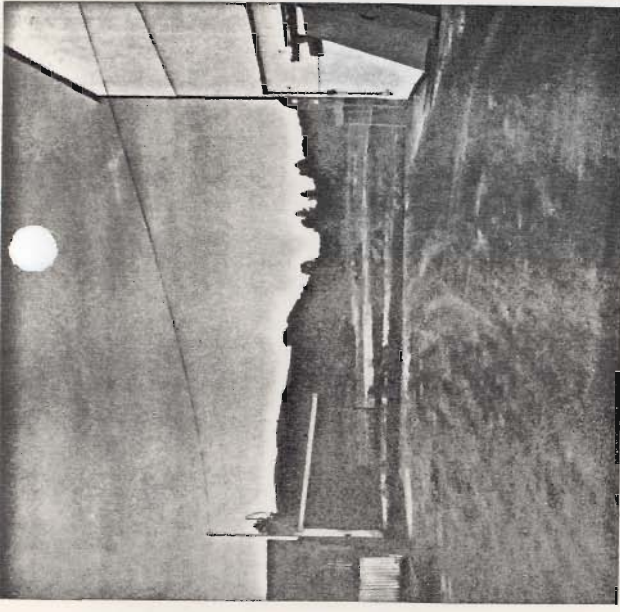
KODIAK TIDE STATION
Bm 20 1972 base of building at night
Bm 19 1971 base of quonset hut at left.

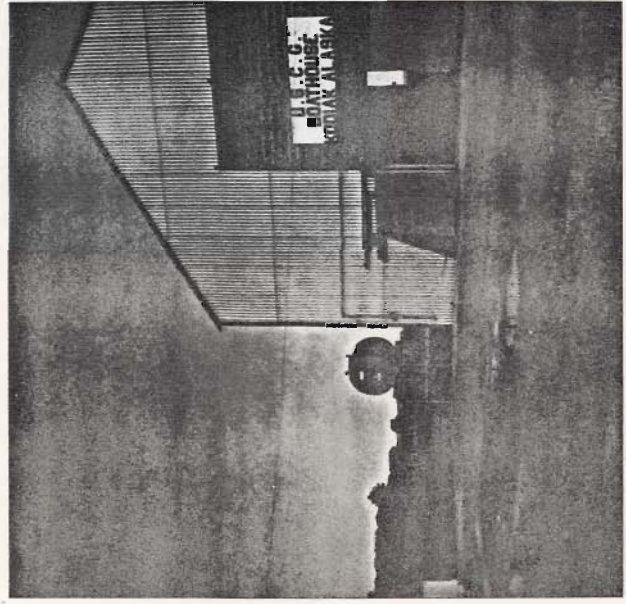
KODIAK TIDE STATION
STAFF + GAUGE INSIDE BATHHOUSE
Bm 20 1972 foreground center of building
Bm 19 1971 base of quonset hut at left

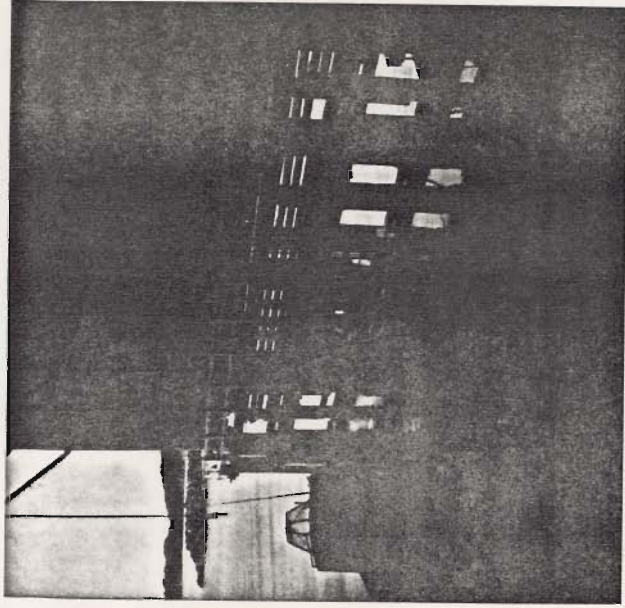
KODIAK TIDE STATION
Center: ADR GUAGE
Center right: TIDE STAFF
INSIDE BATHHOUSE
