DESCRIPTIVE REPORT

Type of Survey ... Hydrographic
Field No. MI-10-01-83
Registry No. H10073

State Puerto Rico
General Locality .. Atlantic Ocean
Sublocality Punta Salinas to
..... Punta Escambron
.....
..... 1985
.....
CHIEF OF PARTY
..... CAPT J.A. Yeager

HYDROGRAPHIC TITLE SHEET

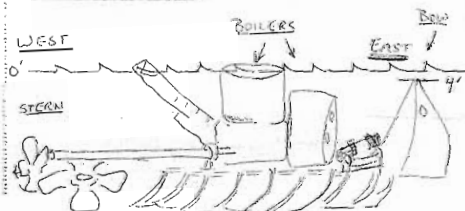
SKETCH AND COMMENTS:

NO 2734 AND 2735. BELIEVE BOW TO BE
SOURCE OF PSR 2735 AT EARLIER TIME WHEN
BOW EXTENDED ABOVE DATUM. WRECK LIES IN
AREA OF HIGH SURF IMPACT AND HAS BROKEN UP EXTENSIVELY. WRECK IS STEEL HULLED, EARLY 1900
MONTAGE.

STERN

POS 1182 JD 097
DEPTH: 7.7 FT
RANGE: 2.390
AZ: 105/12/25
