DESCRIPTIVE REPORT

Type of Survey ... Basic Hydrographic
Field No. WH-10-1-84
Registry No. H-10148

State Wisconsin
General Locality .. Lake Superior
Sublocality Chequamegon Bay

HYDROGRAPHIC TITLE SHEET

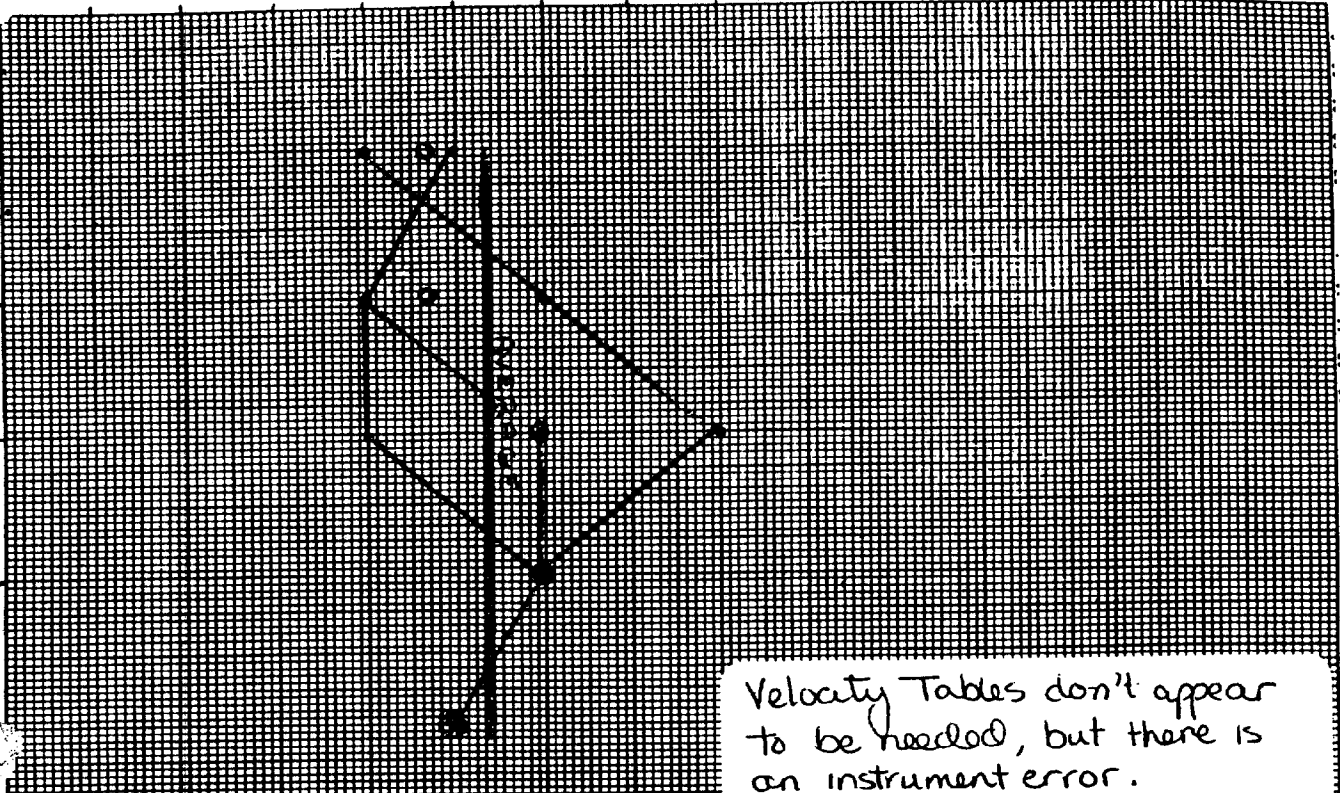
ATTACHMENT D

Instrument Error
gain or calibration

Velocity Tables don't appear to be needed, but there is an instrument error.

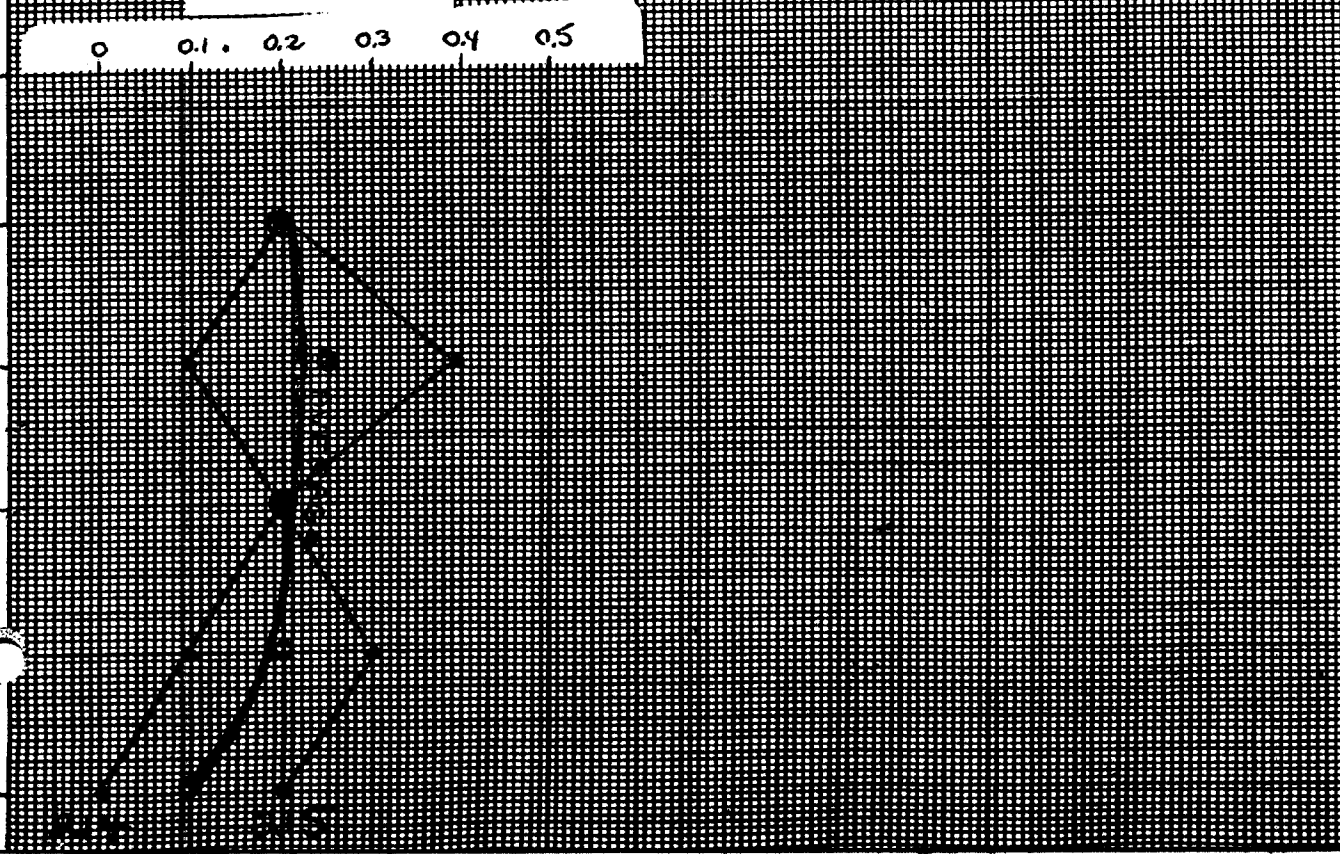
Instrument error?
gain or calibration

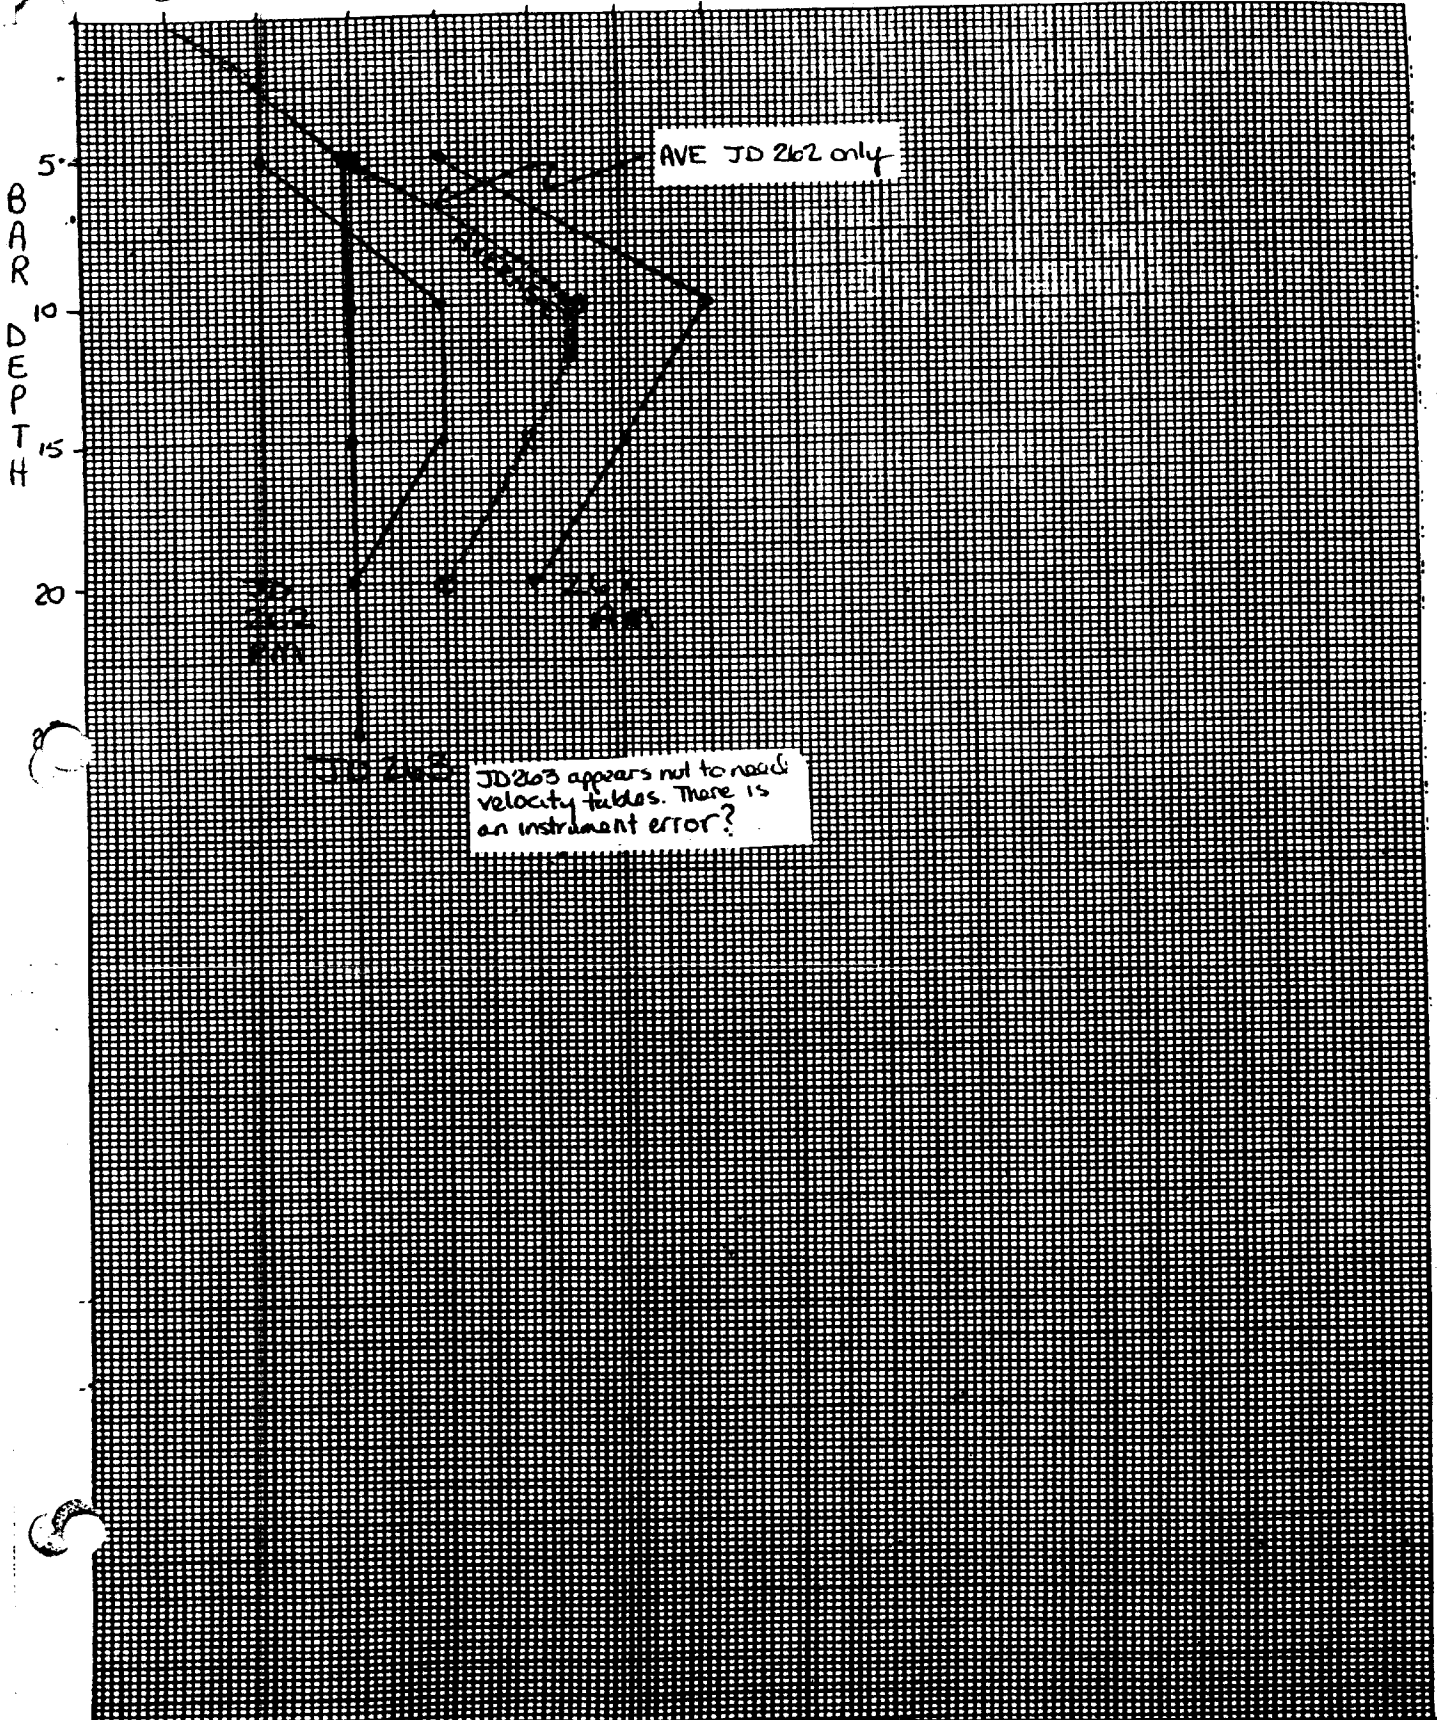
ATTACHMENT G

JD 263 appears not to need velocity tables. There is an instrument error?
