DESCRIPTIVE REPORT

Type of Survey ..Hydrographic.....
Field No.RA-10-1-85.....
Registry No.H-10176.....

StateAlaska.....
General Locality ..Seymour Canal.....
SublocalityMole Harbor to Pleasant Bay.....

HYDROGRAPHIC SURVEY
SEYMOUR CANAL, ALASKA

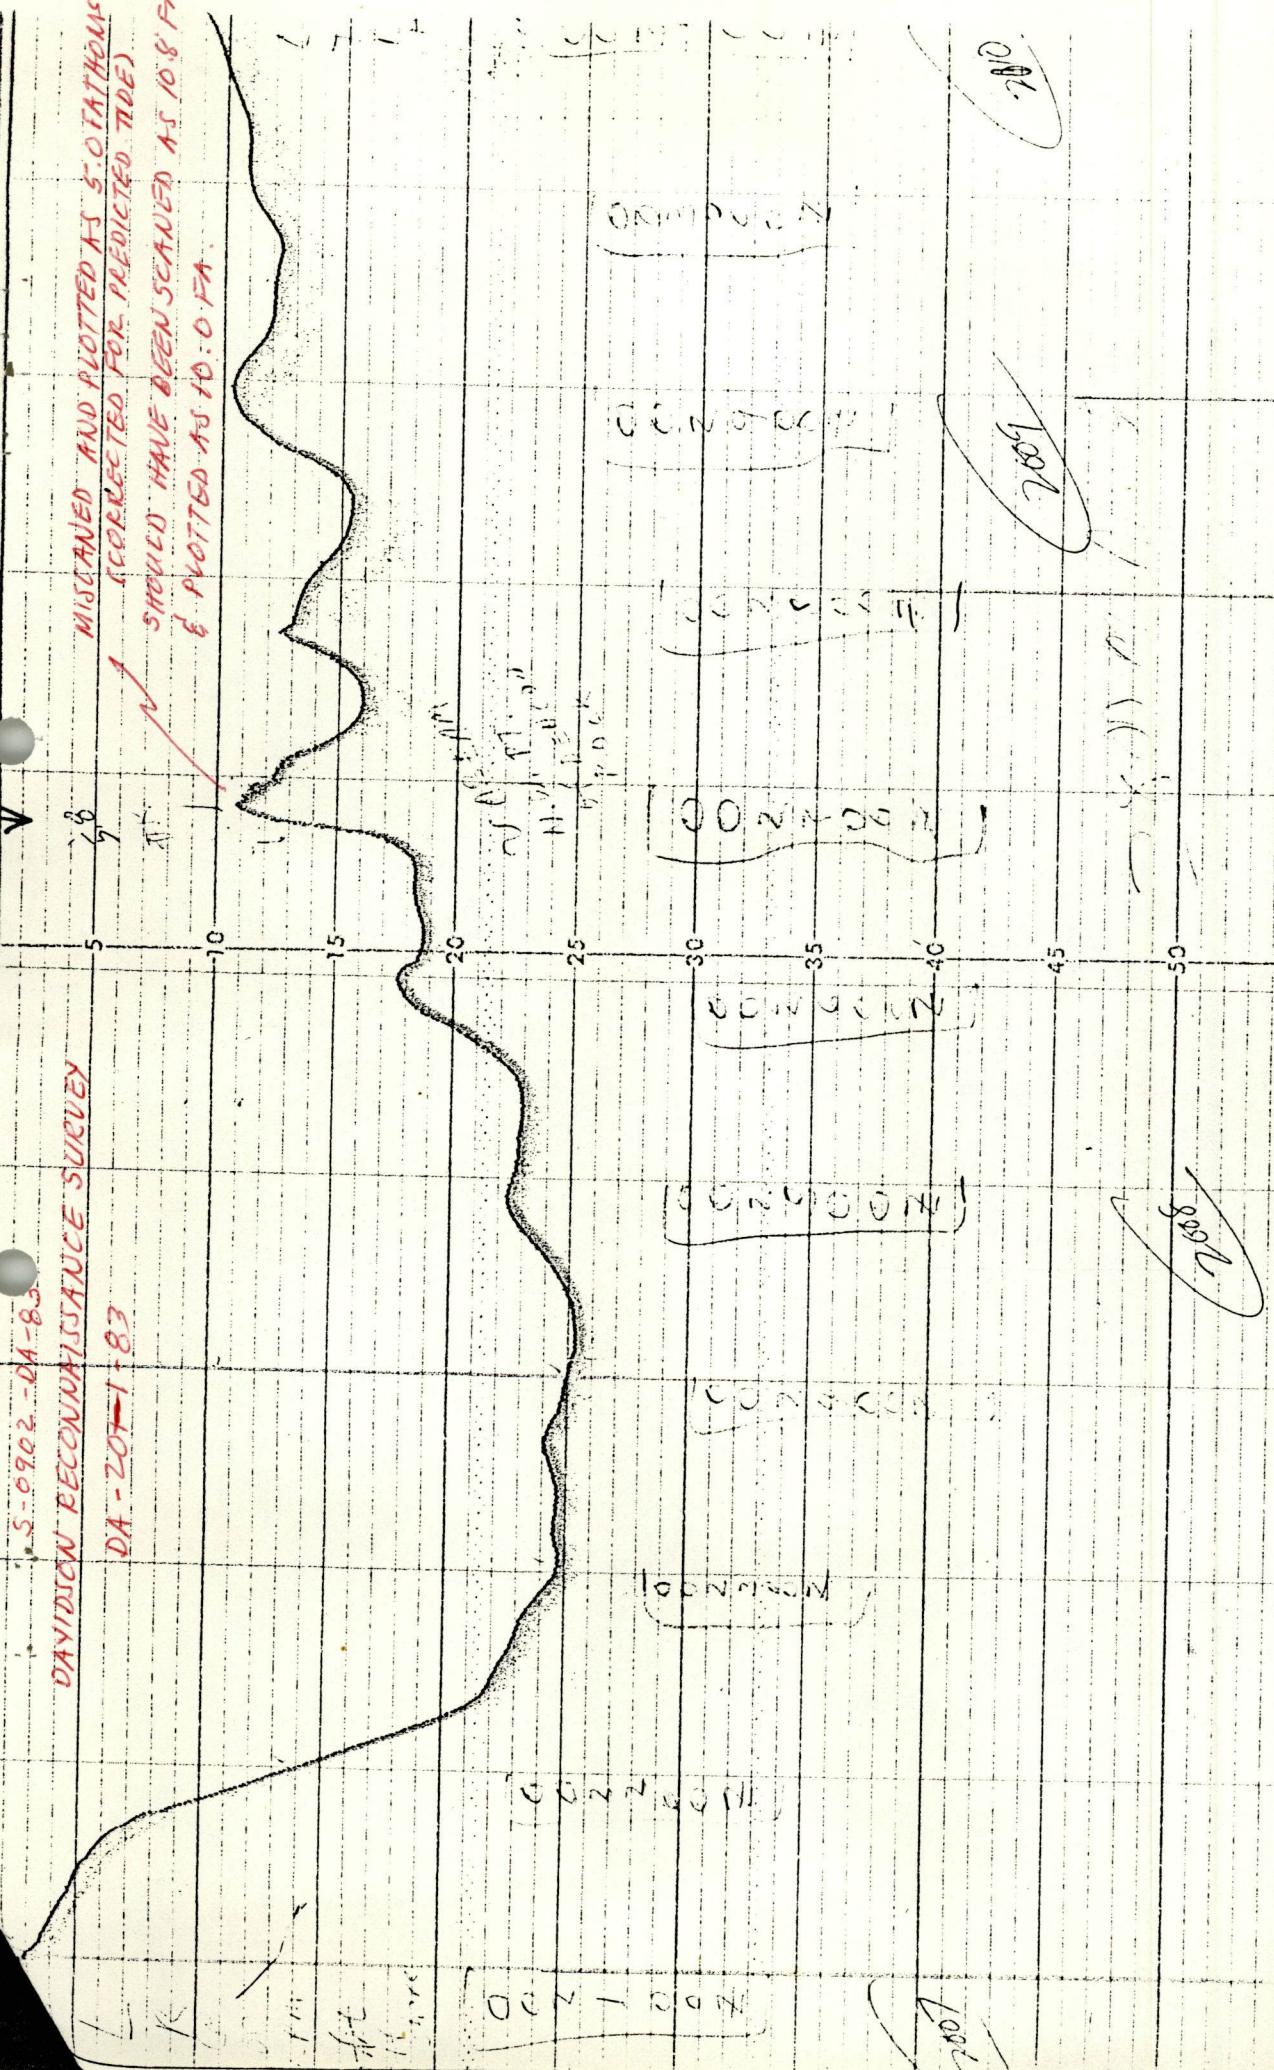
S-0902-DA-83
DAVIDSON RECONNAISSANCE SURVEY
DA-20-1-83

MISSED AND PLOTTED AS 5.0 TATONS.
CORRECTED FOR PREDICTED TIDE
SHOULD HAVE BEEN SCANNED AS 10.8 FA
& PLOTTED AS 10.0 FA.
