H10223

DESCRIPTIVE REPORT

Type of Survey Hydrographic
Field No. PHP-10-02-86
Registry No. H-10223

State California
General Locality San Pablo Bay
Sublocality Mare Island Strait &
Western Approach to Carquinez Strait

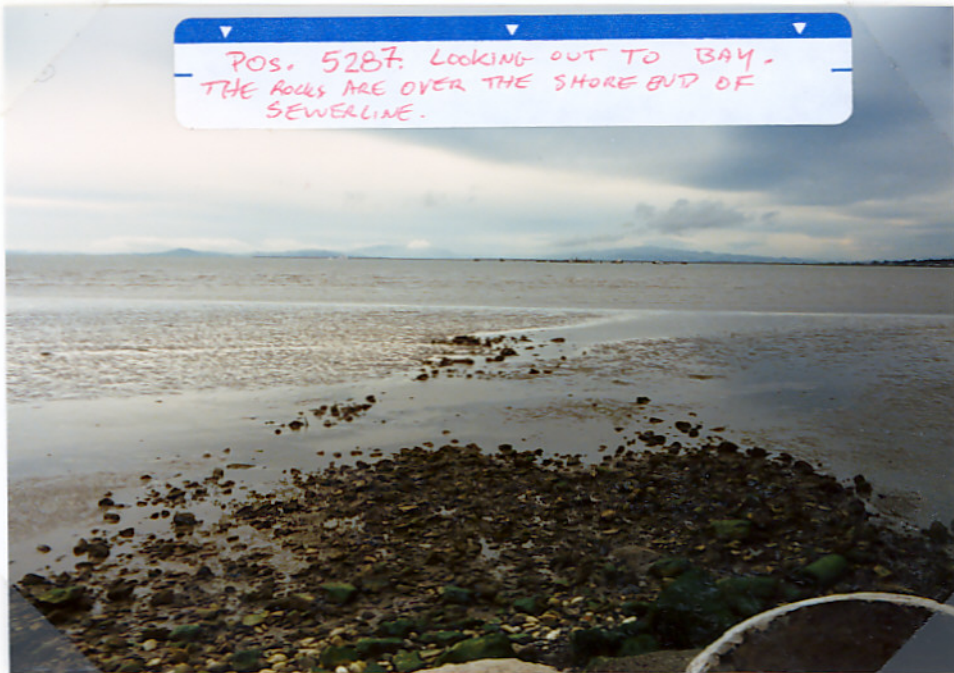
POS. 5287

POS. 5287. LOOKING OUT TO BAY.
THE ROCKS ARE OVER THE SHORE END OF
SEWERLINE.

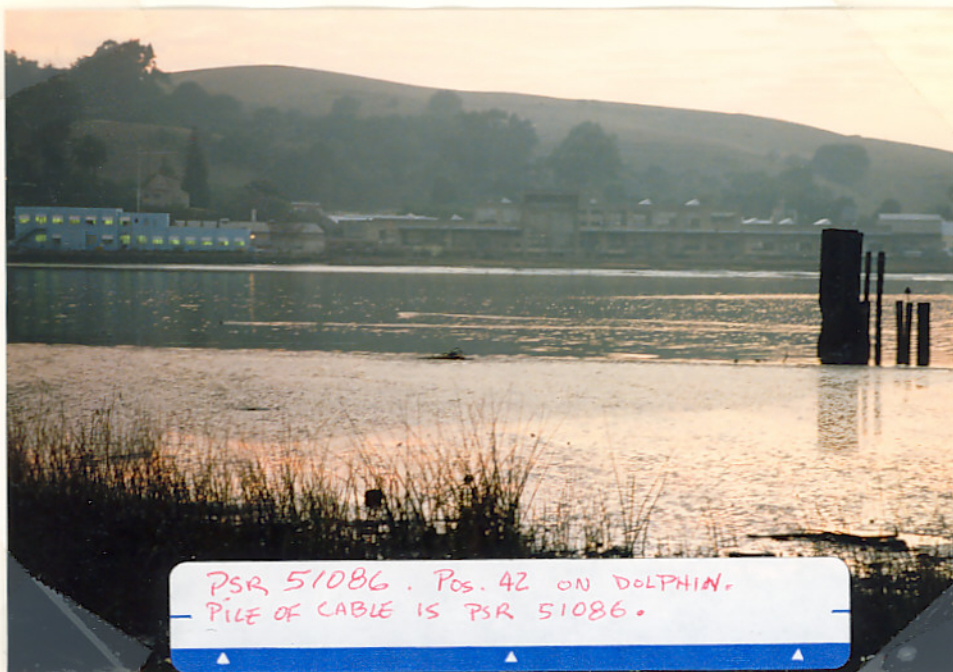
Pos. 42
38/04/57.48
122/14/46.75

PSR 51086. Pos. 42 ON DOLPHIN.
PILE OF CABLE IS PSR 51086.

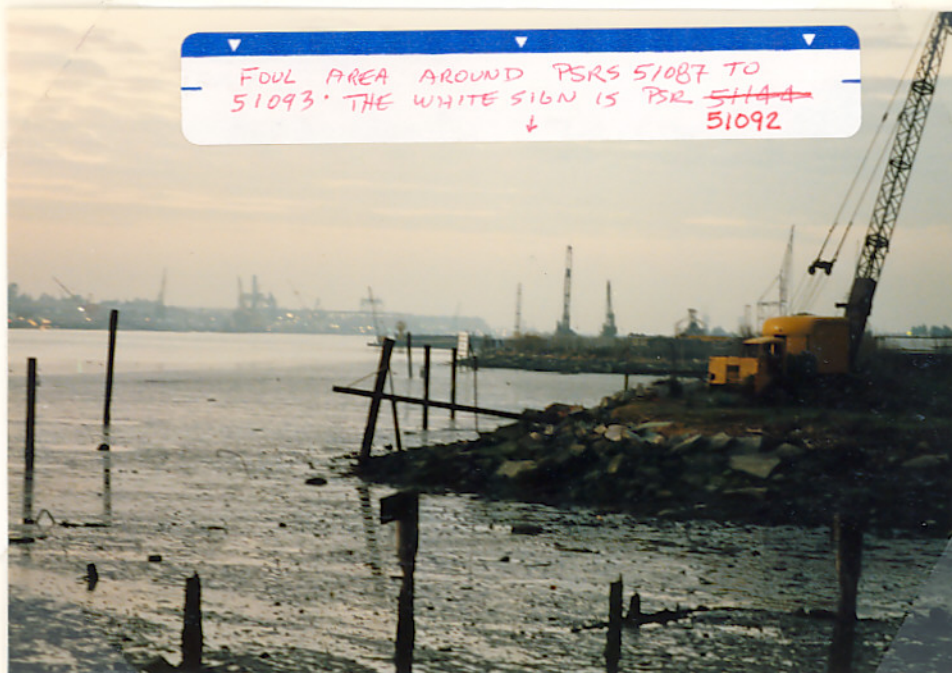
AW015 51087
38/05/03.17
122/14/49.39

FOUL AREA AROUND PSRS 51087 TO
51093. THE WHITE SIGN IS PSR ~~51144~~
↓ 51092

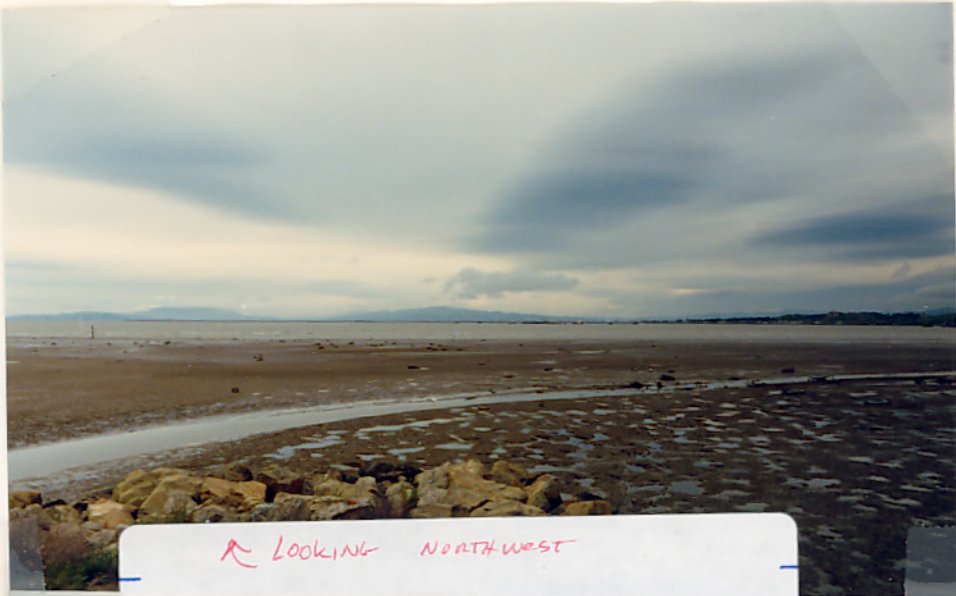
Looking NORTHWEST

FOUL AREA AT CITY OF RODEO, 38/02/20
122/15/00

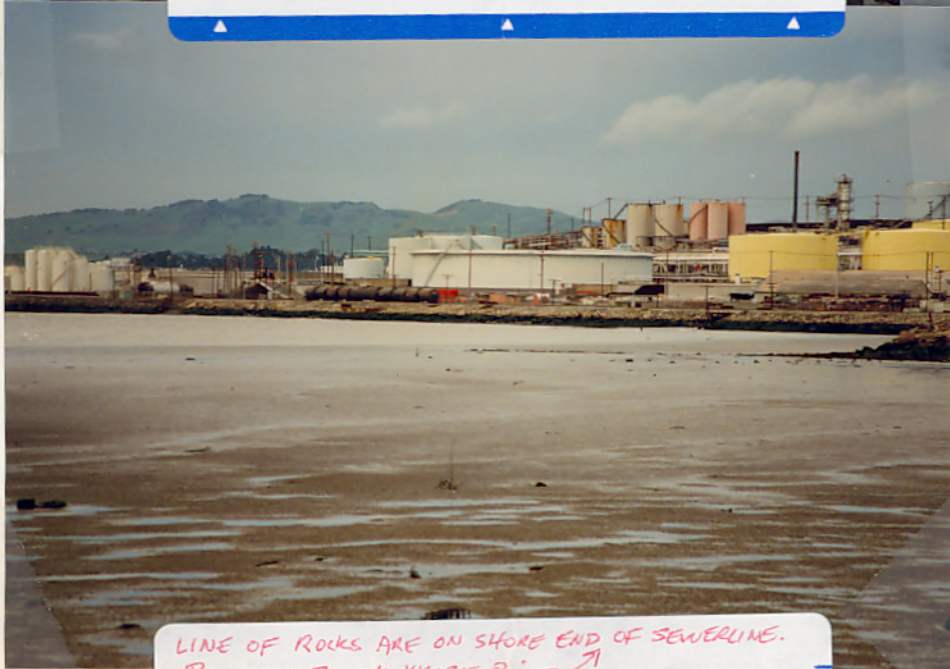
AWOIS #50828

LINE OF ROCKS ARE ON SHORE END OF SEWERLINE.
POS. 5287 ON VISIBLE POINT
Looking NORTHWEST

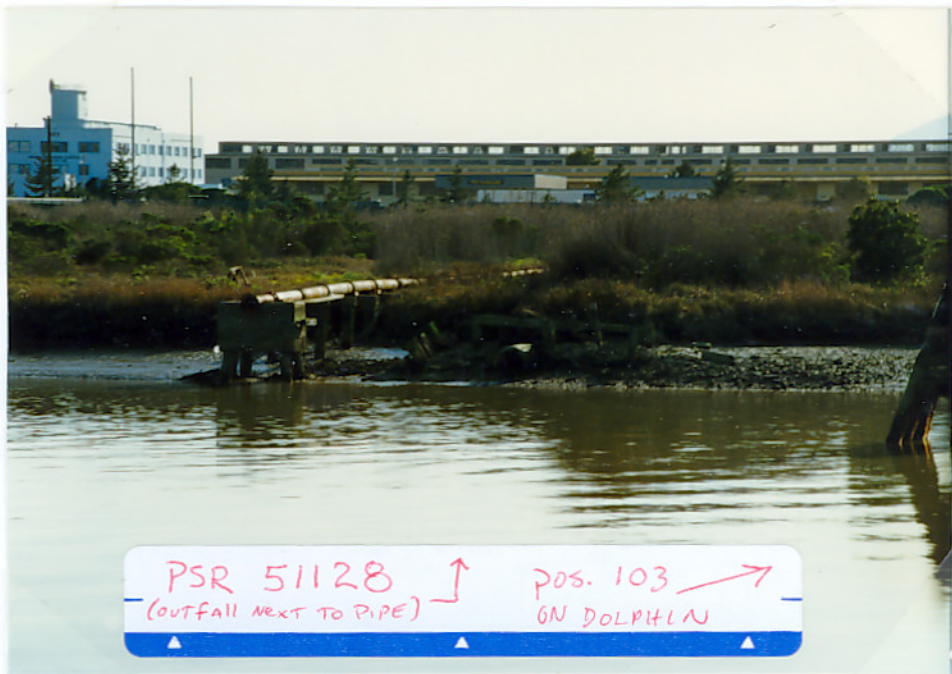
AWO/S 51128
POS. 103
38/06/56.45
122/16/47.27

PSR 51128 ↑
(OUTFALL NEXT TO PIPE)

POS. 103 →
ON DOLPHIN

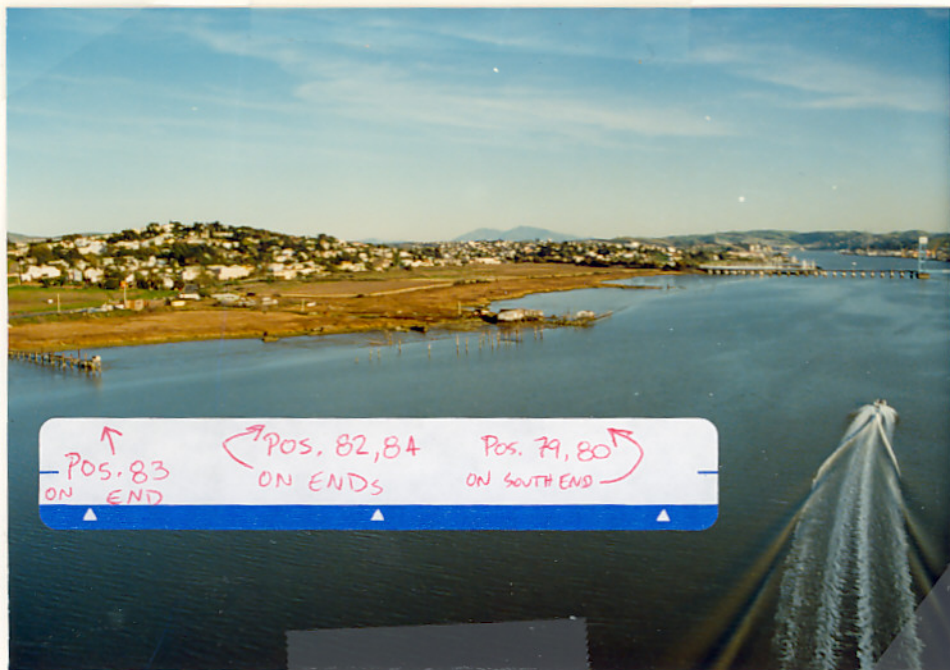
Pos. 83
38/07/11.63
122/16/33.47

Pos. 100 ON NORTH END OF
Row of DOLS. →

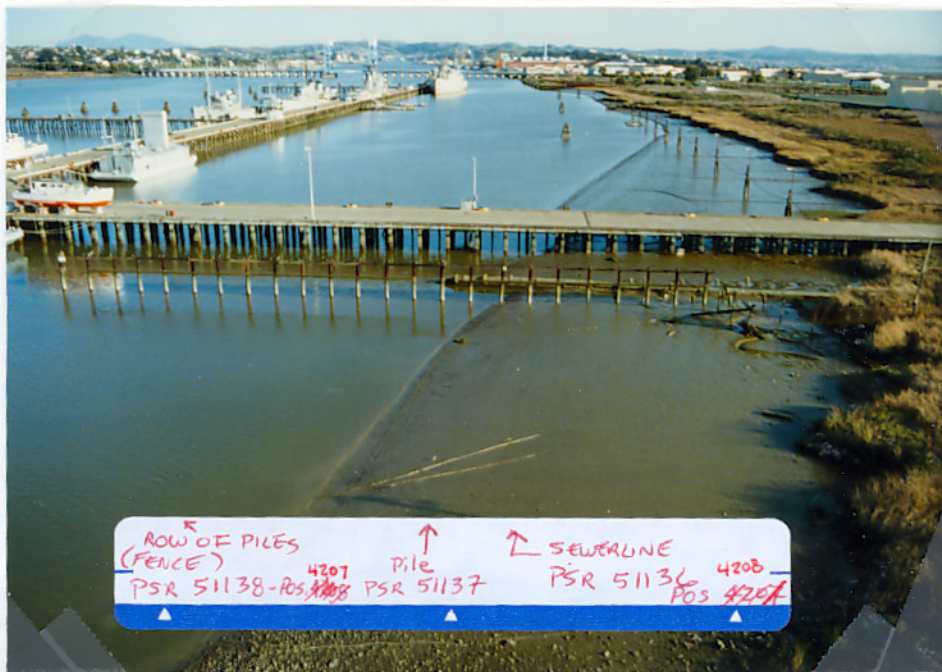
← Pos. 100

ROW OF PILES
(FENCE) ↑ Pile
PSR 51138-Pos. ~~4207~~ PSR 51137
SEWERLINE ↑ PSR 51136 4208
Pos. ~~4207~~

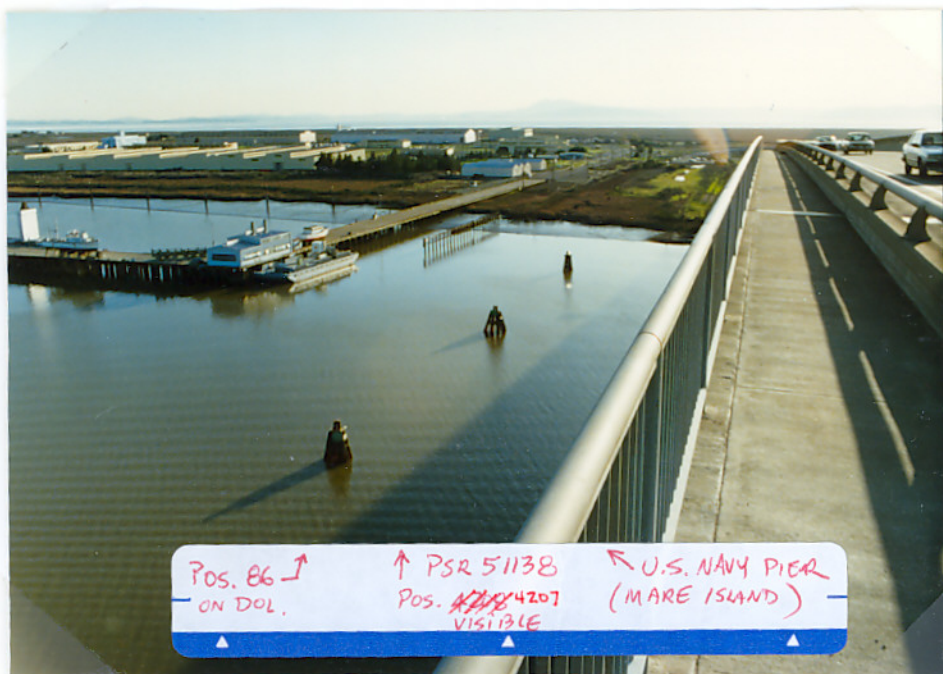
Pos. 86 ↑
ON DOL.
↑ PSR 51138
Pos. ~~4207~~ 4207
VISIBLE
U.S. NAVY PIER
(MARE ISLAND)

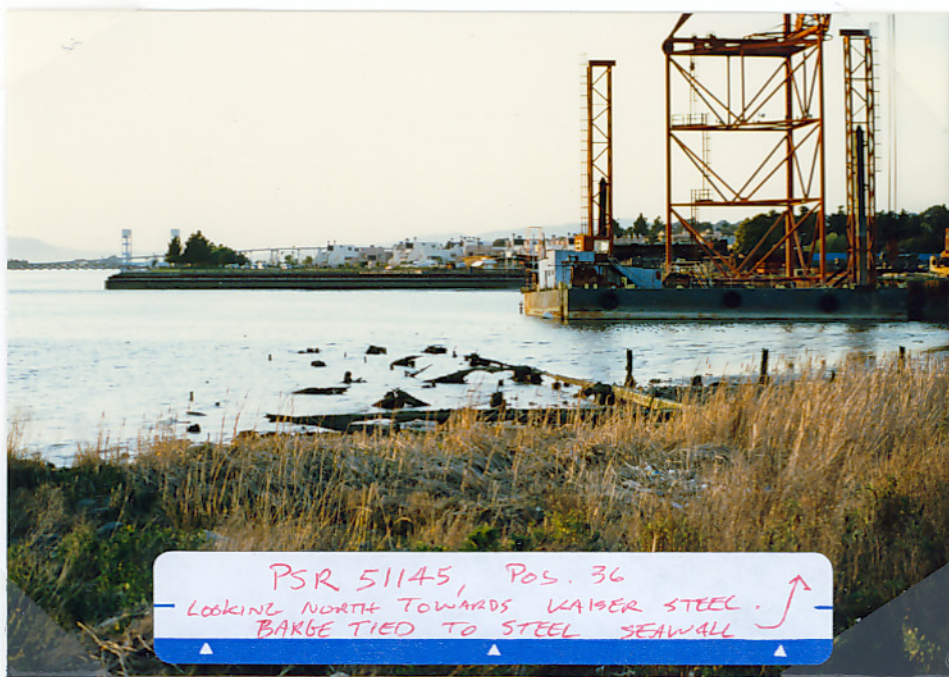
AWO/S 51145
Pos. 36

PSR 51145, Pos. 36
— Looking NORTH TOWARDS KAISER STEEL. —
BARGE TIED TO STEEL SEAWALL —

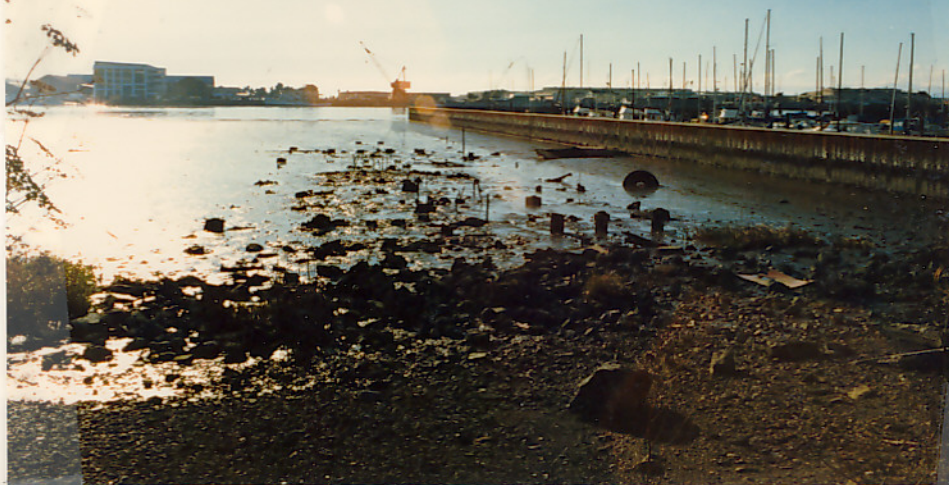
Pos. 59

RUINS AND WRECK IN FOUL AREA,
SOUTH OF SOUTH BULKHEAD OF VALLEJO
MUNICIPAL MARINA. POS. 59 IS ON TALL PIPE. ↗

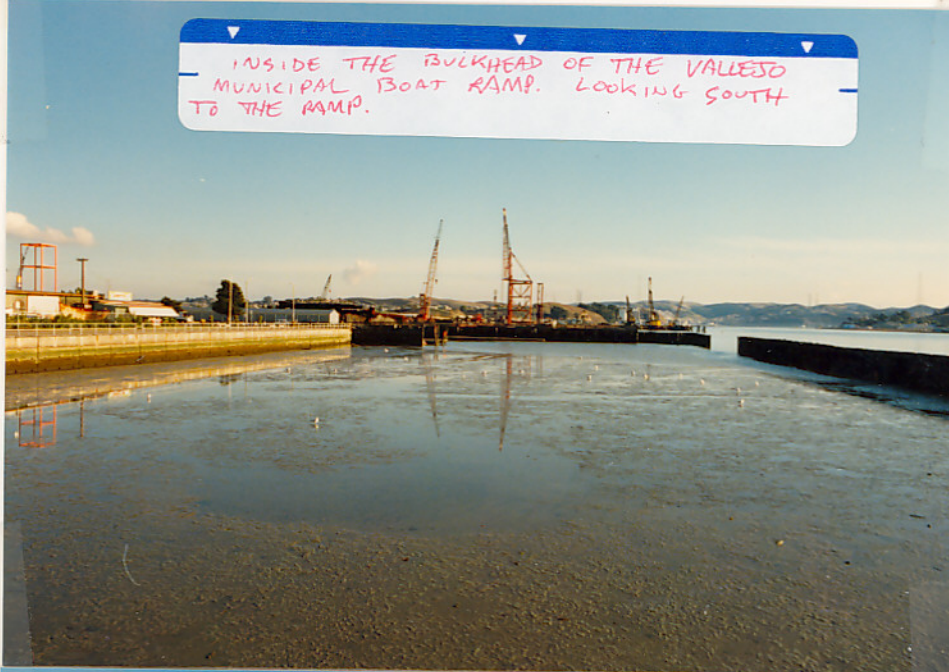
INSIDE THE BULKHEAD OF THE VALLEJO
MUNICIPAL BOAT RAMP. LOOKING SOUTH
TO THE RAMP.

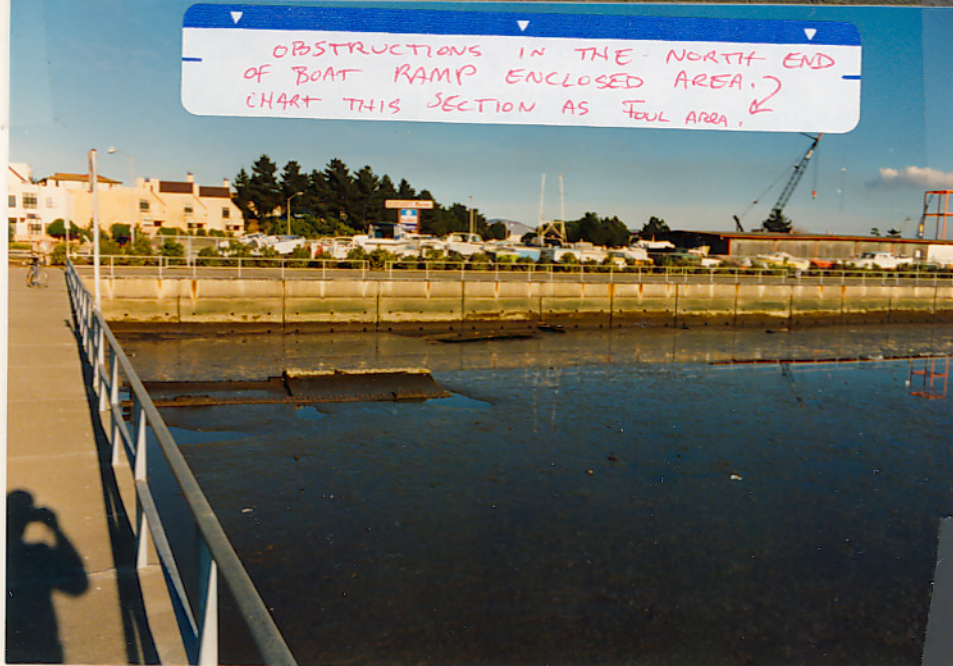
OBSTRUCTIONS IN THE NORTH END
OF BOAT RAMP ENCLOSED AREA. ↗
CHART THIS SECTION AS FOUL AREA.
