DESCRIPTIVE REPORT

Type of Survey Hydrographic
Field No. RA-10-1-86
Registry No. H-10228

State Alaska
General Locality Seymour Canal
Sublocality North and West of Swan Island

HYDROGRAPHIC TITLE SHEET

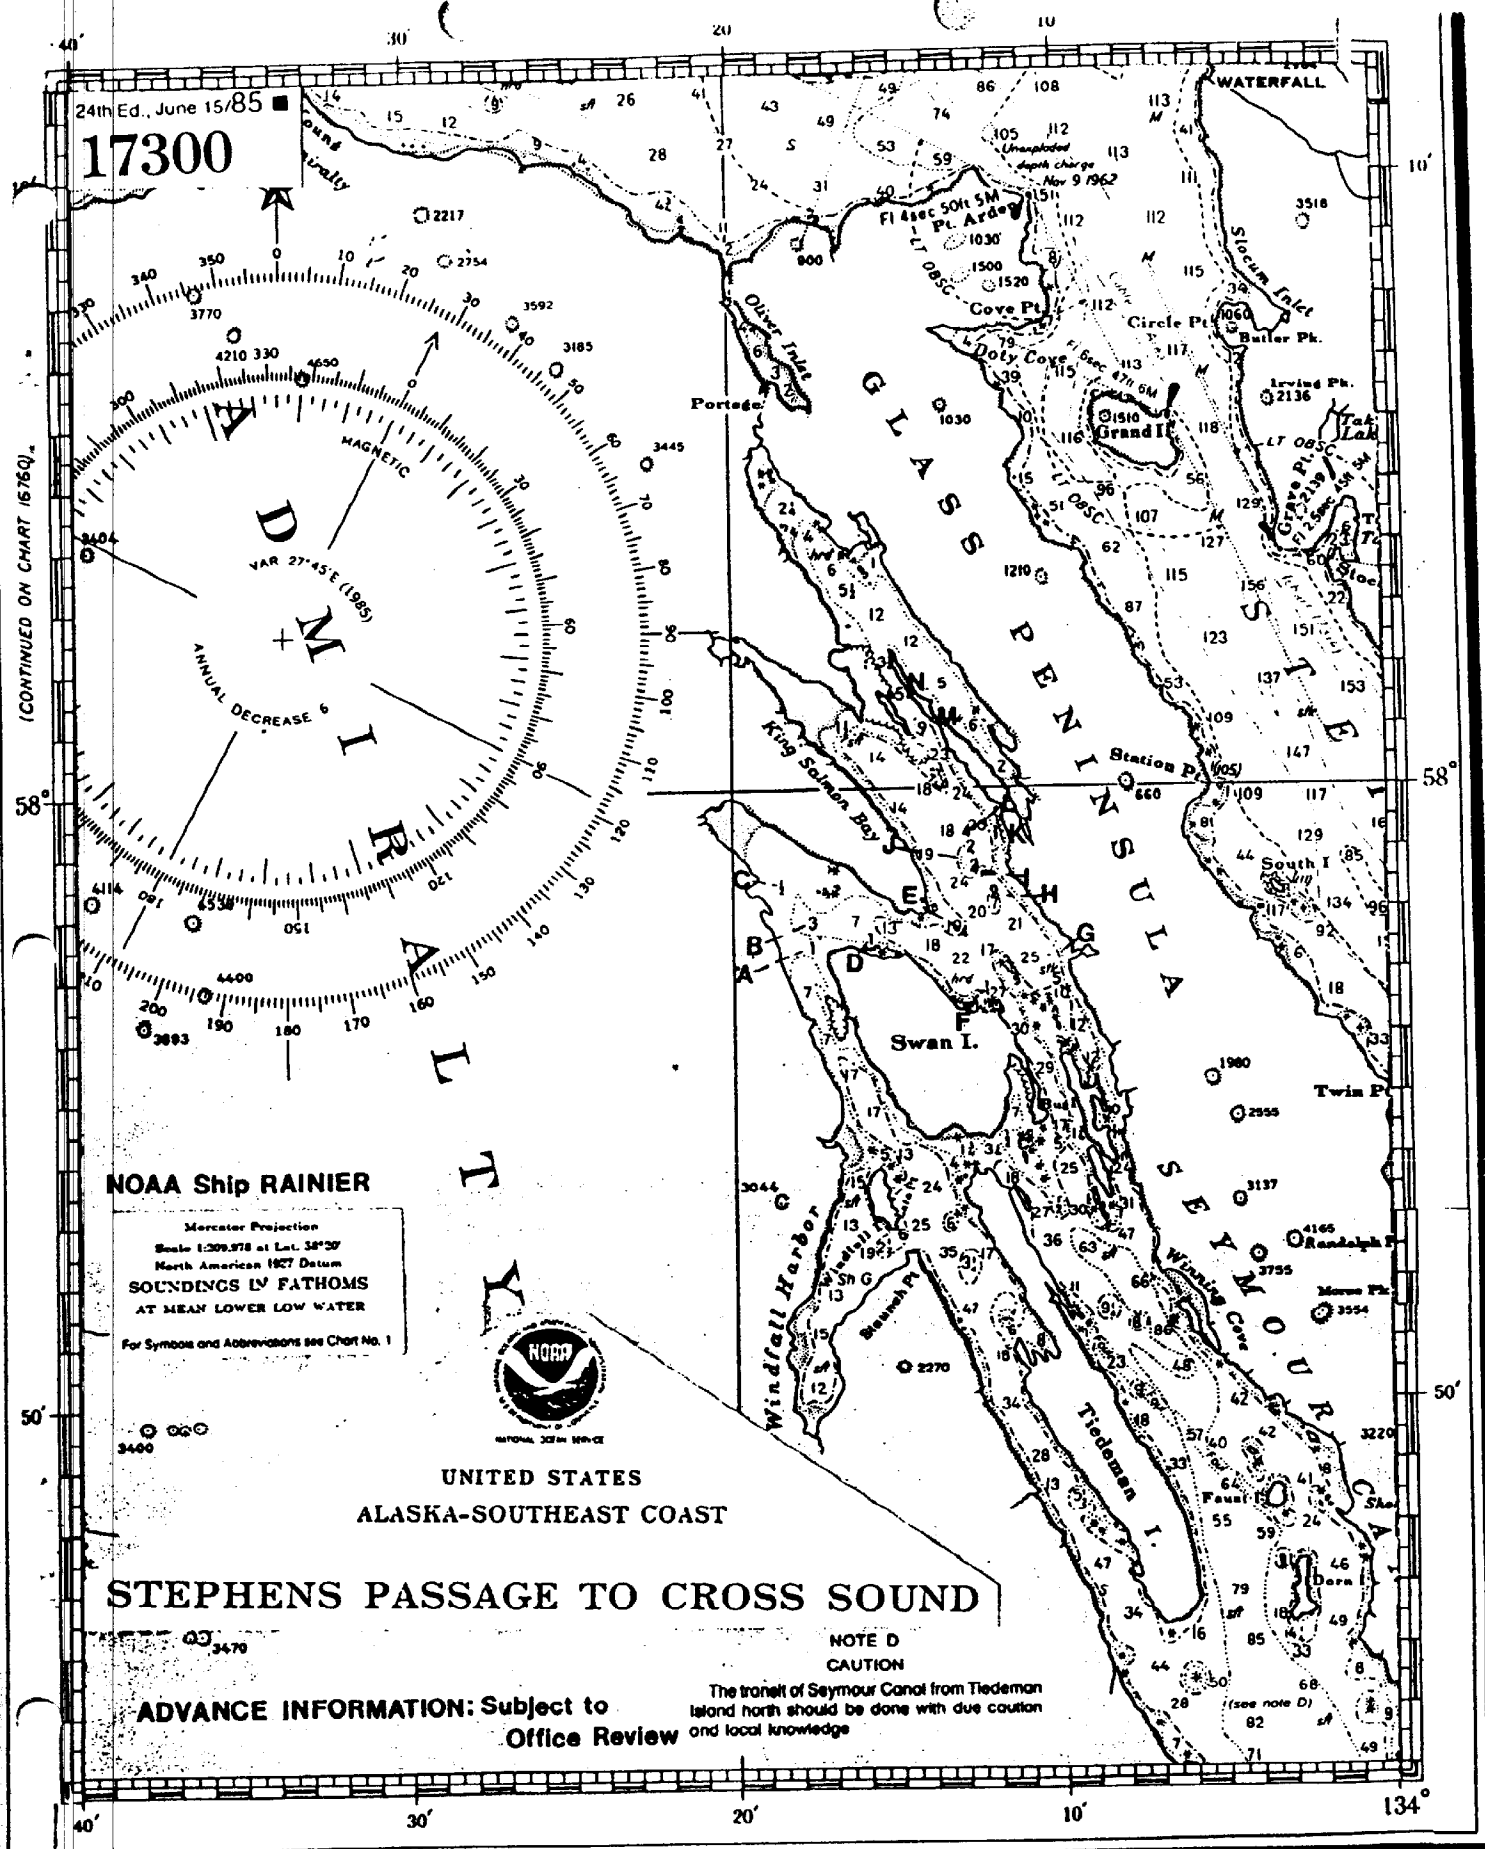
Recommendation: At the present chart scale, the charted 2 1/4 fm depth is a misleading representation. Change the charted depth to 1 fm.

Recommendation: Add a 1 fm depth at the above position.

ITEM A: Change 2 1/4 fm to 1 fm
ITEM D: Add 1 fm
H-10228
SEYMOUR CANAL ALASKA

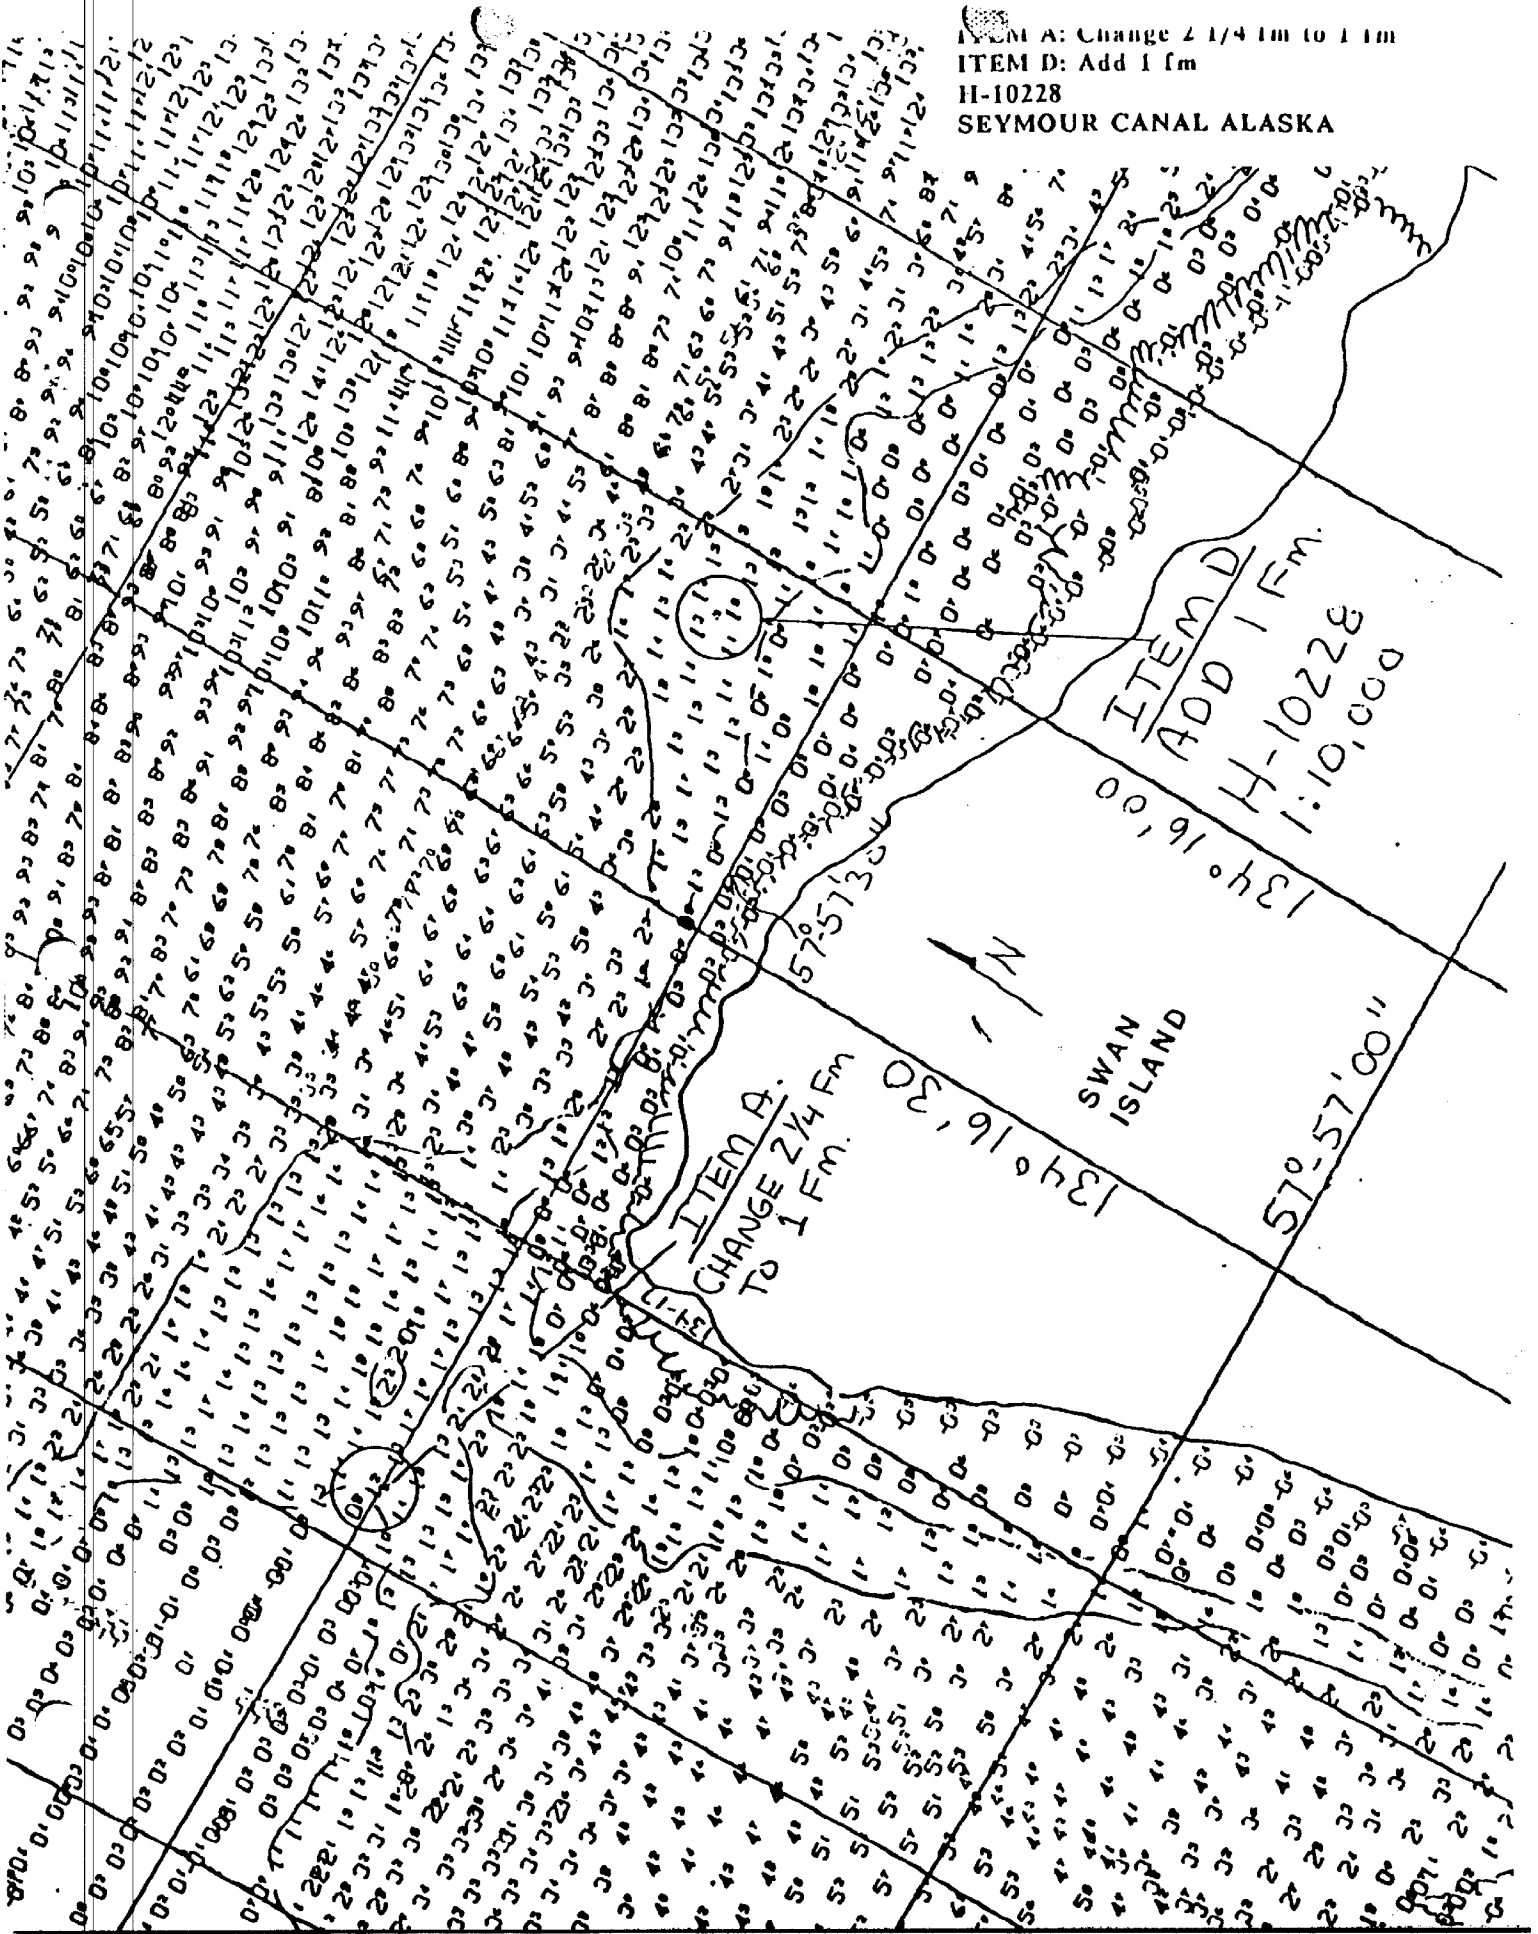
ITEM A:
CHANGE 2 1/4 Fm
TO 1 Fm.

ITEM D:
ADD 1 Fm.
H-10228
1:10,000

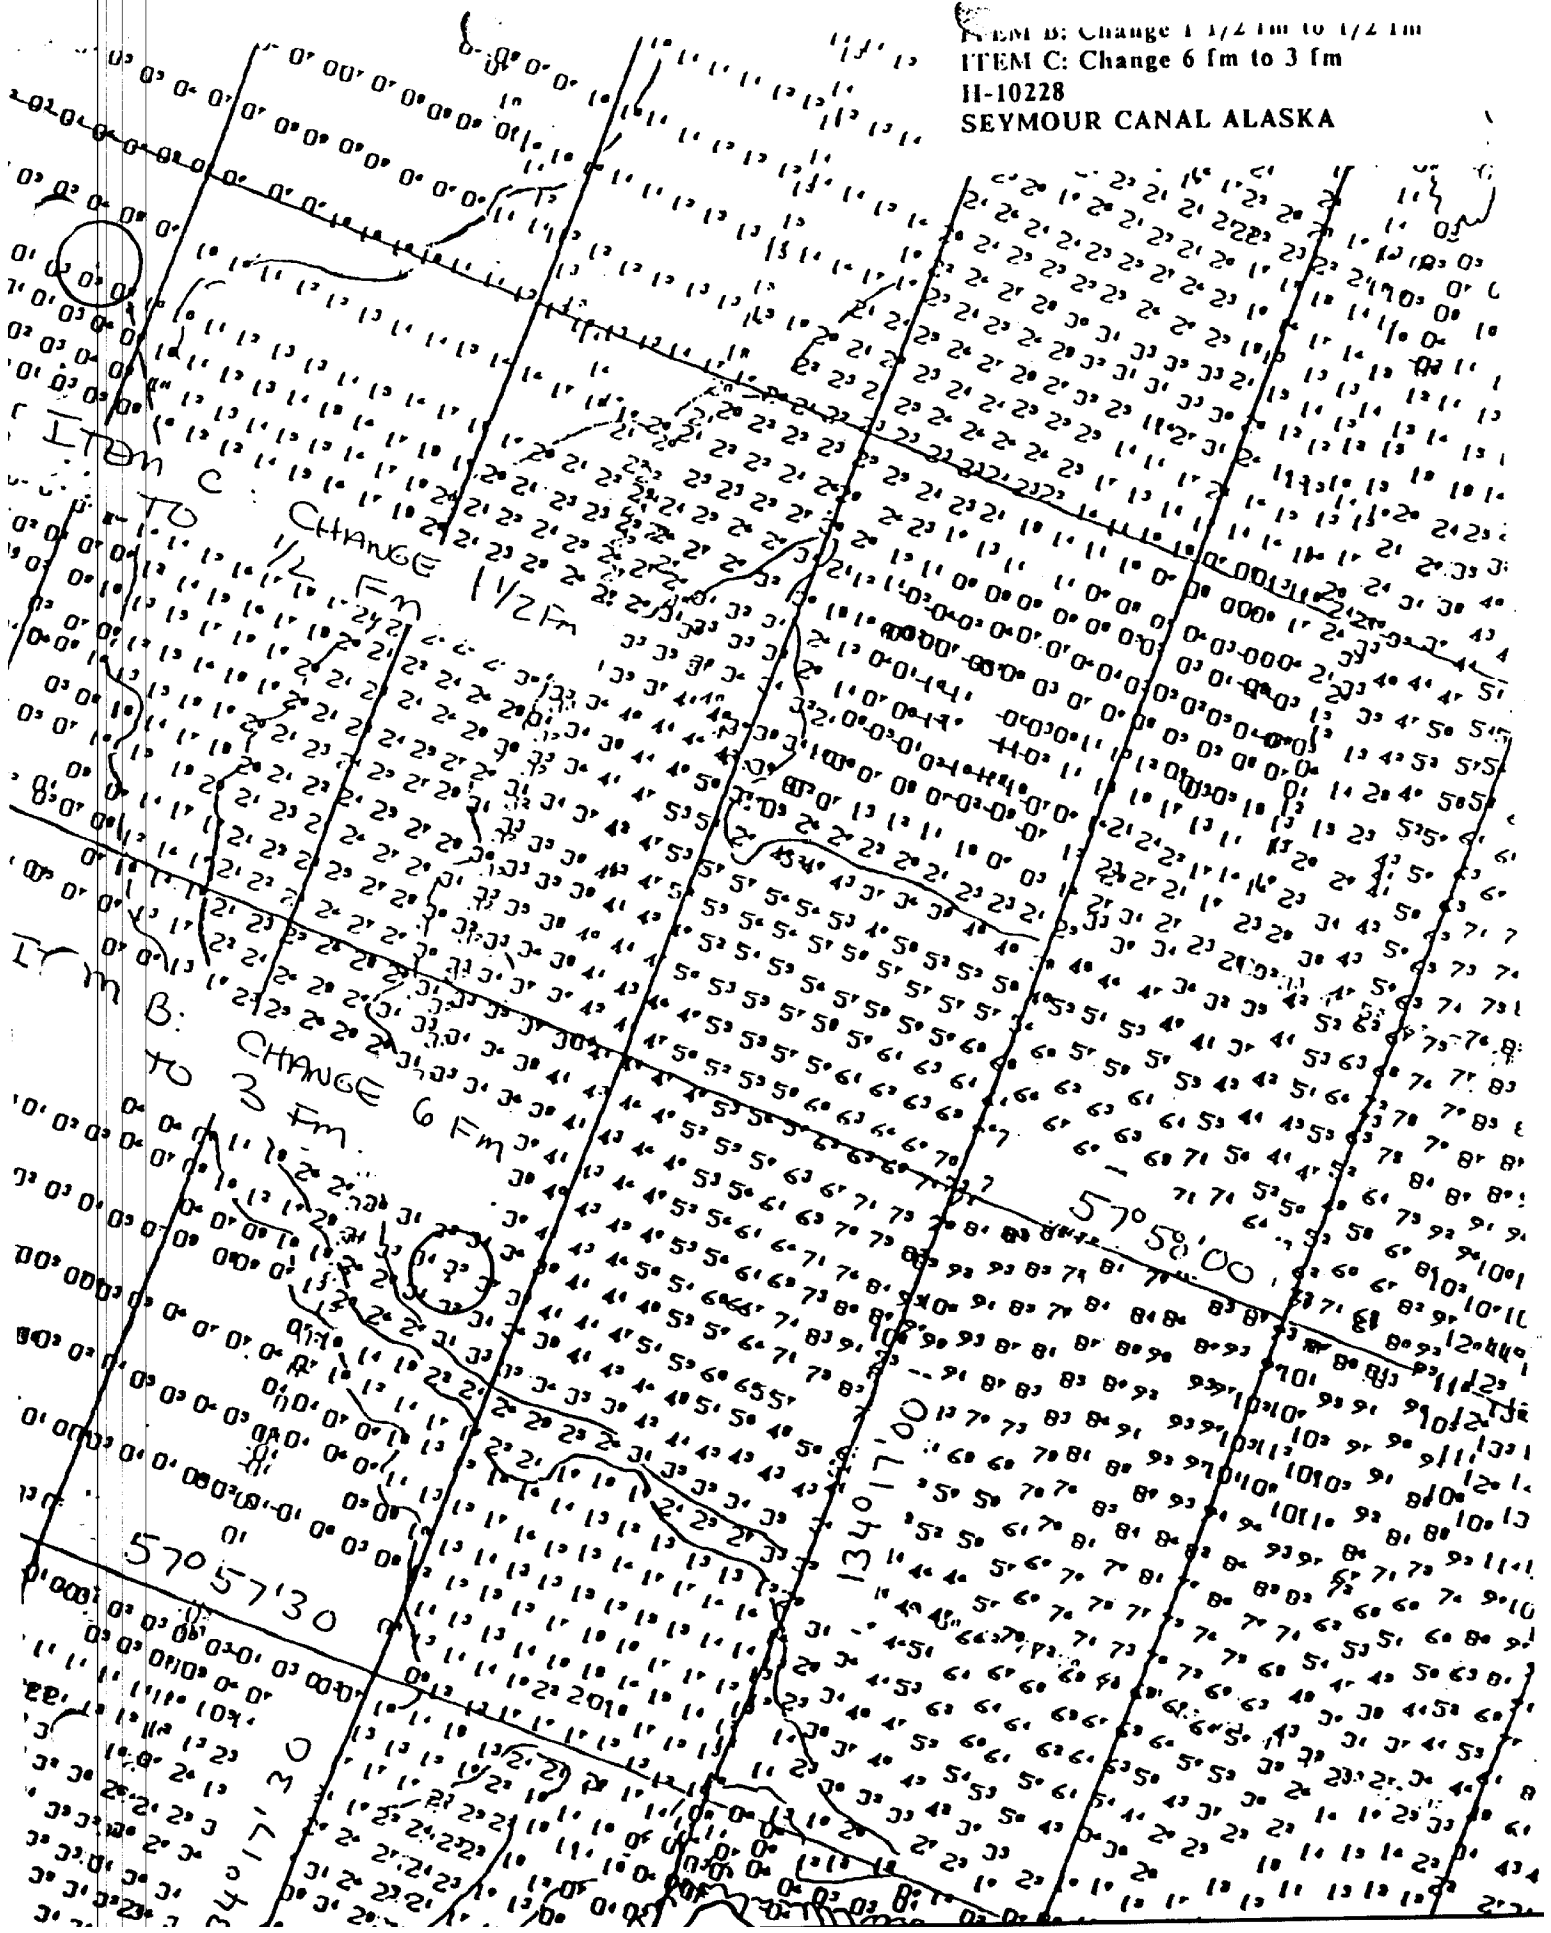
Method of Investigation: The area was developed at 50 meter spacing. Depths of 3 to 6 fm were found in the vicinity of the charted 6 fm depth.

Recommendation: Change the charted 6 fm depth to 3 fm.

Method of Investigation: The area was sounded at 100 meter spacing. Depths of -1/2 fm to 2 fm were found in the immediate area. A large area which bares at MLLW exists to the west and northwest of the charted 1 1/2 fm depth.

Recommendation: Change the charted 1 1/2 fm depth to 1/2 fm.

ITEM C:
TO CHANGE
1/2 Fm
1/2 Fm

ITEM B:
TO CHANGE
3 Fm
6 Fm
