DESCRIPTIVE REPORT

Type of Survey ... Hydrographic.....
Field No. HFP-10-5-86.....
Registry No. H-10235.....

State Florida.....
General Locality .. St. Andrew Bay.....
Sublocality Sulphur Point to West.....
..... Bay Point.....

H-10235

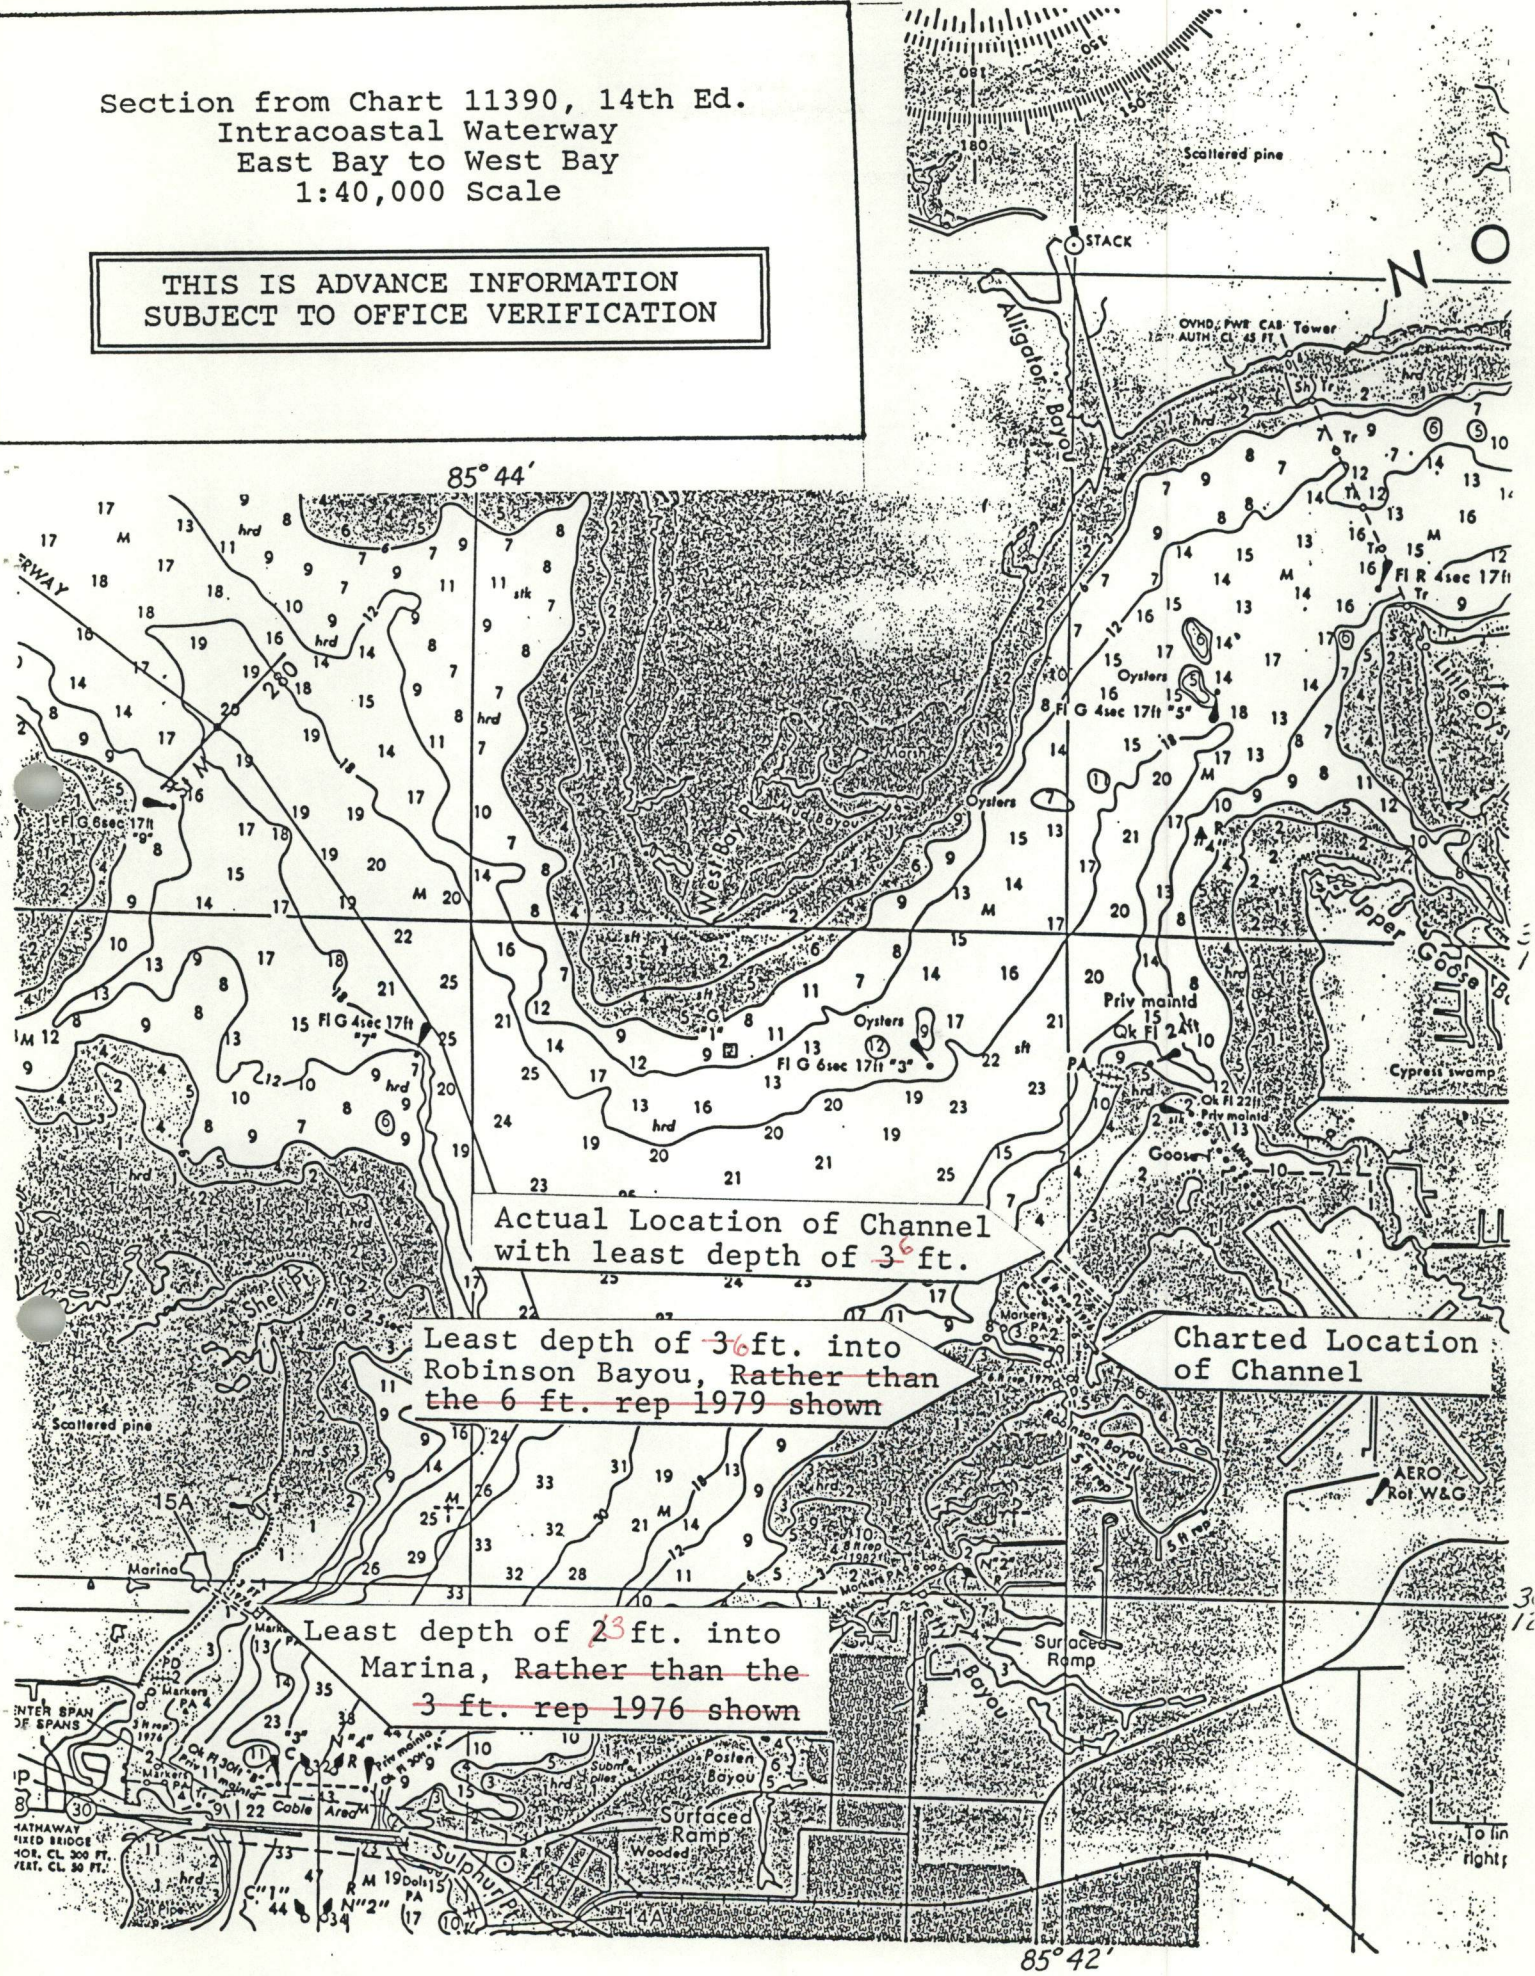
Section from Chart 11390, 14th Ed.
 Intracoastal Waterway
 East Bay to West Bay
 1:40,000 Scale

-- The channel leading into Robinson Bayou, marked with private channel markers, currently charted with "6 ft. rep 1979", was found to have a shoal least depth of ~~3~~^{36.47} ft. at MLLW at lat. 30°12'46.2"N, long. 085°42'10.5"W. ^{41'59.82"W} *SEE ALSO SECTION 7.b.3) OF THE EVALUATION REPORT.*

Actual Location of Channel
 with least depth of ~~3~~⁶ ft.

Least depth of ~~3~~⁶ ft. into
 Robinson Bayou, Rather than
 the ~~6 ft. rep 1979~~ shown
