DESCRIPTIVE REPORT

Registry No. H-10239.....

General Locality .. Seymour Canal.....

Sublocality Head of Seymour Canal.....

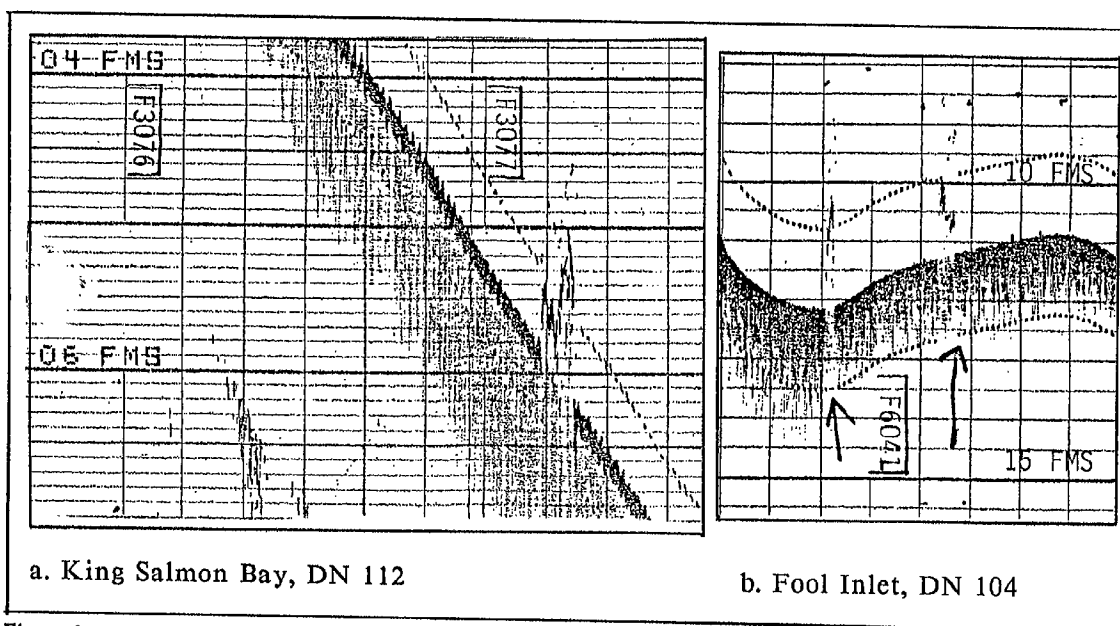
During the course of mainscheme hydrography occasional strays and side echoes were detected which indicated that further development was necessary to better define the limits of these objects. However, many of the strays visible on the high-frequency echo-sounder trace during mainscheme hydrography were not seen on subsequent passes

over the same line, nor on lines closely adjacent to the mainscheme line. In those cases in which a bottom feature could not be discerned by further investigation the shallowest depths seen on the original echo-sounder trace were inserted into the digital record anyway, and caused no significant shifts to the depth contours on the final field sheet (Figure 2).

Figure 2, a and b. Examples of high-frequency sounding anomalies which were not found again on subsequent reruns of the same sounding lines. In cases such as these the shallower soundings were inserted into the digital records for plotting of the final field sheet.

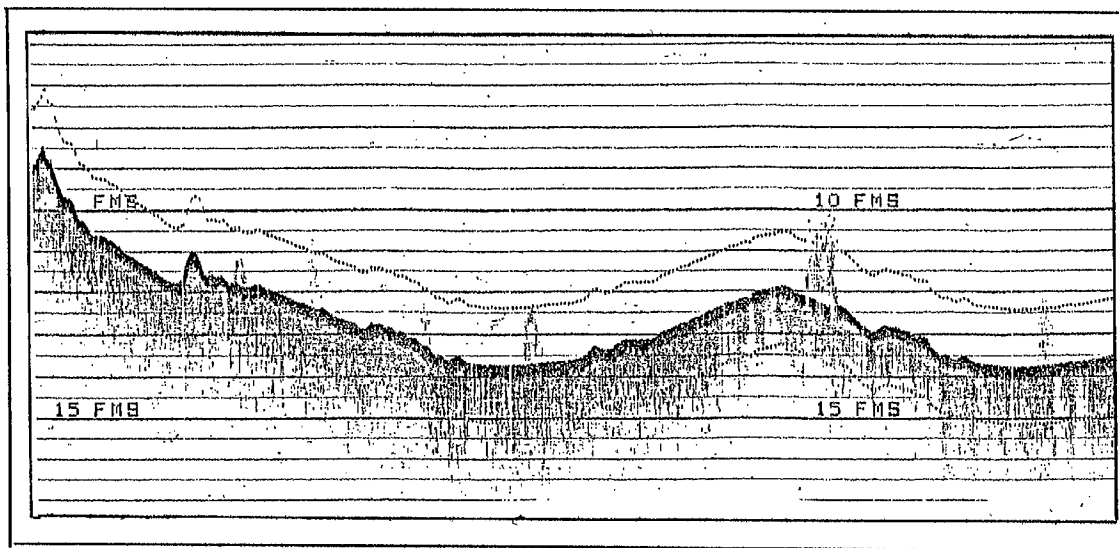
Perhaps more perplexing than the high-frequency strays was the occurrence of many side echoes on the low-frequency trace. These ghostlike images showed up mostly in King Salmon Bay on day 116, and only when the water surface was flat calm and the launch was running a straight line with no rolling or pitching. Significant time and effort was spent trying to develop apparent contacts rising 2 to 3 fathoms in 9 to 13 fathoms depth as seen on the low-frequency echo-sounder trace (Figure 3). Developments were run at 10-meter spacing in an attempt to get strong high-frequency images of the peaks, but with very little success. For this reason, a side scan investigation was conducted (Section L).

Figure 3. Examples of low-frequency side echoes encountered in King Salmon Bay on day 116. Subsequent narrowing of line spacing often failed to provide further confirmation of the objects with the high-frequency beam. The most significant low-frequency peaks were inserted into the digital record when high-frequency returns could not be obtained.

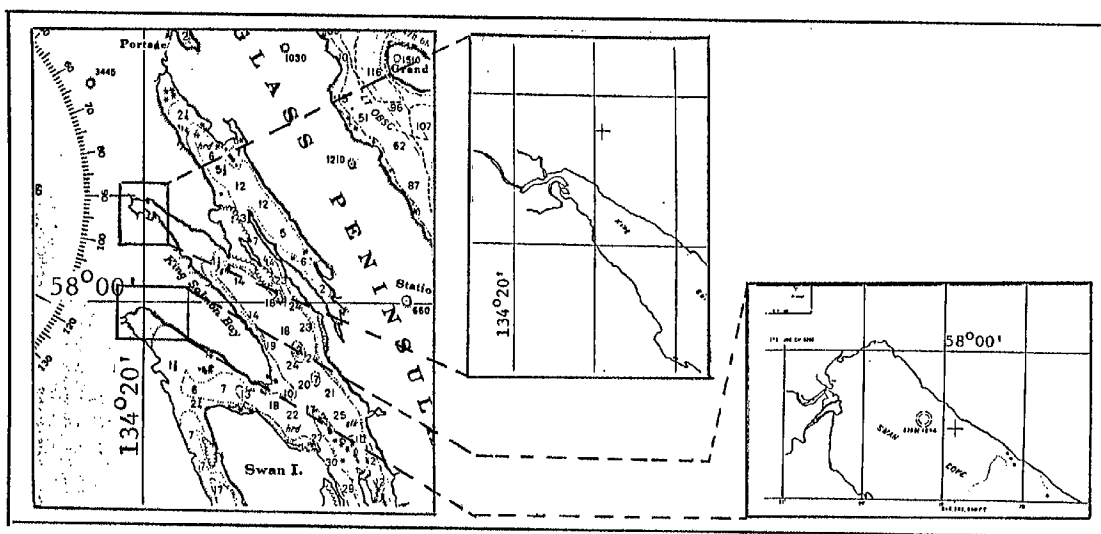
This survey was compared to Chart 17300, NAD27, 24th edition, June 1985. Ten depths appear on Chart 17300 within the area of the present survey. It is difficult to compare the charted depths on the basis of their plotted geographic positions because Seymour Canal is apparently not charted correctly on Chart 17300. As can be seen in Figure 4, positions of shoreline features on the chart do not agree with the TP-sheet. However, a rough visual comparison of the chart with this survey indicates that the charted depths relative to the shoreline are adequate when considering the scale difference in the comparison.

Figure 4. A comparison of Chart 17300 and Shoreline Manuscript TP-01163 shows that Seymour Canal is not charted correctly, thus making it difficult to compare geographical positions of charted depths with current survey depths.

The hydrographer recommends that the ^{shoreline} location of Seymour Canal be revised before printing the next edition of Chart 17300. The existing chart did not agree with the TP-sheet as to the location of the shoreline relative to the longitude and latitude lines. This discrepancy is clearly shown in the examples in Figure 4. RAINIER believes the TP-sheet to be the more accurate source, as geodetic stations plotted on field sheets and overlaid with the TP-sheet agreed. *concur.*
