DESCRIPTIVE REPORT

Type of Survey Hydrographic
Field No. RA-10-1-88
Registry No. H-10273

State Alaska
General Locality .. Alaska Peninsula
Sublocality Eastern Chiginagak Bay

Descriptive Report to Accompany Hydrographic Survey H-10273

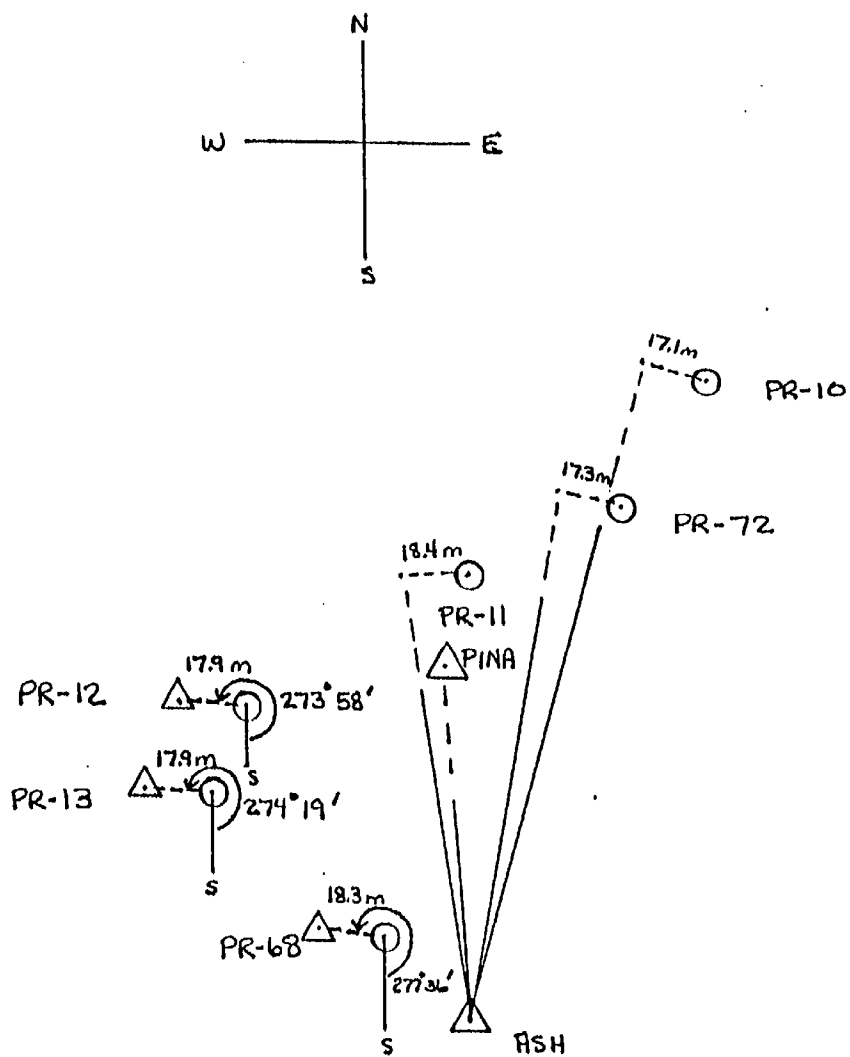
ATTACHMENT A - Displacement of Stations

To verify the location of station PR-12, launch critical system checks were accomplished using theodolite intersection. Differences of 15 to 20 meters from the Mini-Ranger baseline correctors were found. To verify other photo stations, a First-Order geodetic station (ASH) was occupied with horizontal angles (four-plate settings) turned from a First-Order station (PINA) to PR-72, PR-10, and PR-11. Using the computed distances from ASH to the aerotriangulated stations, differences between the observed and computed angles leads to positional errors of 17 to 18 meters (see Attachment A).

Third-Order, Class I positions were then determined for PR-12, PR-13, and PR-68. All three geodetic positions are approximately 18 meters west of the aerotriangulated positions (see Attachment A). This is the same error that was found with stations PR-72, PR-10, and PR-11, discussed above.

It is recommended that Job CM-8200 be reviewed as an 18-meter error to the east is suspected in both the aerotriangulated positions and the shoreline. FAIRWEATHER will not attempt to use any photogrammetric station positions from this project until the problem is resolved. Geodetic control has been extended south to Cape Providence as of this time.
